## Load Compartment Cover Noises

| Topic number | LI68.50-P-079347 |
| Function group | 68.50 - Curtains, roller blinds, luggage net |
| Validity | BR 254 before production date 09.12.2024 |

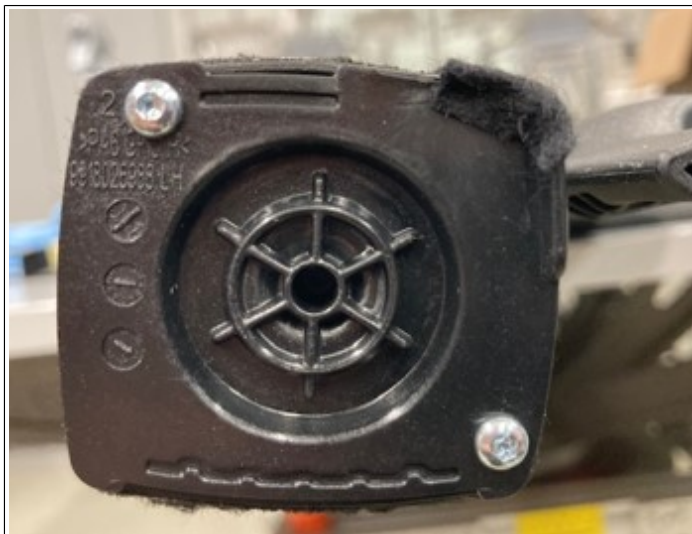
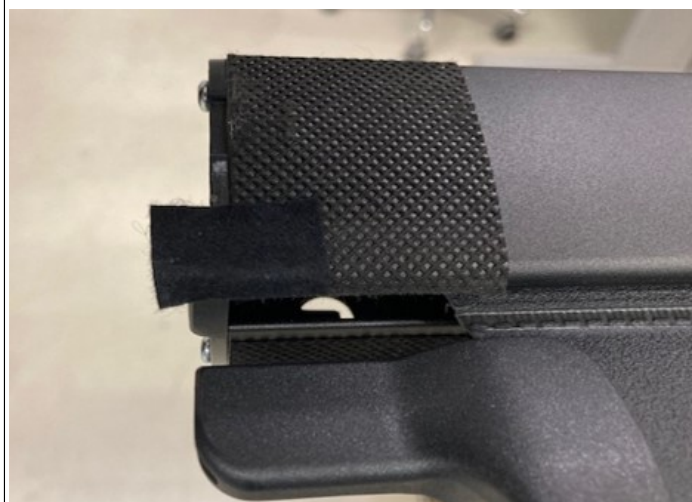
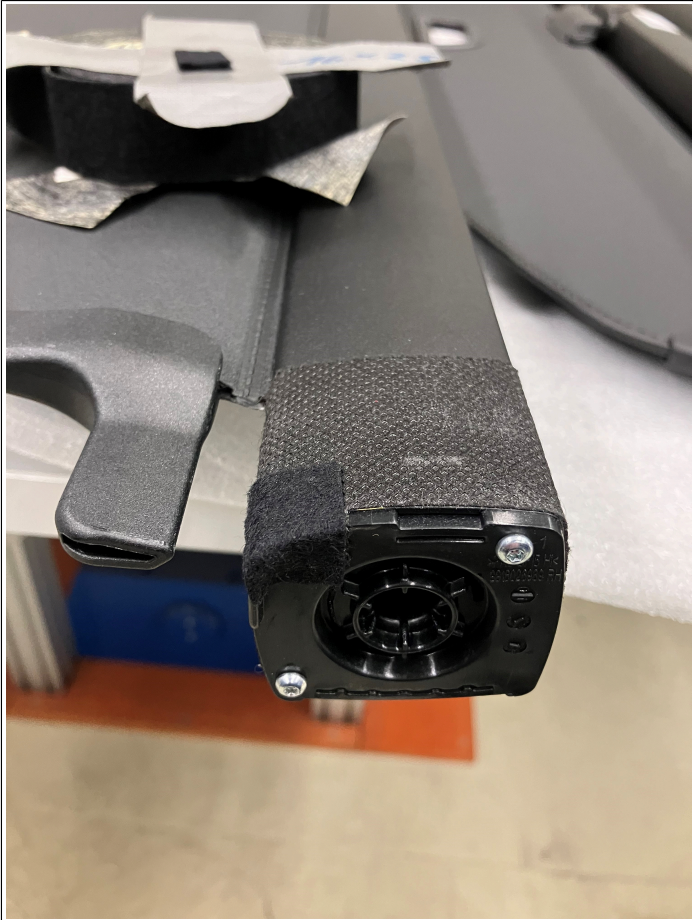
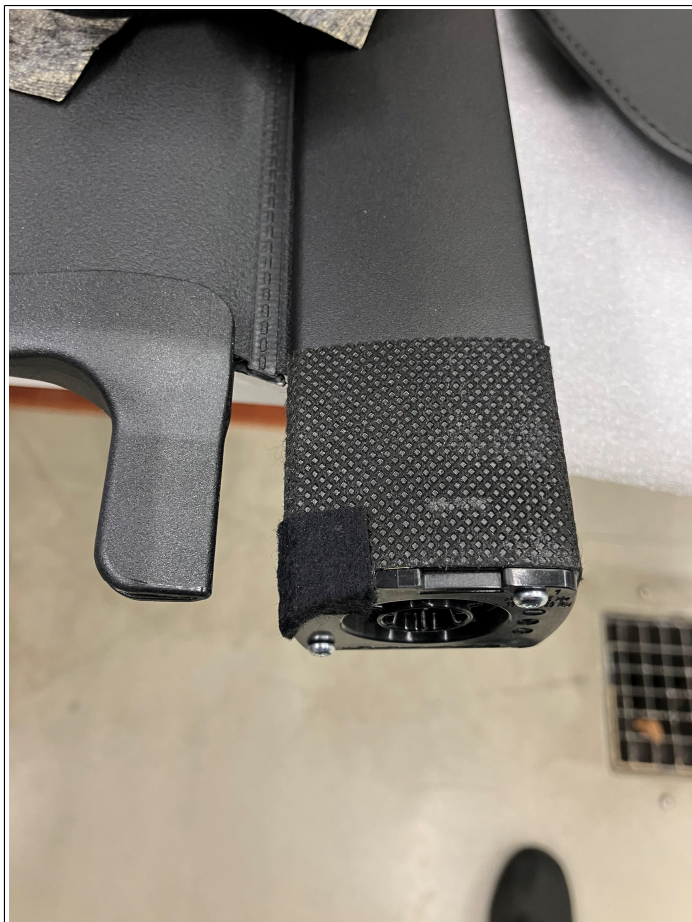
Aluminum cassette scrapes on the inside of the end cap. The contact point causes creaking noises.

Glue a piece of felt (see attachment) to each top corner in the direction of the roller blind outlet (left and right side).

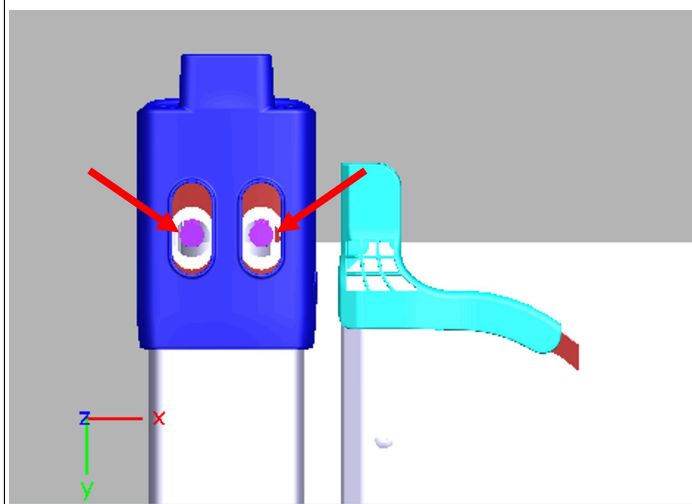
Pins.jpg

Guide pins for disassembling the end cap.

Disassemble end caps of load compartment cover by pressing the guide pins (see attachment) inwards and removing the end caps.

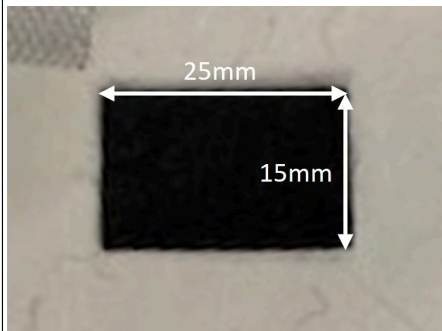
| Attachments | |
|---|---|
| <a href="#">Filz.jpg</a><br> | Felt 25 mm x 15 mm x 1 mm (L/W/H) |

Cut 2 felt strips to required size of 25 mm/15 mm/1 mm (length/width/height).
