E-Series	Model Description
G05	X5 Sport Activity Vehicle
G06	X6 Sports Activity Coupe
G07	X7 Sports Activity Vehicle

A whistling sound is heard coming from the front end of the vehicle while driving at various speeds.

AREAS OF POTENTIAL WIND NOISE

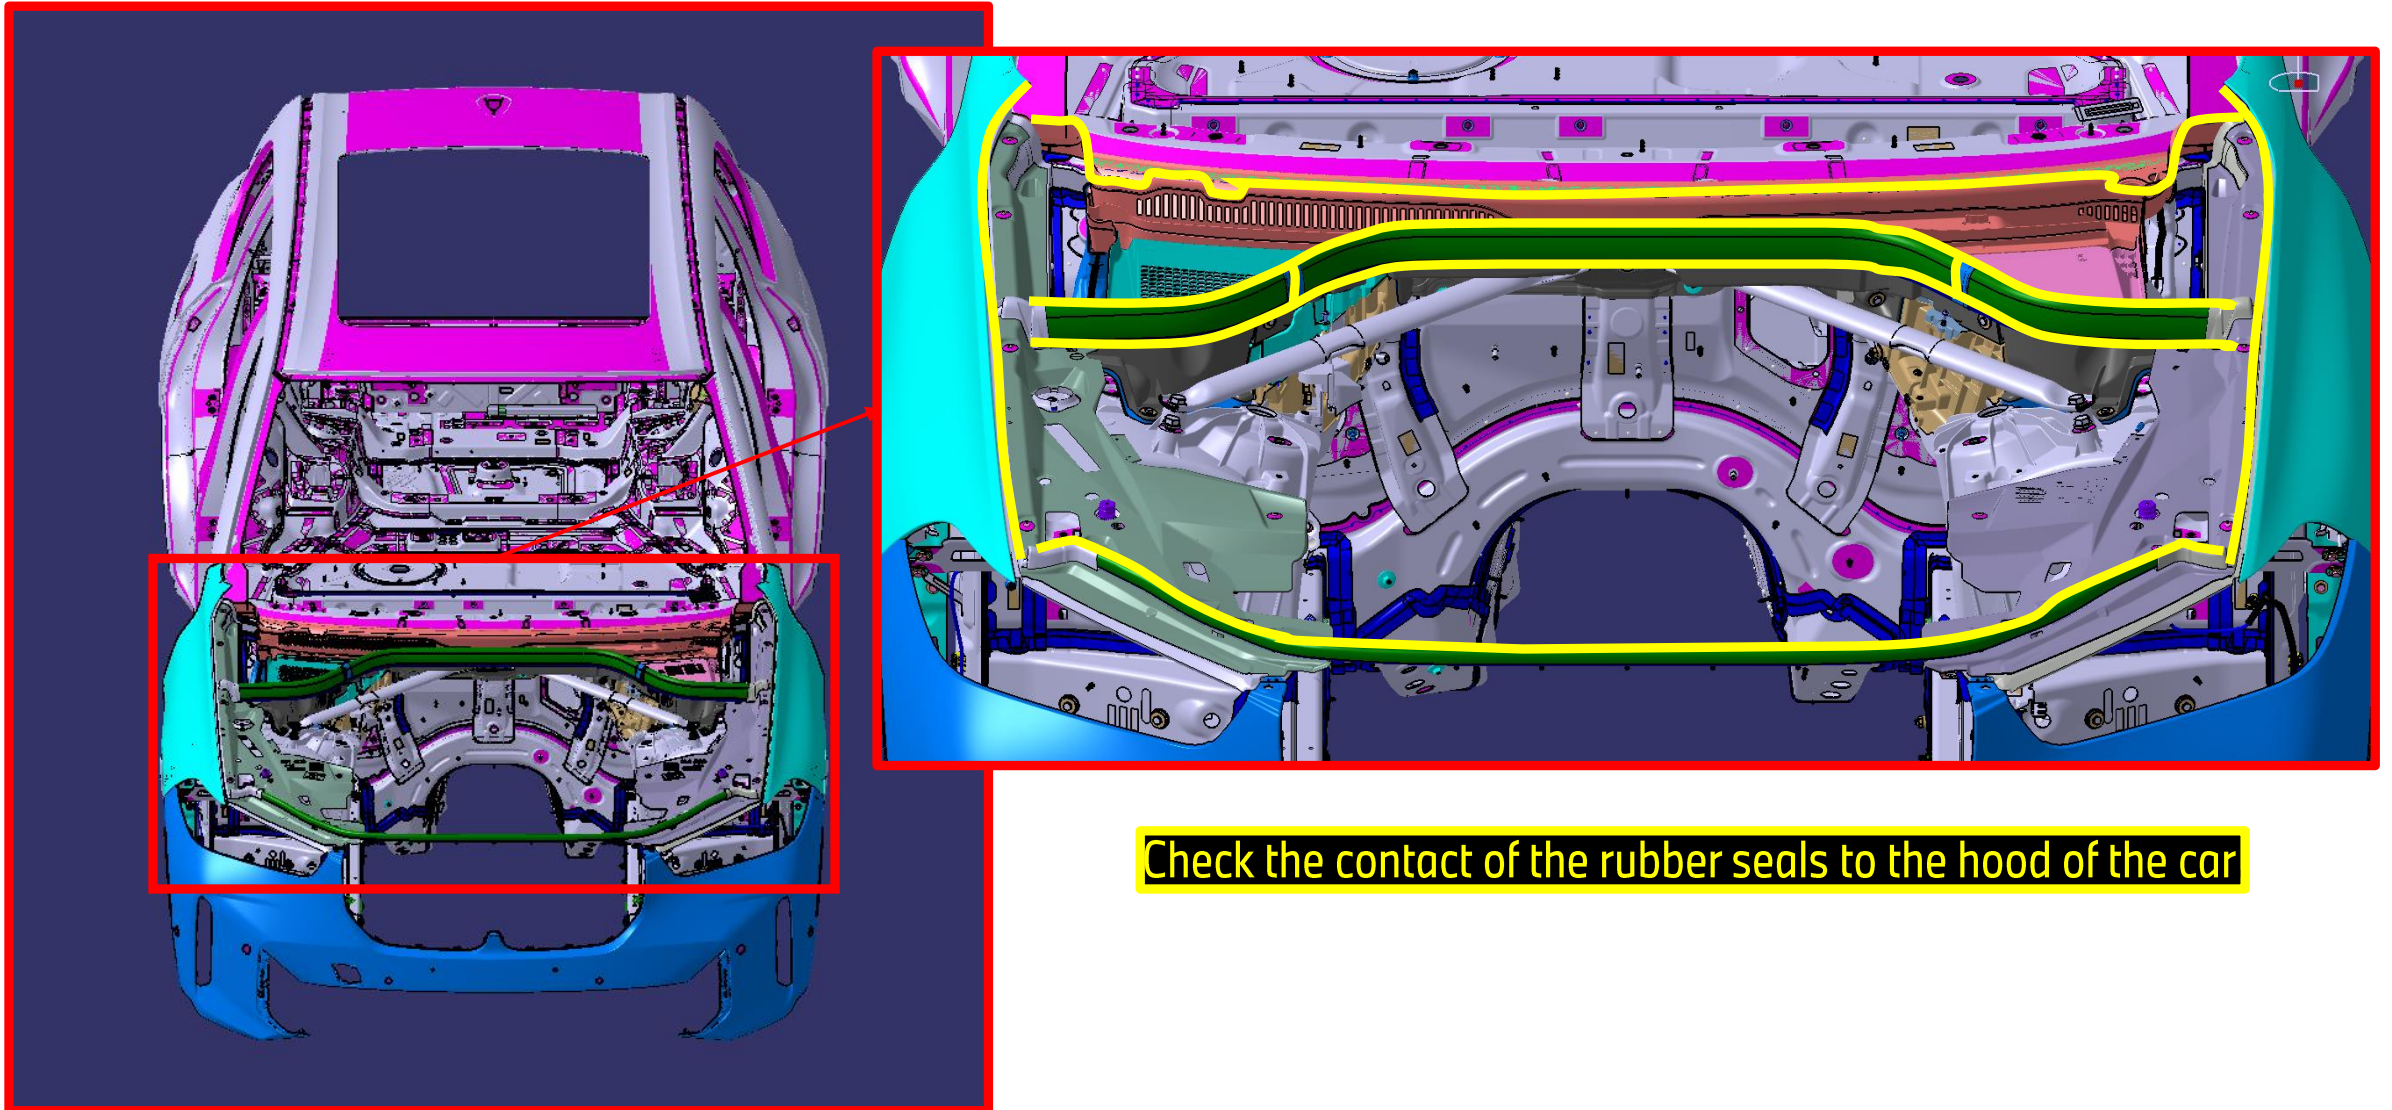
HOOD SEALS

Check the contact of the rubber seals to the hood of the car

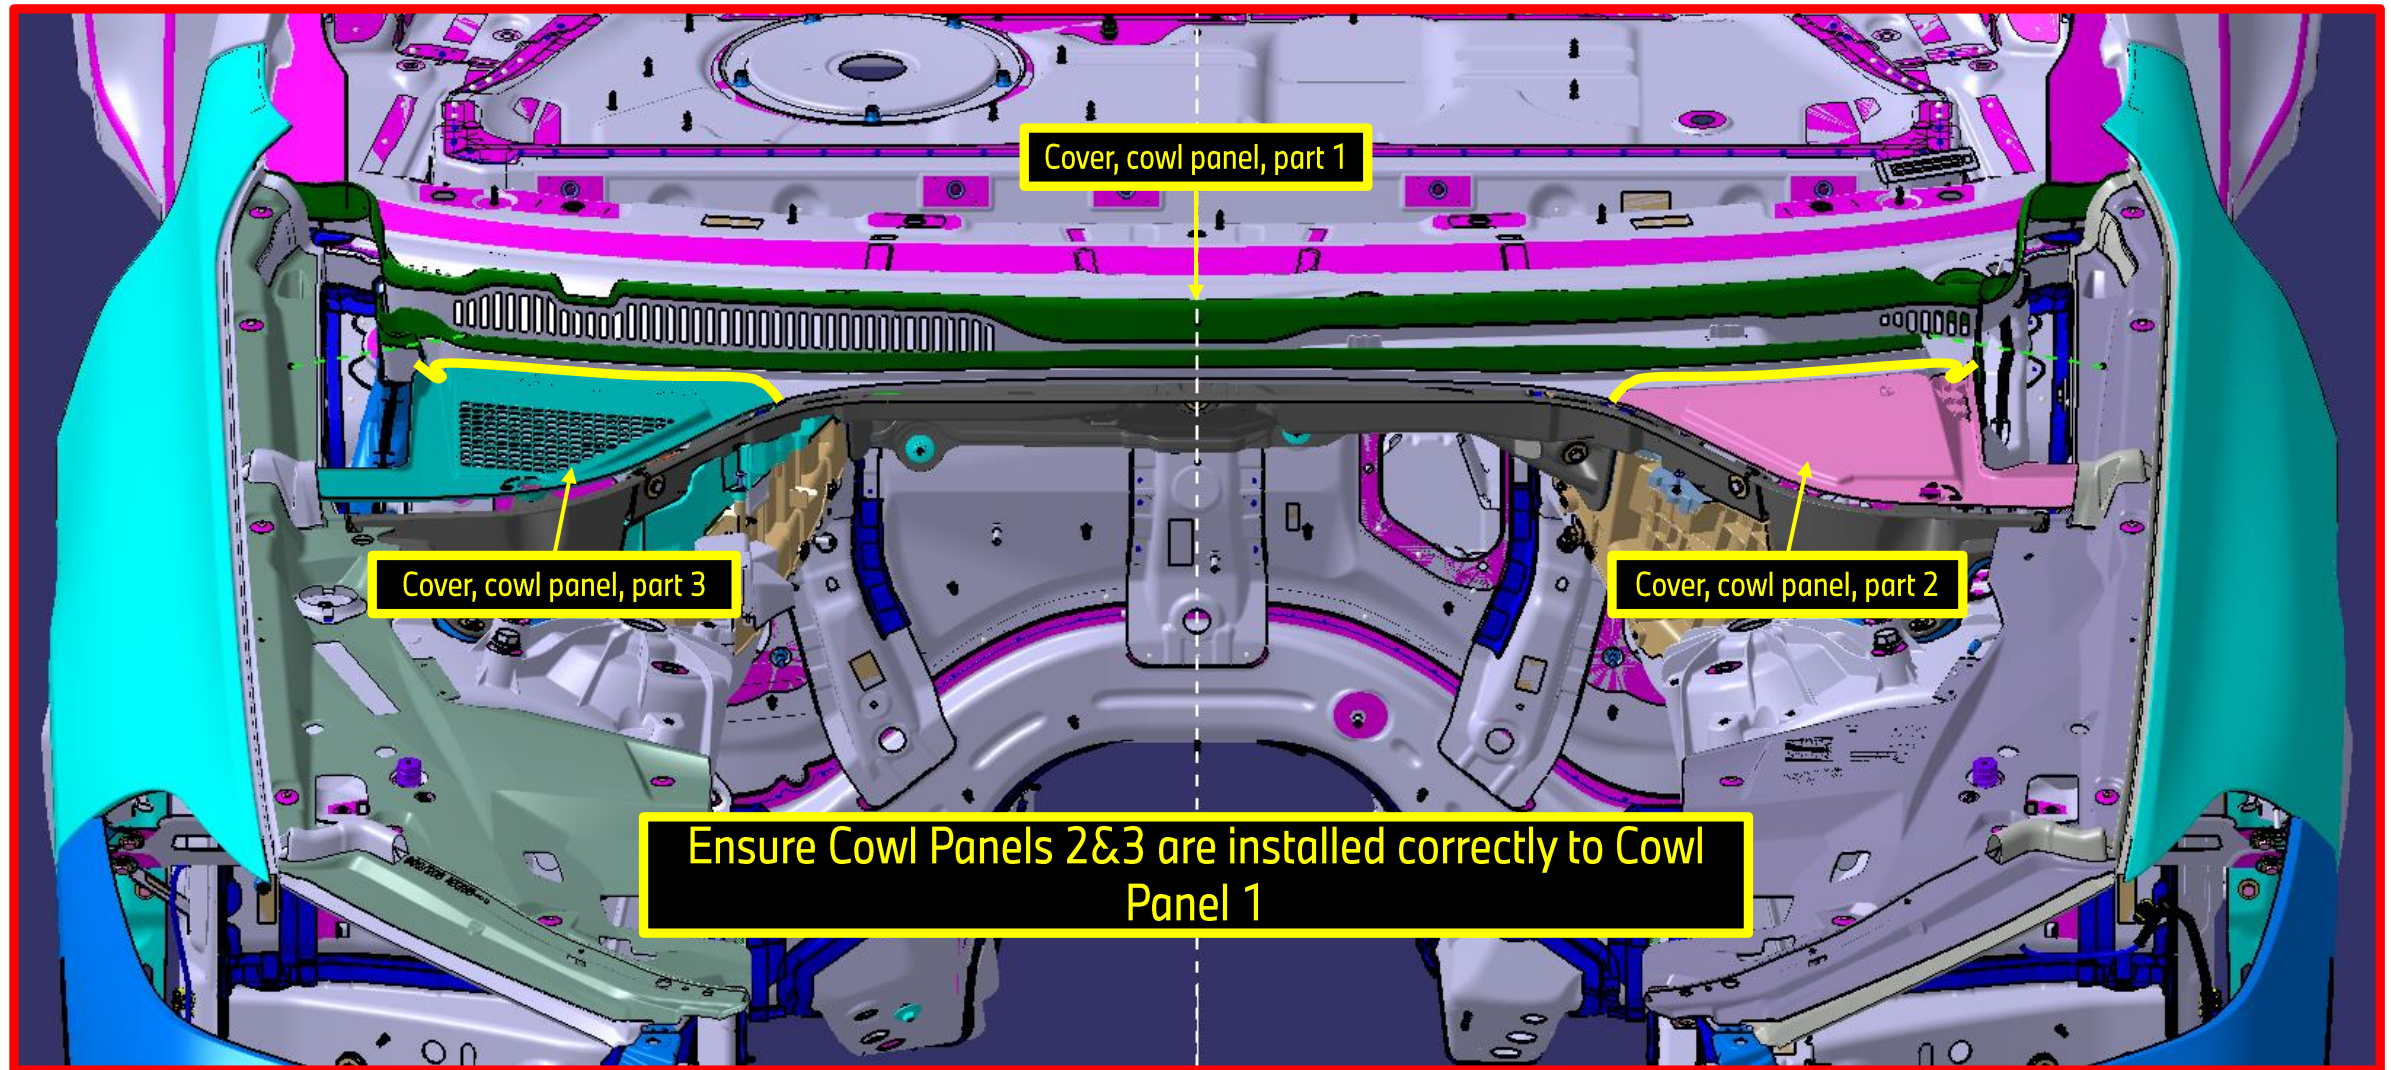
VISUAL INSPECTION

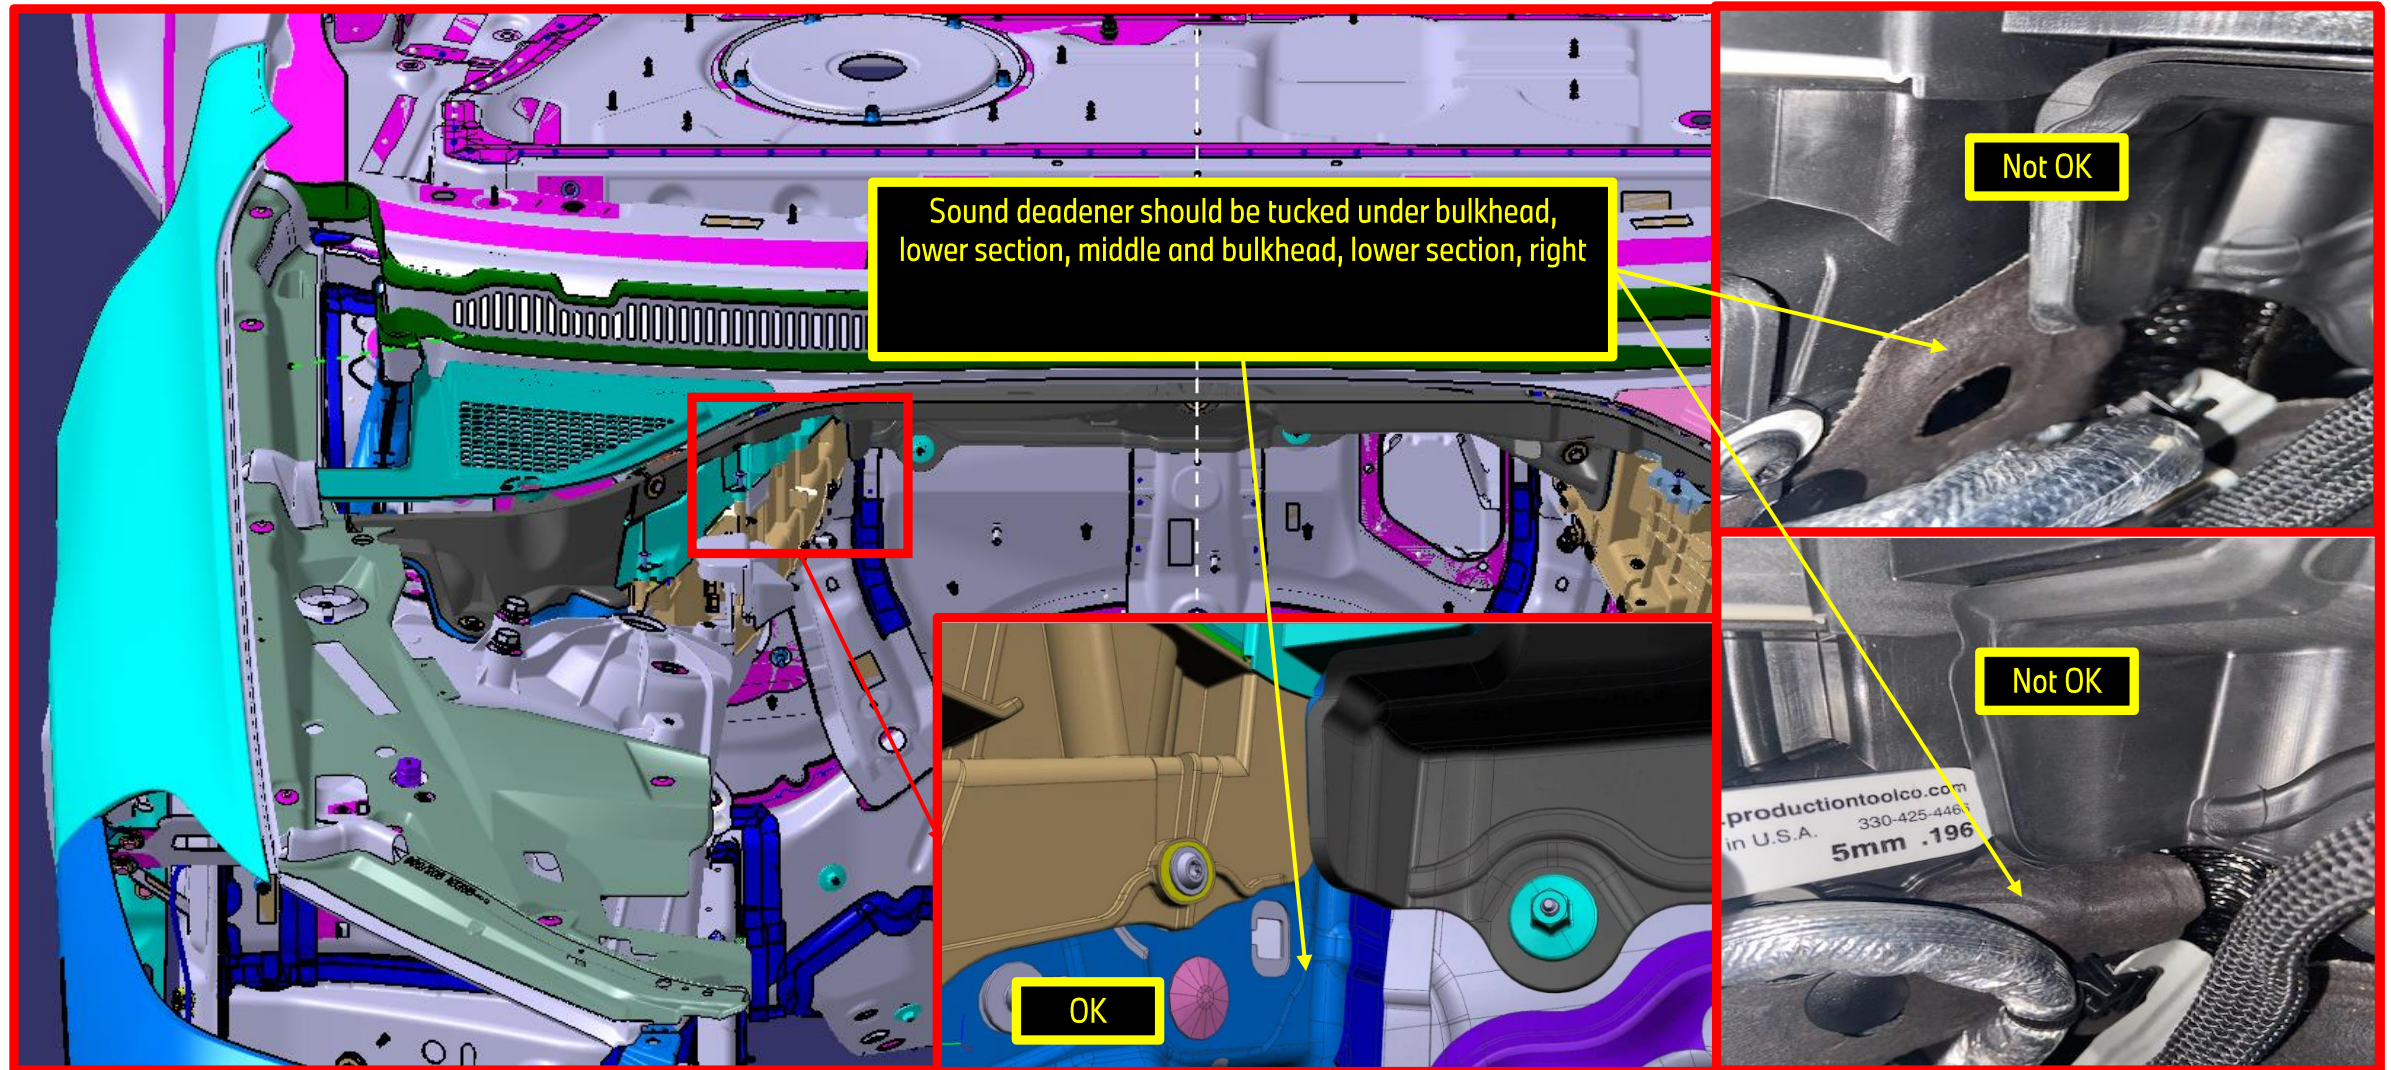
VISUAL INSPECTION

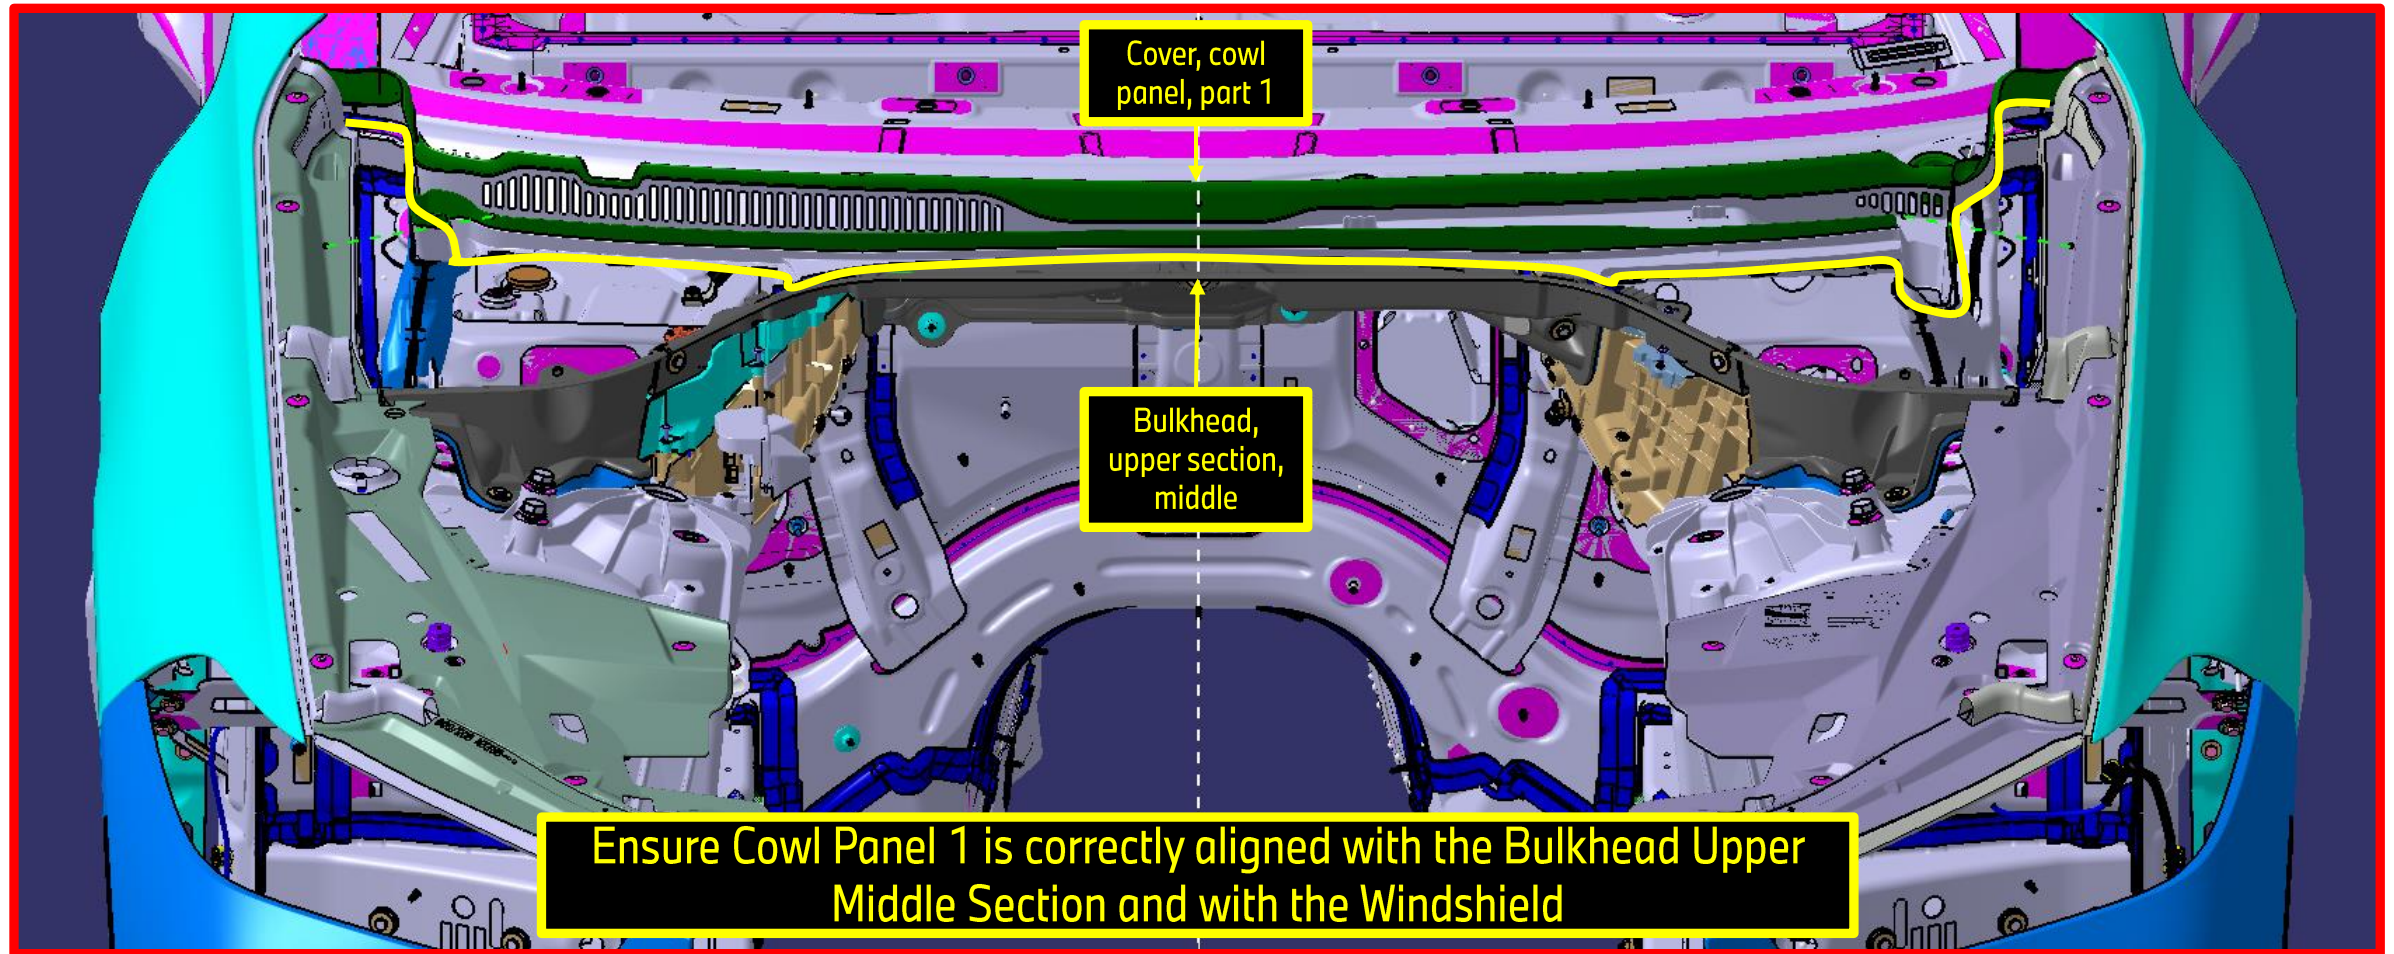
VISUAL INSPECTION

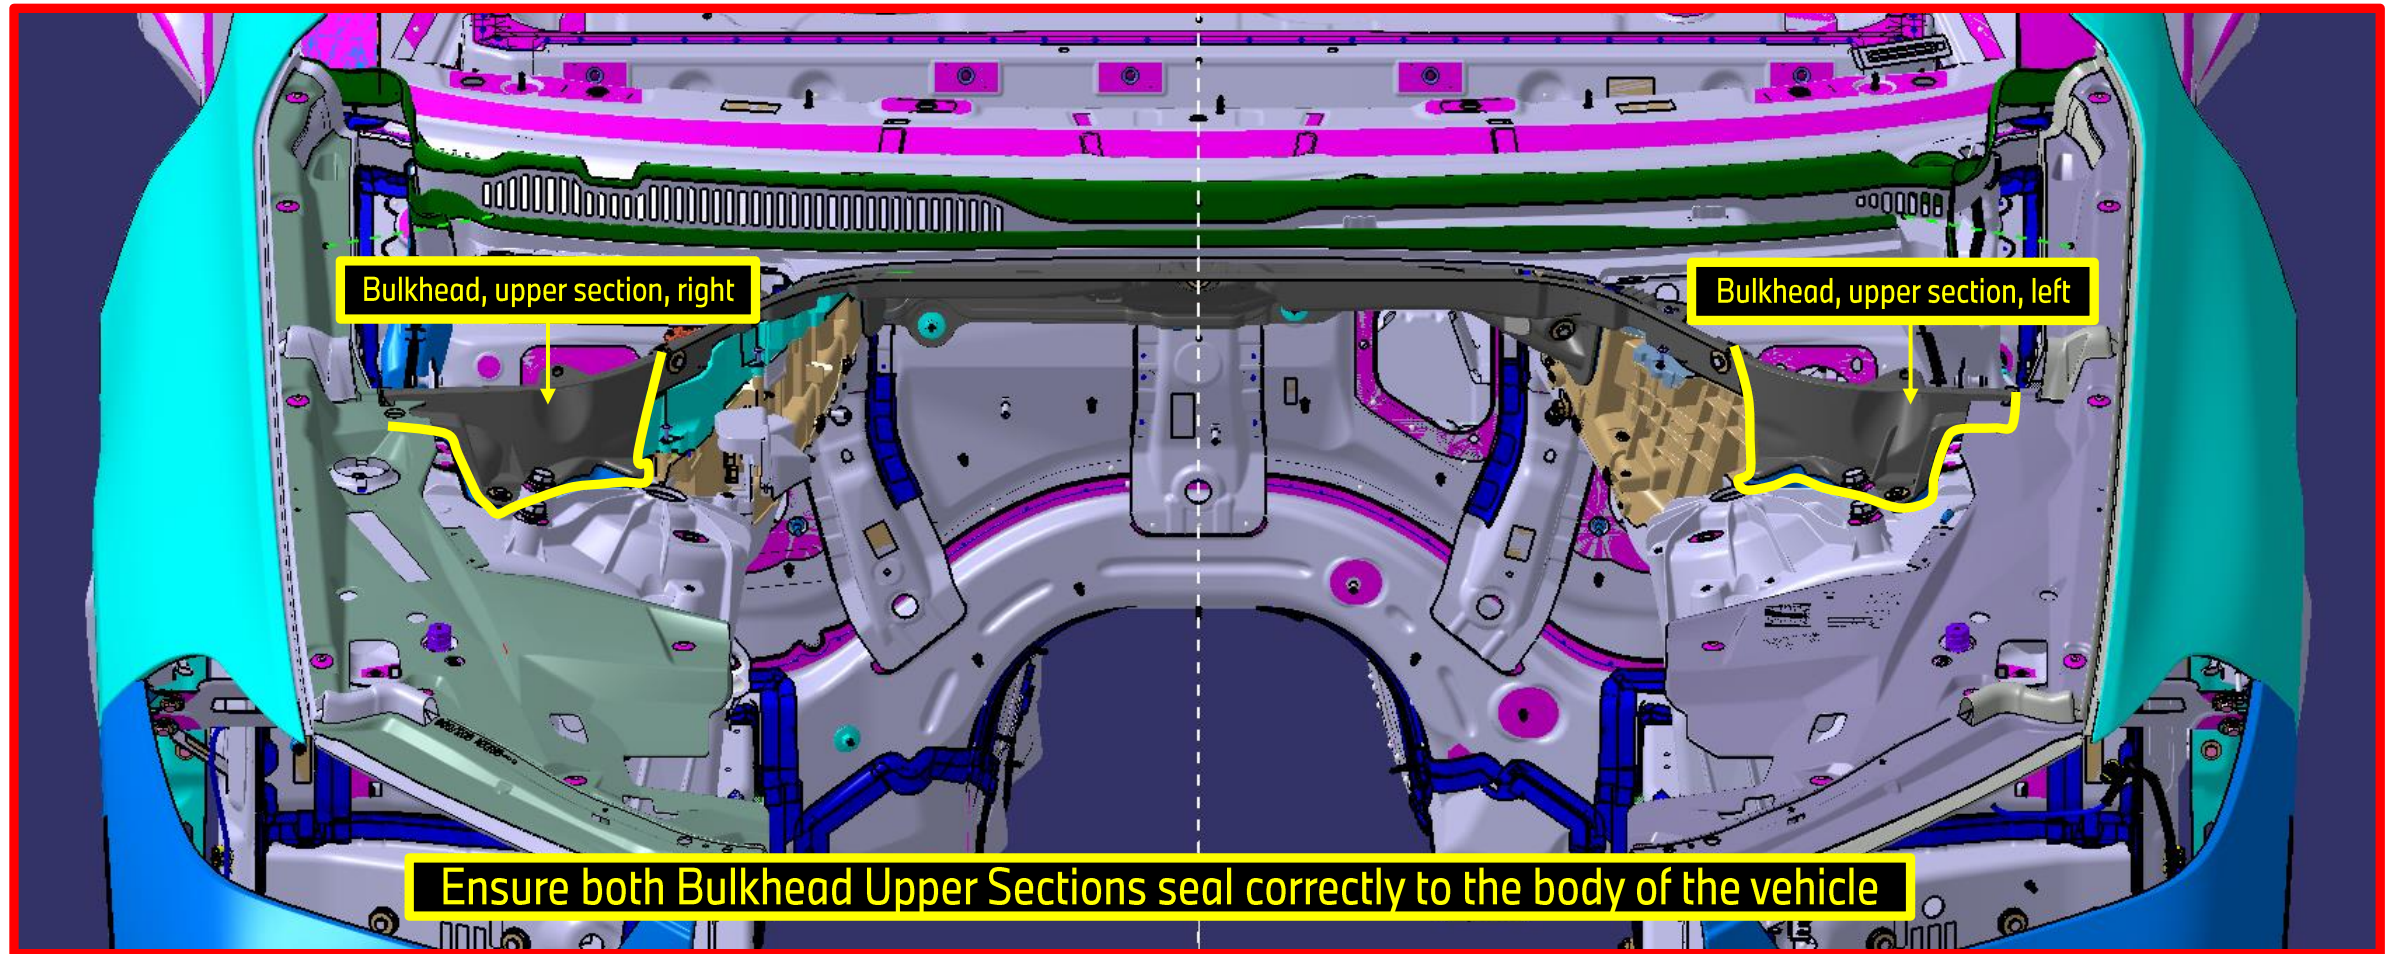
VISUAL INSPECTION
