2025-05-28

E-Series	Model Description	Affected Option Code
G07	X7 Sports Activity Vehicle (SAV)	All with Third-Row Seat Option

## **THIRD-ROW SEAT ANCHOR BODY-NUTS BREAK FREE WHILE ATTEMPTING TO REMOVE THE BOLTS**

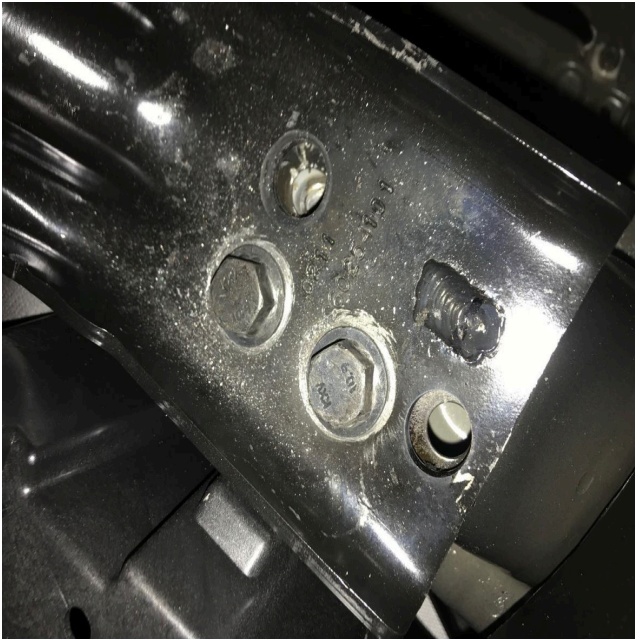
While attempting to unbolt the third-row seat to perform, or to gain access to perform another required repair, one or more of the bolts may not easily loosen. Applying addition force to loosen the bolts may cause the seat anchor body-nuts to break free from their welds.

The bolts will then just spin, not allowing the seat to be removed.
