This Service Information Bulletin (Revision 1) replaces SI B61 05 25 **dated March 24, 2025.**

E-Series	Model Description	Production Date
G45	X3 Sports Activity Vehicle	August 1, 2024 – February 12, 2025

BMW AG has issued a Delivery Stop (effective March 21, 2025) on certain Model Year 2025 BMW vehicles that were produced between August 1, 2024, and February 12, 2025.

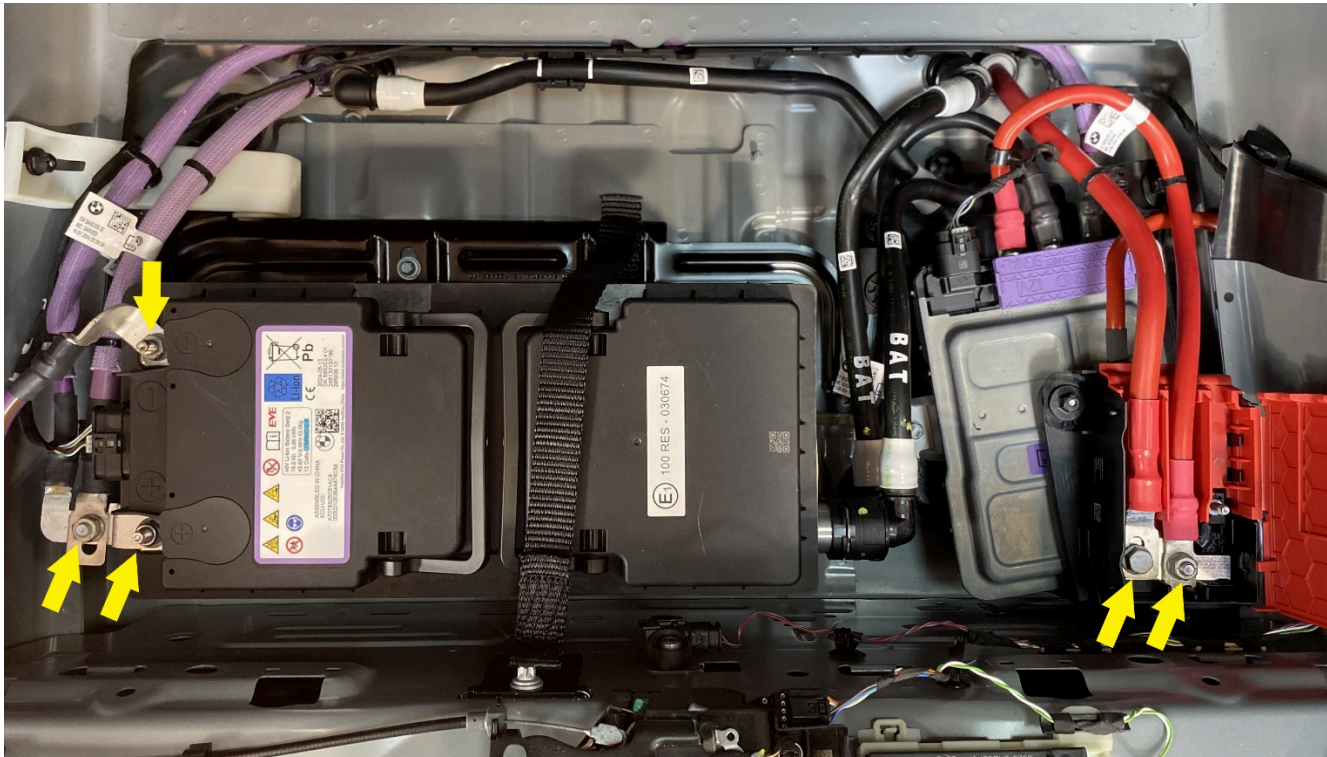
**Threaded connection points to be tested  
(Power distribution, base Z83\*1B, Z83\*2B and 48-volt battery G14\*2B and G14\*3B)**

The terminals of the 48V battery may have not been torqued properly. In the event of a loose connection, the vehicle’s electrical system might suffer numerous malfunctions. This is generally indicated by the corresponding Check Control messages (CCMs) that will display.

1. Visual inspect the (5) threaded connection points below marked by yellow arrows. If a loose threaded connections is detected, unfasten the nut and check the connection point (cable shoe, nut, bolt) for damage.

2. When consequential damage is visible: renew the associated cable, nut, 48V battery, distributor, or Power Control Unit (PCU) if necessary. Select and follow the appropriate repair instructions in AIR based on the extent of damage that has occurred.
3. If no consequential damage is visible or found, reassemble the threaded connection points in accordance with specifications.
4. Retorque the threaded connections to **19 Nm** and reassemble the vehicle.
