2025-05-28

E-Series	Model Description	Production Date
G26	BMW i4 Gran Coupe (Battery Electric Vehicle)	October 1, 2022 to July 31, 2023

The Check Control message (CCM): "You can continue driving. Drivetrain" (00029) is displayed, together with the following fault code:

- 224188 – Accelerator pedal module, pedal sensor, sensor 1, sensor 2: Signals implausible

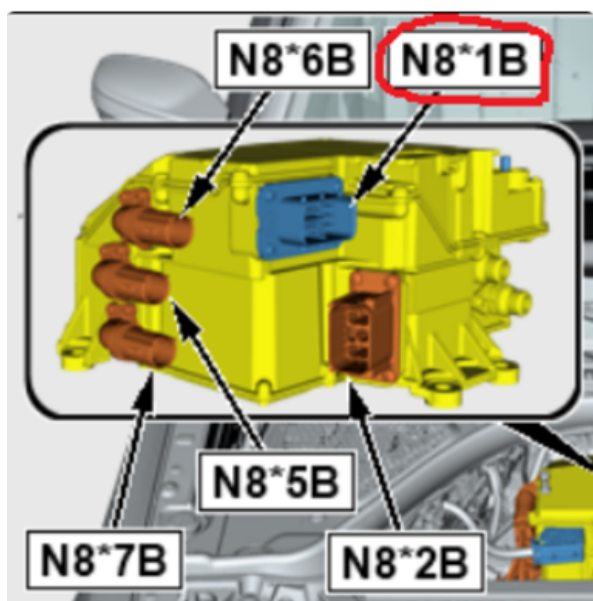
Faulty pin connections for the low-voltage (12 V) wiring harness at the plug connector (N8*1B) to the CCU results in this sporadic "signal fault."

Perform a Vehicle Test. If fault code 224188 is found to be stored, then **first** visually inspect the pins in the CCU's low-voltage plug connector (N8*1B).

Replace the contact pins as necessary using the proper BMW crimping tool below (both tools are found in tool kit 61 4 320)\

- Crimping tool Die PN 61 4 328
- Crimping Pliers PN 61 4 321

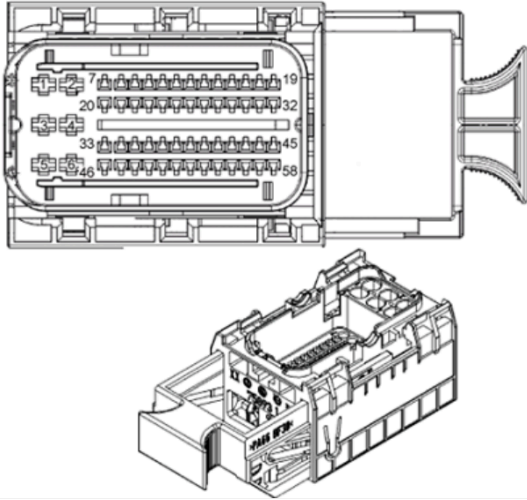
If the pins are found to be faulty, replace the following contact pins 40, 41, 42, 53, 54, 55 for the CCU low voltage (12 V) wiring harness connector (N8*1B) with pin part number 61 13 6 820 598 (bushing contact MLK 1.2 (0.50 mm²/AG.50 mm)).
