2025-05-29

The speed limit warning adopted speed, which is set by the customer, is automatically reverting to lower value after an extended duration of the sleep cycle.

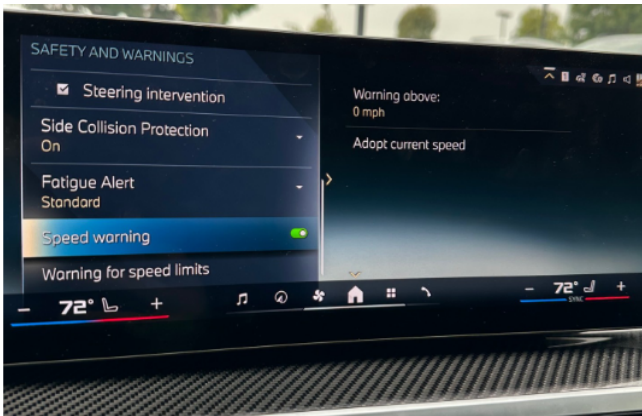
Example photo of the Speed Limit Warning feature and the adopted speed setting discussed in this service bulletin.

Unfavorable Kombi software is causing the adopted speed setting to change after sleep cycle.

Program the Kombi with updated software.
