Diagnostic Sheet

MC20 – Side Door Anomalies

DATE: MAY 30, 2025

MODELS: M240 MC20 and MC20 Cielo (All MY).

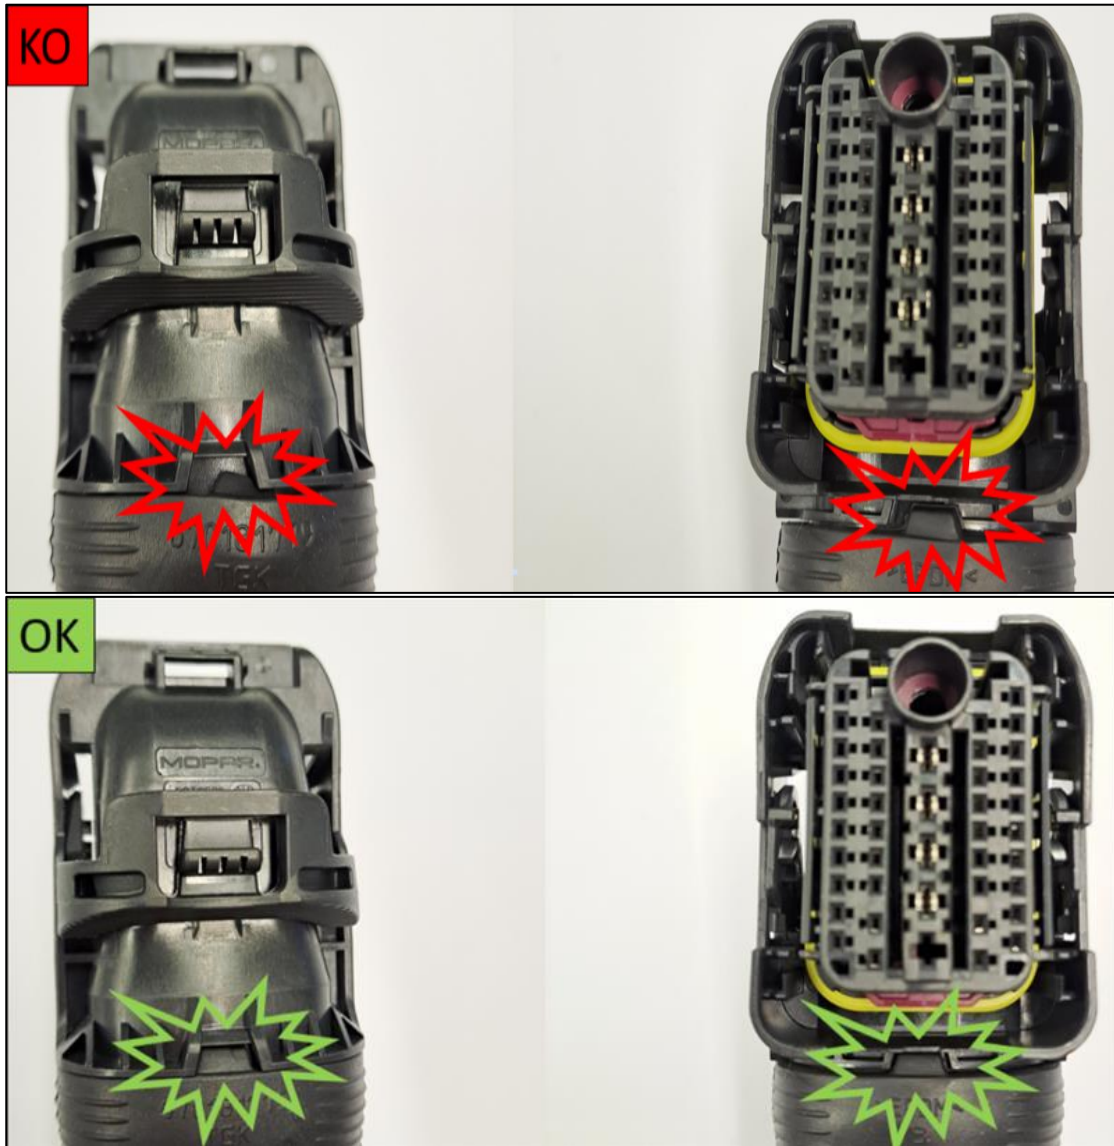
- 1) Disconnect the 12V battery, inspect the condition of the electrical connection between the door wiring and the passenger compartment wiring, take pictures of the protective rubber position.

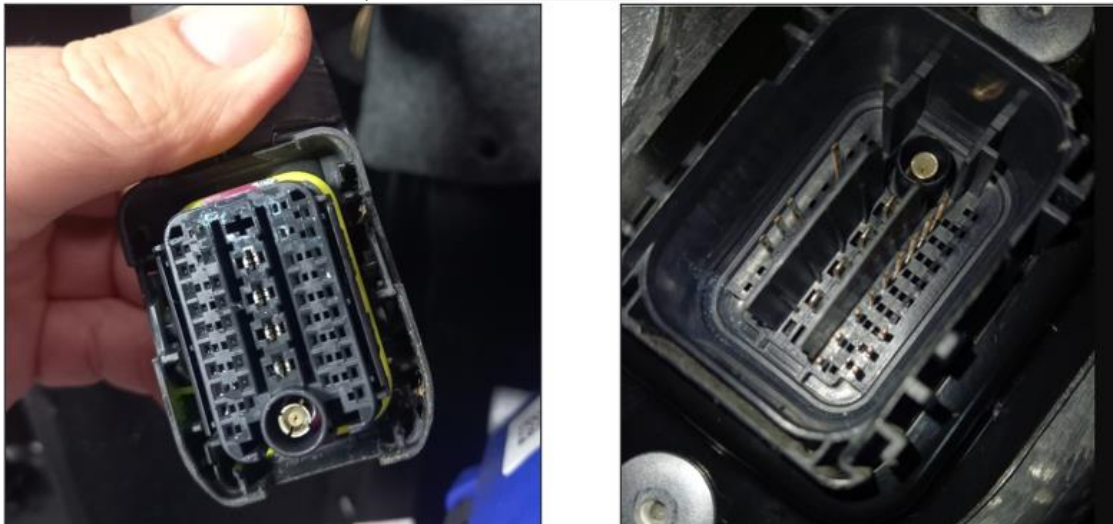
In case of oxidation as shown in the photo below:

Door side: Replace the door wiring harness with the corresponding P/N of the GT2S version, which has a slightly revised shape. It is recommended to replace both wiring harnesses, right and left.

Vehicle side: open a Blue on Line as Support Request and wait for instructions from the Product Support Team.

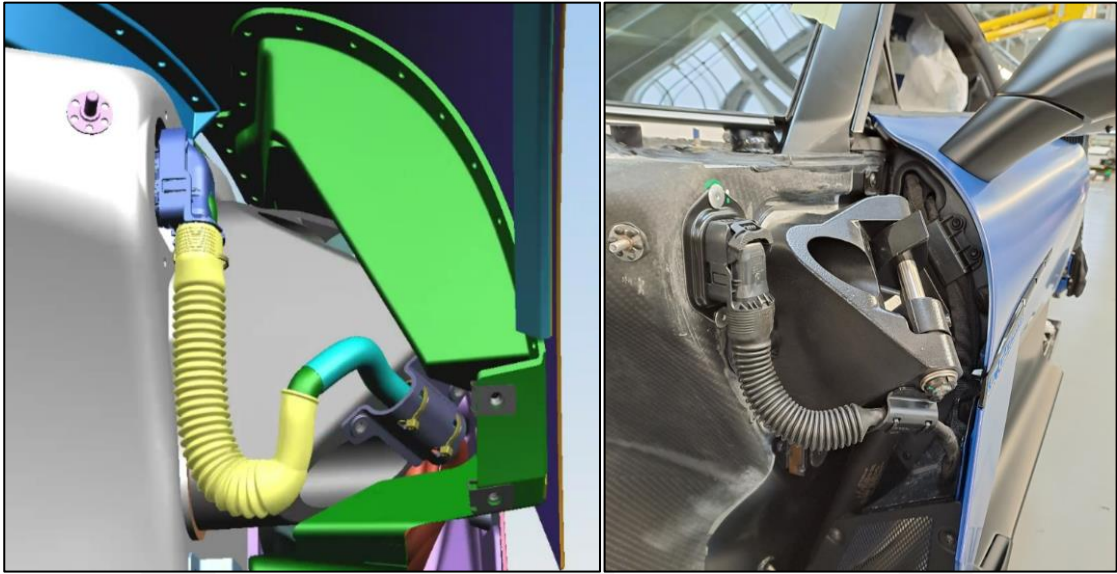
Old Layout

New Layout

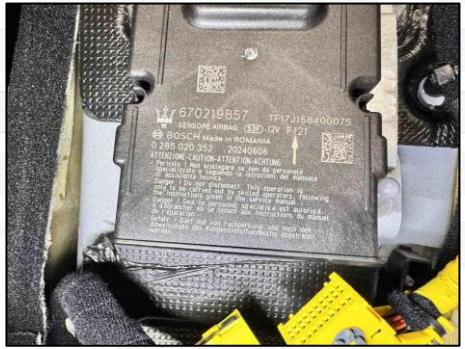
If the customer complains exclusively about the Airbag warning light being on with only **DTC B010049** = "ECU internal errors - Internal Electronic Fault" stored in the ORC control unit, proceed with replacing the ORC control unit by saving:

- a. ORC control unit fault reports and parameters.
- b. Photo of ORC control unit and its traceability as per photo below.

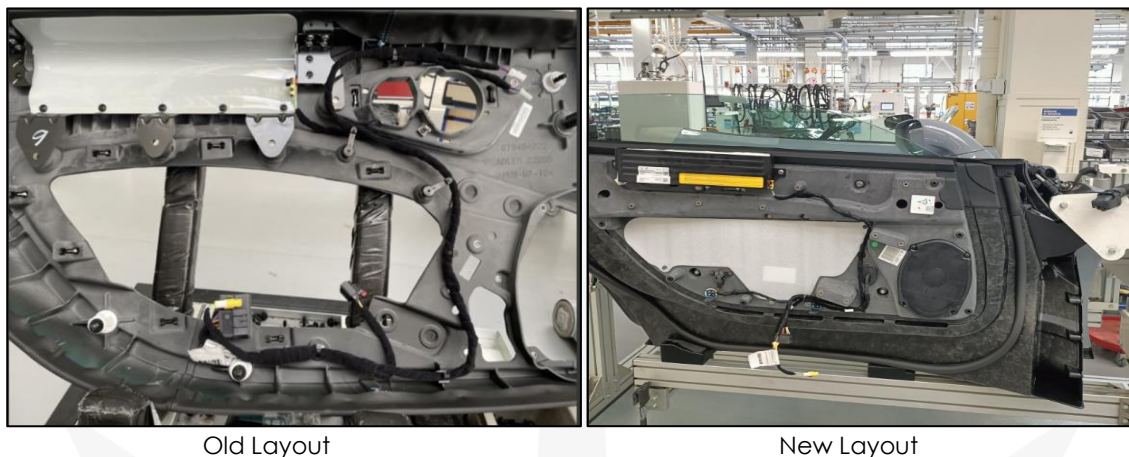
For information purposes only, starting from the vehicle assembly date of 22 September 2022 (Chassis #409912) the connecting bridles of the RH and LH curtain airbags are no longer integrated into the door panel wiring harness but are provided as a separate component (Component #14 in table 08.60 - 2 MAIN WIRING HARNESSES). This change avoids damage to the airbag connections during the door panel removal phase.

Old Layout

New Layout

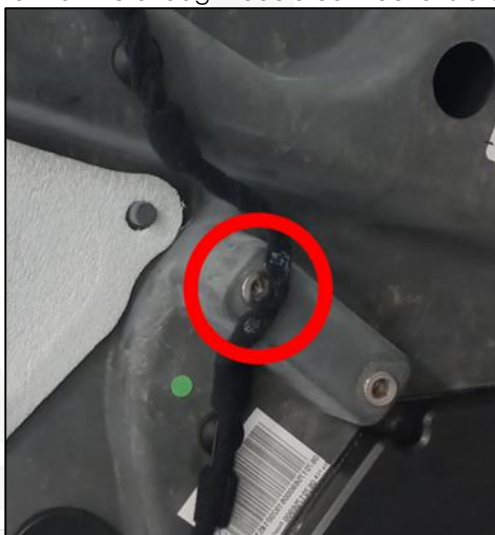
In both the old and new layout, it is still necessary to check that the wiring is not pinched (as shown in the photo below as an example) and that the airbag module connections are not damaged.

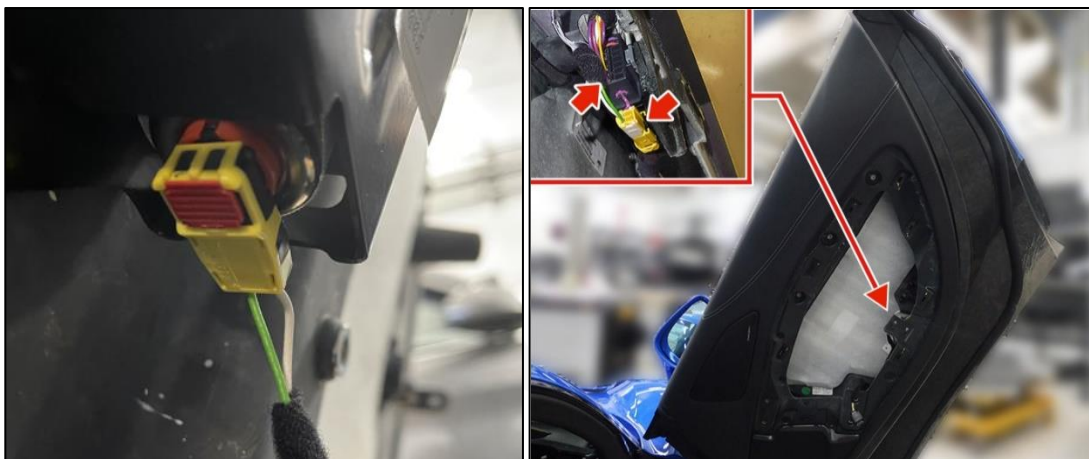
NOTE: when removing the door panel, pay close attention to gently release the plastic clip retaining the connection shown in the image below on the right.

- 1) Save an ORC ECU parameter and DTC report.
- 2) Remove the door panel and inspect only visually and without disconnecting the electrical connections of the airbag module and the door panel bridle and the related wiring. Take photos of the related connections and of any anomalies found on the wiring.

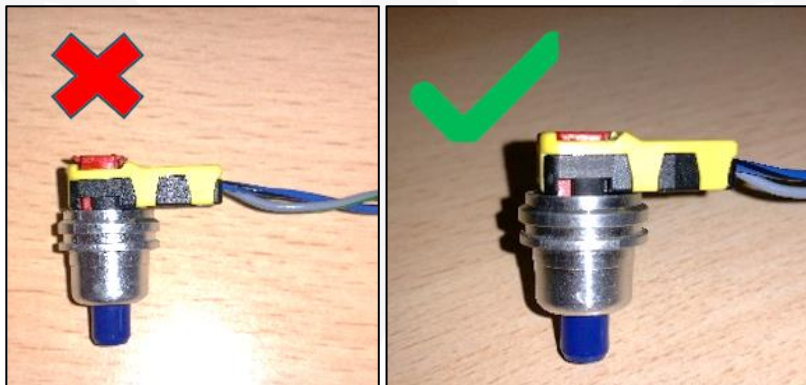
With the battery disconnected, check the condition of the connector on the pyrotechnic charge on the curtain airbags; the red safety clip MUST be in the FULLY inserted position (see photo below).

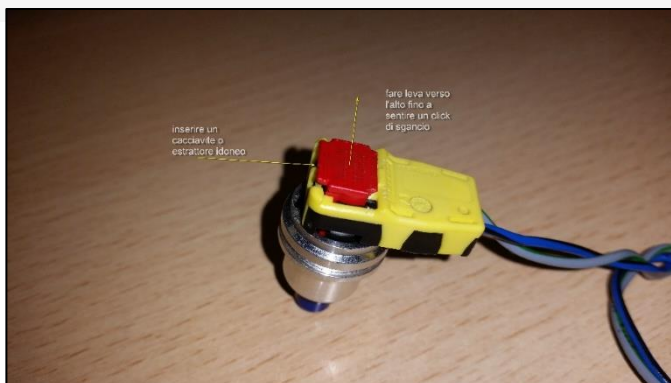
In case of incorrectly entered CPA, proceed as follows:

- Gently insert a flat screwdriver into the CPA coupling cavity, lever upwards until the CPA disengages.
- Pull the connector out perpendicularly.
