## Advanced Technical Information

Bulletin #: 2512

## Macan Electric – General Troubleshooting

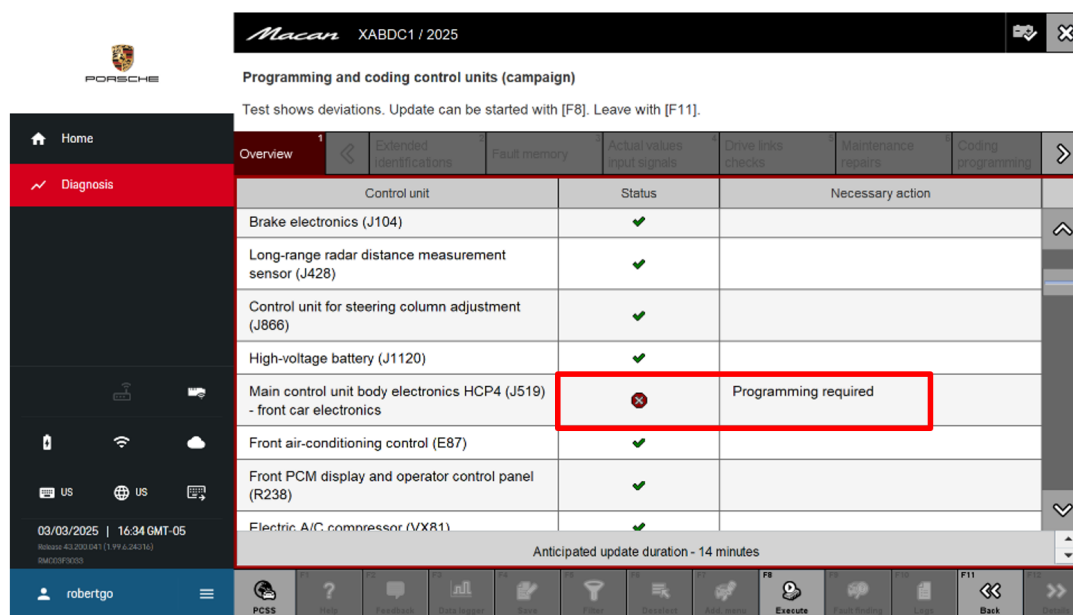
When selecting Additional Menu (F7) -> Programming and coding control units (campaign) on the same vehicle, it will then reveal that programming is possible for certain control units if available.

Test shows deviations. Update can be started with [F8]. Leave with [F11].

Control unit	Status	Necessary action
Brake electronics (J104)	✓	
Long-range radar distance measurement sensor (J428)	✓	
Control unit for steering column adjustment (J866)	✓	
High-voltage battery (J1120)	✓	
Main control unit body electronics HCP4 (J519) - front car electronics	✗	Programming required
Front air-conditioning control (E87)	✓	
Front PCM display and operator control panel (R238)	✓	
Electric A/C compressor (VXR1)	✓
