**WRE7 - Re-Programming Porsche Rear Seat Entertainment (Workshop Campaign)**

Model Year: **As of 2017 up to 2020**

Model Line: **Panamera (971)**

Concerns: **Porsche Rear Seat Entertainment (M-no. 9WY)**

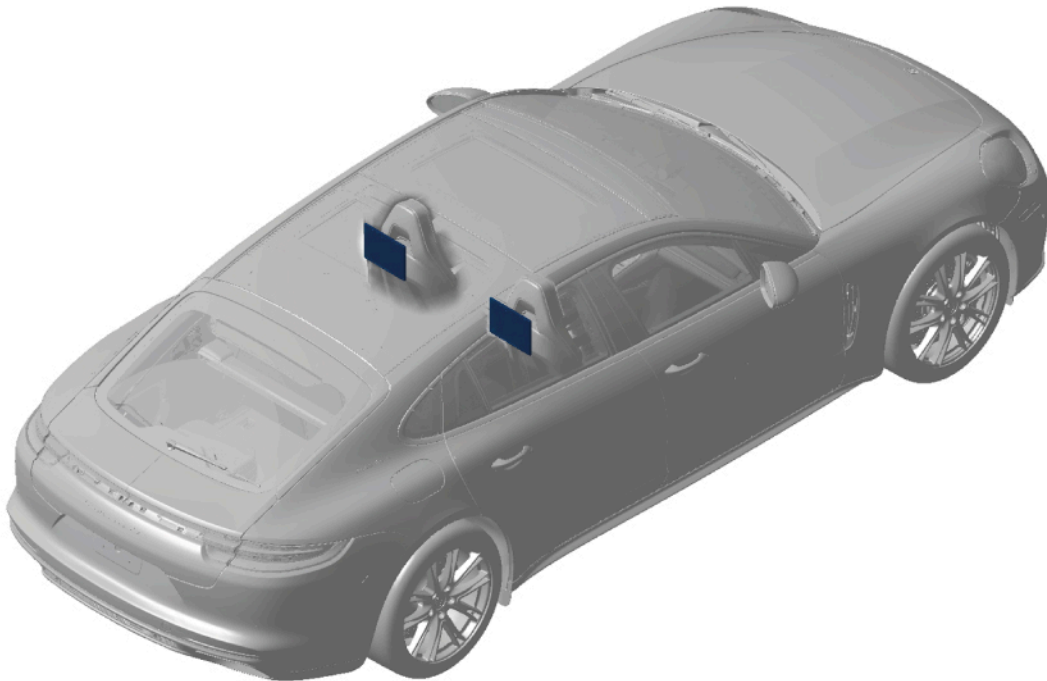
*Installation position of display unit*

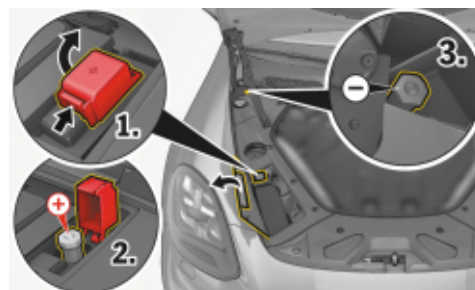
Connect battery charger to jump-start terminals

- 1 Connect a battery charger to the jump-start terminals in the engine compartment and switch it on ⇒ Connect battery charger to jump-start terminals.
- 2 Connect PRSE to vehicle WiFi.
  - 2.1 Under **"Settings"**, select the **"Wireless & Networks"** function.
  - 2.2 Select **"More"**.
  - 2.3 Switch on **"Porsche Connect App"** and allow PRSE preconditions via PCM Connect App.

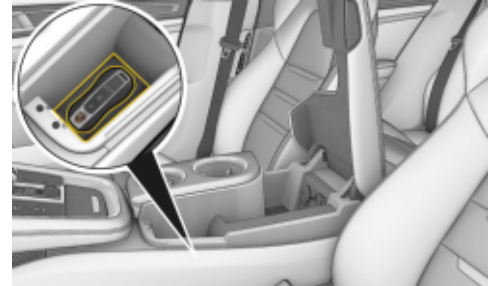
*Place the driver's key in the storage compartment.*

- 10 Place the driver's key with the back facing down in the front left storage compartment inside the center console ⇒ *Place the driver's key in the storage compartment..*
