Preview Solution CBR-2472-2

## Communication Failed Message - VN (4) - PR (4)

Published 29 May 2025

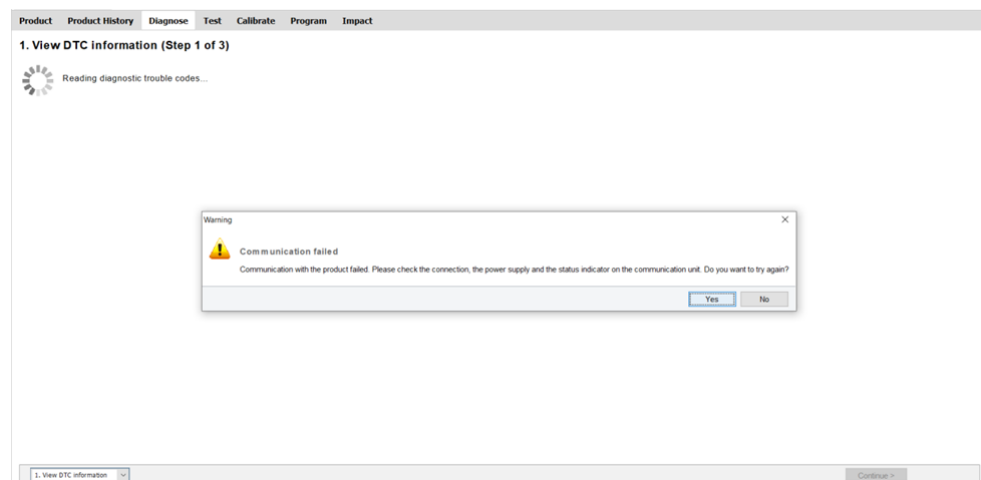
In some instances, PTT may have a Communication Failed Popup message occur when trying to retrieve fault code. If this occurs, please follow steps listed below to alleviate the issue.

1. Navigate to **Program Tab**.

2. Perform Operation **1700-22-03-12 Replace Hardware**.

3. Select Engine Control Module and press program button.
