S-Series™

**2.0 Telematics Control Unit (TCU)
Upgrade - T17 to T27**

Date: May 1, 2025
Bulletin Name: FDM-SVC-041
Model: Oshkosh S-Series
Units Affected: 2.0 Front Discharge Mixers
VIN 821990 - 827769

This bulletin provides instruction for installing a T27 TCU module in place of a T17 TCU module.

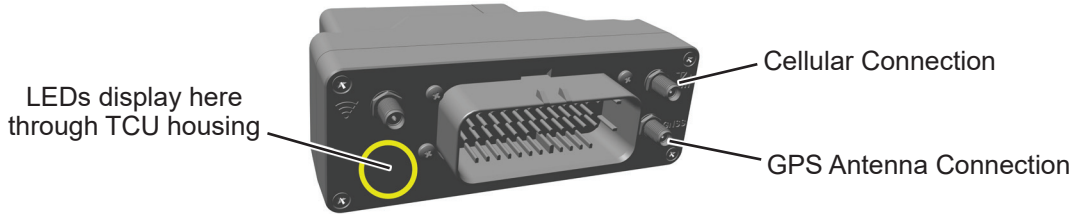
Figure 13

1. Make sure TCU version number populates in overhead display ABOUT screen. If TCU version is not populated the TCU is not communicating.
 - a. Check for a solid red LED and flashing green LED on front of TCU. See Figure 13. No lit LEDs on front of TCU indicates no power to TCU.
 - b. Make sure TCU connectors are fully seated and there are no bent or damaged pins.
2. Make sure GPS antenna and cellular cables are connected correctly.

3. Turn vehicle's battery disconnect switch OFF and wait until LEDs on front of TCU turn off, the TCU has an internal battery which can take up to 3 hours to fully drain before LEDs go out.
4. Turn vehicle's battery disconnect switch ON.
5. Turn vehicle ignition switch ON and recheck if TCU is operating and populates the version number in overhead display ABOUT screen.
6. Contact S-Series service if these troubleshooting steps do not correct TCU operation.
