**Technical Service Bulletin (TSB)**  
**Flexplate Bolts Loose**

<b>REFERENCE:</b>	<b>TSB:</b> 09-012-25 <b>GROUP:</b> 09 - Engine	<b>Date:</b>	May 28, 2025	<b>REVISION:</b>	—
<b>VEHICLES AFFECTED:</b>	<b>2025 (DT) RAM 1500 Pickup</b> <b>2025 (WS) Wagoneer / Grand Wagoneer</b> This bulletin applies to DT vehicles built on or after March 21, 2025 (MDH 0321XX) and on or before April 17, 2025 (MDH 0417XX) equipped with either of the following: This bulletin applies to WS vehicles built on or after March 24, 2025 (MDH 0324XX) and on or before April 17, 2025 (MDH 0417XX) equipped with either of the following: <ul style="list-style-type: none"> <li>• 3.0L I6 Hurricane HO or SO Twin Turbo ESS (Sales Code EFC or EFH).</li> </ul>			<b>MARKET APPLICABILITY:</b>	
				<input checked="" type="checkbox"/> NA	<input type="checkbox"/> MEA
				<input type="checkbox"/> EE	<input type="checkbox"/> IAP
				<input type="checkbox"/> SA	<input type="checkbox"/> CH
<b>CUSTOMER SYMPTOM:</b>	Customers may experience the following: <ul style="list-style-type: none"> <li>• Noise coming from under the hood.</li> </ul>

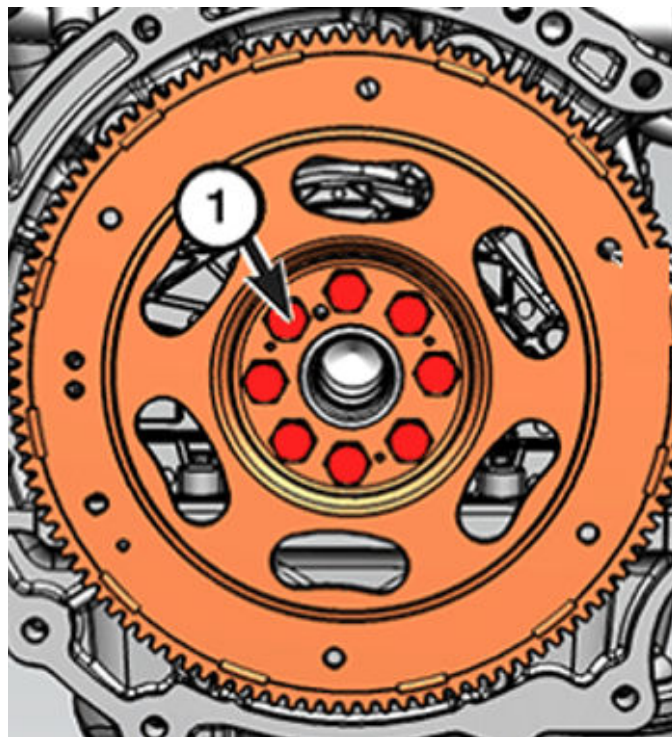
**Fig. 1**  
Flexplate Bolts

<b>CAUSE:</b>	Improper flexplate bolt torque

1. Replace all flexplate to crankshaft bolts [Fig. 1](#). Refer to the detailed service procedures available in DealerCONNECT/Service Library under: Service Info> 21 - Transmission and Transfer Case / Automatic - 8HP75 / Flexplate / Removal and Installation.
