**Technical Service Bulletin (TSB)**  
**Motor Generator Unit (MGU) Replacement**

| <b>REFERENCE:</b> | <b>TSB:</b> 08-178-25<br><b>GROUP:</b> 08 - Electrical | <b>Date:</b> | May 30, 2025 | <b>REVISION:</b> | 08-144-24 |
| <b>VEHICLES AFFECTED:</b> | <b>2023 - 2024 (JL) Jeep Wrangler</b><br><b>2023 - 2024 (WL) Jeep Grand Cherokee / Grand Cherokee L</b><br>This bulletin applies to vehicles equipped with a 2.0L I4 DOHC DI Turbo PHEV Engine (Sales Code ECX). | | | <b>MARKET APPLICABILITY:</b> | |

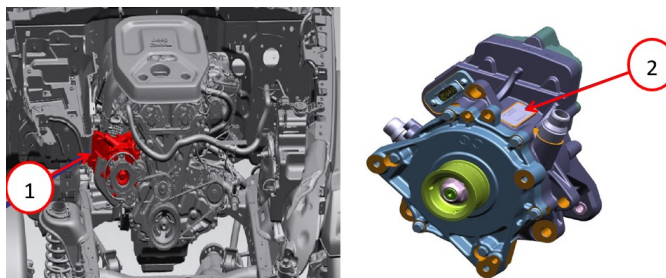
**Fig. 1**  
MGU Location

- 1 - MGU Location
- 2 - MGU Label Location

- Is DTC P1B0F-00 - Drive Motor A Position Sensor Offset Incorrect set?
  - YES>>> Proceed to [Step 2](#).
  - NO>>> This bulletin does not apply.
- Locate the MGU label [Fig. 1](#).

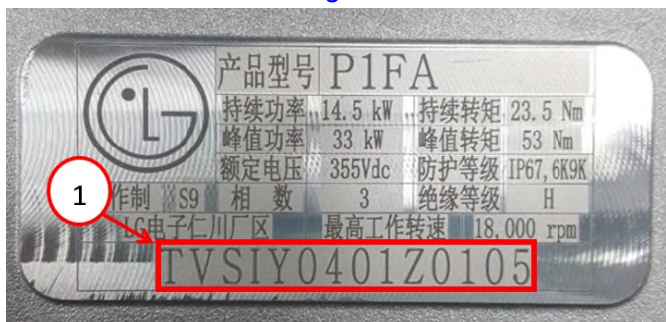
**Fig. 2**  
MGU Serial Number

- 1 - MGU Serial Number

4. Is the serial number within the following ranges?

| JL | TVSIY0813Z0241 - TVSIY2413Z0005 |
| WL | TVSIY0903Z0714 - TVSIY2383Z0673 |

- YES>>> Replace the MGU. Refer to the detailed service procedures available in DealerCONNECT/ Service Library under: Service Info> 12 - Electrified Powertrain System / Electric Powertrain Control / Motors, Electric Drive / Removal and Installation.
- NO>>> This bulletin does not apply. Follow the DTC P1B0F-00 - Drive Motor A Position Sensor Offset Incorrect diagnostic procedure in Service Library.
