**Technical Service Bulletin (TSB)**  
**Oil Leakage From The Timing Cover**

| <b>REFERENCE:</b> | <b>TSB:</b> 09-013-25 REV. A<br><b>GROUP:</b> 09 - Engine | <b>Date:</b> | May 30, 2025 | <b>REVISION:</b> | 09-013-25 |
| <b>VEHICLES AFFECTED:</b> | <b>2020 - 2024 (GA) Alfa Romeo Giulia</b><br><b>2020 - 2024 (GU) Alfa Romeo Stelvio</b><br>This bulletin applies to vehicles built on or before May 02, 2024 (MDH 0502XX) equipped with the 2.0L 280 HP I4DI Turbo Engine (Sales Code EC2). | <b>MARKET APPLICABILITY:</b> | | | |

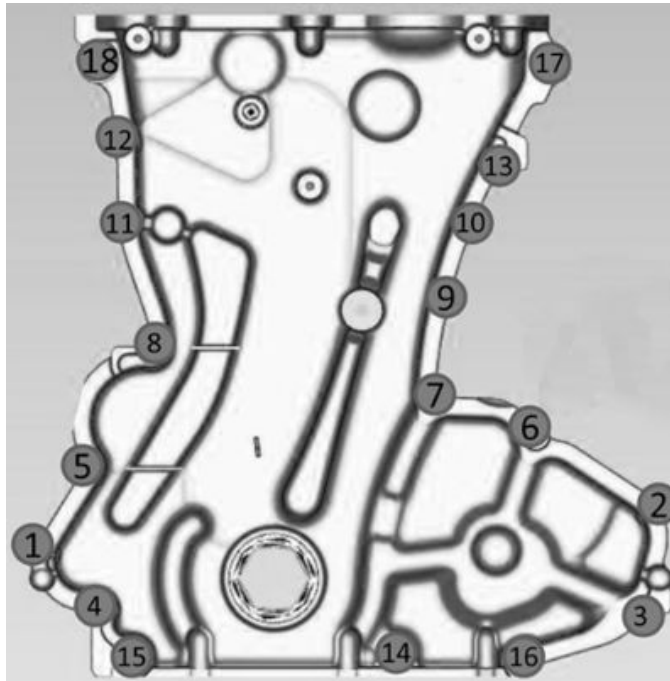
**Fig. 1**  
Tightening Sequence

| <b>CAUSE:</b> | Loose timing cover fasteners | | | | |

3. Using a paint pen, mark every fastener corresponding to its current rotational position. Then turn the fasteners to loosen and return it to their original position for tightening torque. The current torque must be between 8.6 Nm (6.343 ft lb) and 11.0 Nm (8.113 ft lb).

4. If the residual torque is below the 8.6 Nm (6.343 Ft lb) limit, proceed as follows:
  - Using a digital torque wrench (recommended), loosen the fasteners, tighten to a torque of 5 Nm (3.687 Ft lb) and apply another 40°. The current torque must be between 11.0 Nm (8.113 Ft lb) and 16.0 Nm (11.801 Ft lb).

- Using a digital torque wrench (recommended), apply a torque of 10.0 Nm (7.376 ft lb) using a mechanical torque wrench.

**NOTE:** Refer to the order shown in [Fig. 1](#) for tightening the fasteners.
