HYUNDAI

Technical Service Bulletin

GROUP BODY ELECTRICAL	NUMBER 25-BE-005H-2
DATE MAY 2025	MODEL(S) SEE BELOW

SUBJECT: HORN ASSEMBLY REPLACEMENT
(WARRANTY EXTENSION Z03)

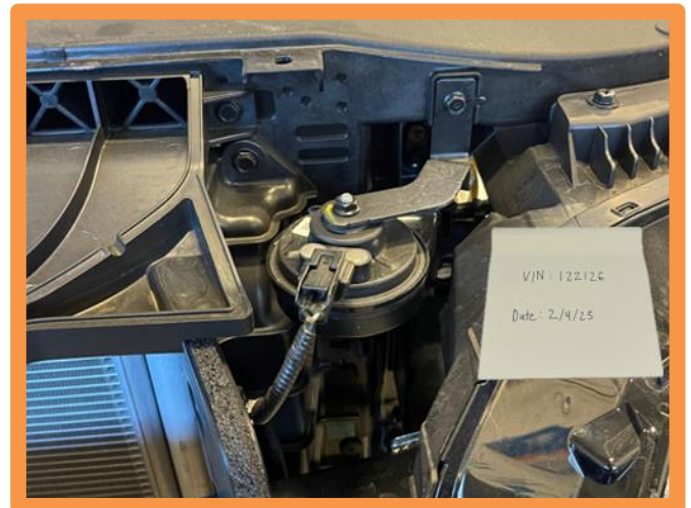
Using STUI, take a photo of the original horn on either side in their horizontal position with the last 6 digits of the VIN and the date of repair on a piece of paper.

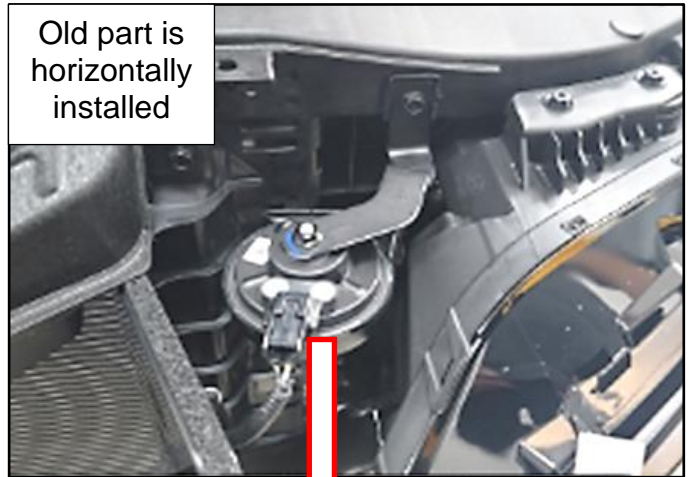
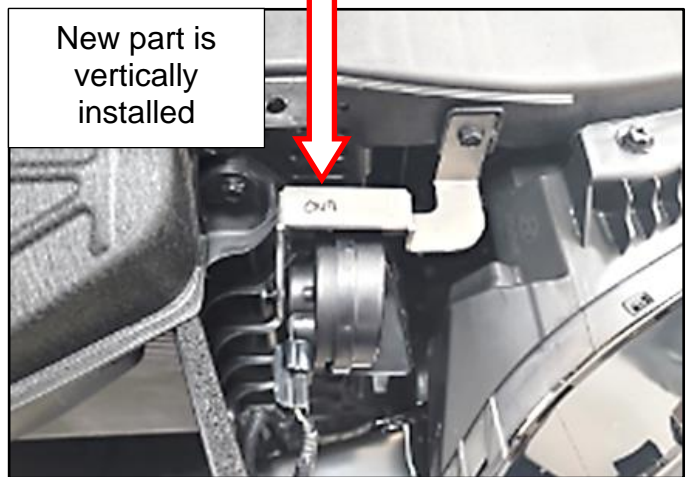
Ensure the horns (high and low) are installed vertically with the bell holes facing downward to prevent water intrusion.

3. Replace both horns (high and low) in a vertical orientation by connecting the horn connectors to the external wirings.
