Technical Service Bulletin

GROUP	NUMBER
CAMPAIGN	25-01-034G
DATE	MODEL(S)
MAY 2025	GV70 (JK1)

SUBJECT: REAR FLOOR PANEL DAMAGE INSPECTION & REPAIR
(SERVICE CAMPAIGN T75G)

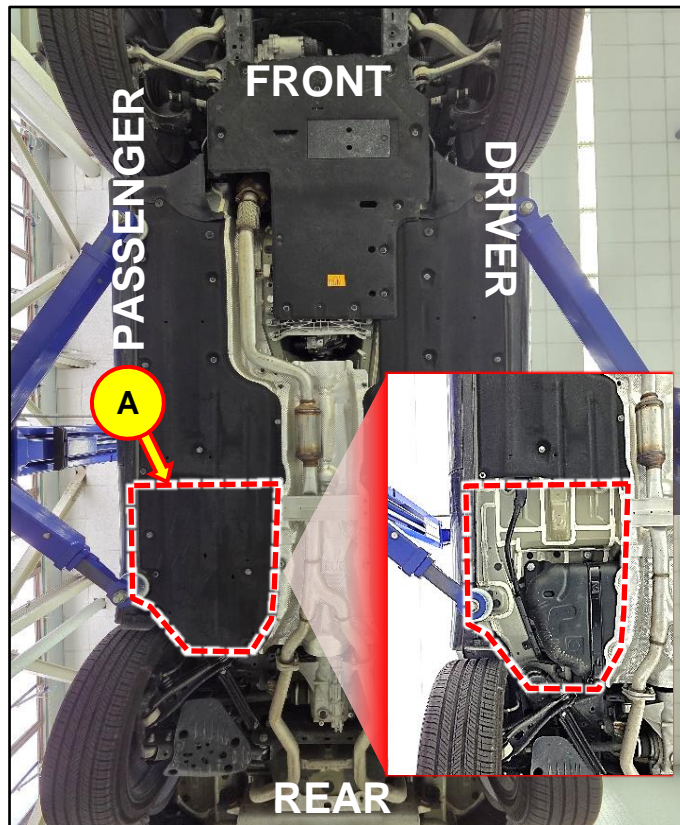
- Inspect the rear floor panel (B) for damage.
 - GOOD:** If there is **NO** damage, **NO** repair is necessary.
 - NO GOOD:** If there is damage, then the damaged area needs to be repaired.
