Field campaign

Topic	Software Update BiL 5.3.1 v1 to v2 Flying Spur 25MY (SC25/11)
Market area	Bentley: worldwide (2WBE),China 796 VW Import Comp. Ltd (Vico), Beijing (6796)
Brand	Bentley
Transaction No.	2077583/4
Campaign number	ED42
Note	
Type	
US code

25MY Flying Spur

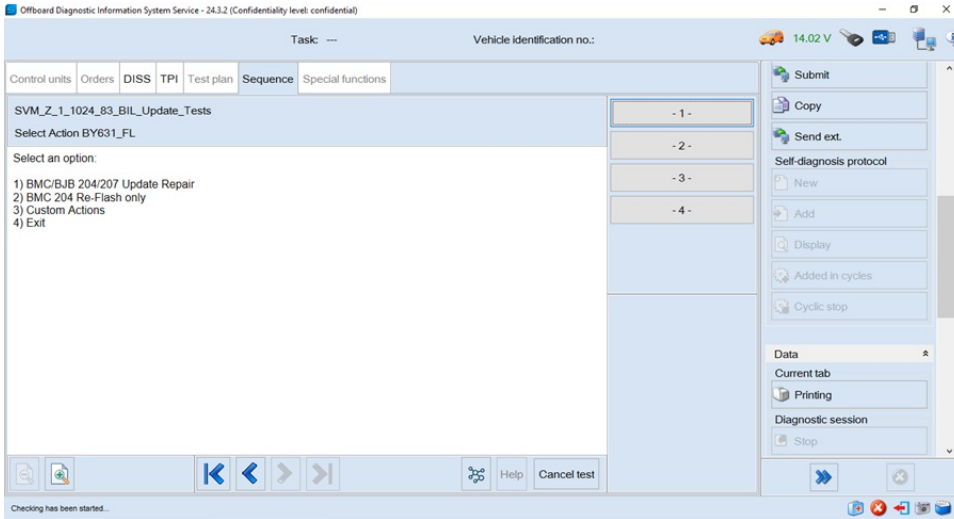
4. Select ‘1) BMC/BJB 204/207 Update Repair’ and follow the on-screen instructions.
 - When the tester attempts to flash ‘008C - Battery regulation control module’ you may receive a message informing you that the pre-conditions have not been met. Select ‘done/continue’.
 - On the following screen (shown below) select option 2 to attempt to flash the ECU – this should allow the ‘008C - Battery regulation control module’ to flash successfully.

- If the flash fails, perform the below actions.

1. Exit the test.

2. Allow the car to sleep for 5 minutes.

- Turn off the ignition.
- Remove all equipment from the car (Diagnostic tester/dongle, battery charger, keys).
- Close all doors, windows, bonnet and boot lid.
- Lock the vehicle to perform a CAN-BUS sleep (wait 5 minutes).

3. Clear DTCs from '008C - Battery regulation control module'.

3a. To do this, right click on control unit 008C, click Guided Functions and then click 'Clear Fault Memory'.

4. Return to 'Special functions' and run the test plan 'SVM – Pre 372BIL5201 Hotfix Routines'.

5. Within this test plan, select option 2 and run until completion.

6. Once the test has been completed, right click on control unit 008C and select guided functions. Then, read ECU Identification and ensure that the 06D0 (Battery Junction Box) appears as a subsystem within the read identification test plan.

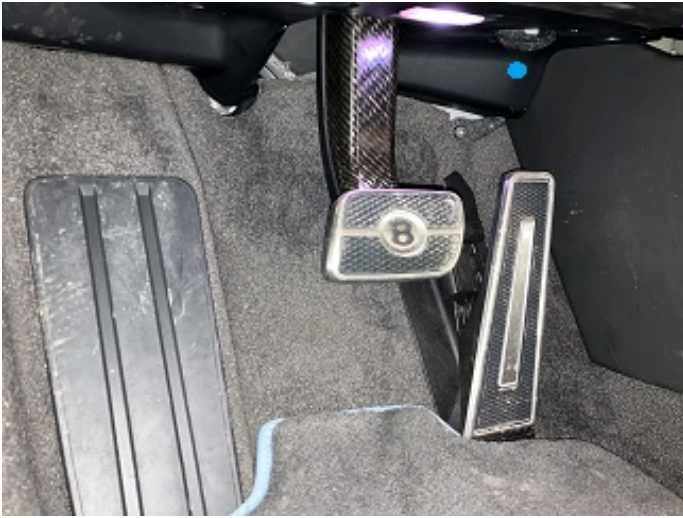
You must also add a blue paint mark as per the picture below.
