HYUNDAI

Technical Service Bulletin

GROUP BODY	NUMBER 25-BD-004H
DATE MAY 2025	MODEL(S) SEE BELOW

SUBJECT: WHITE PAINT WARRANTY EXTENSION (Z05)

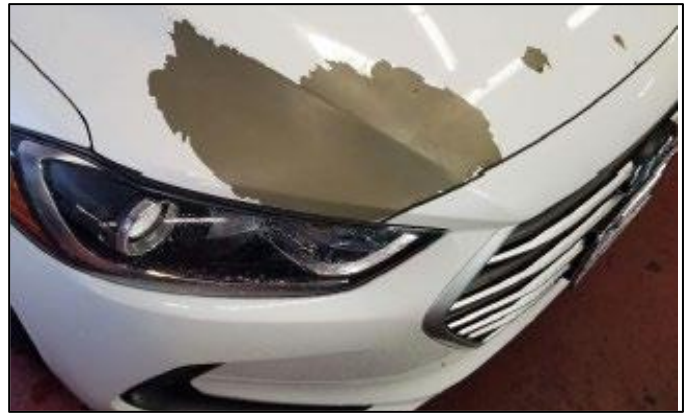
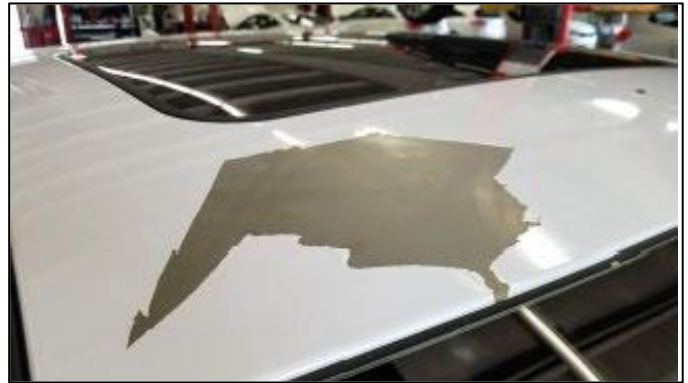
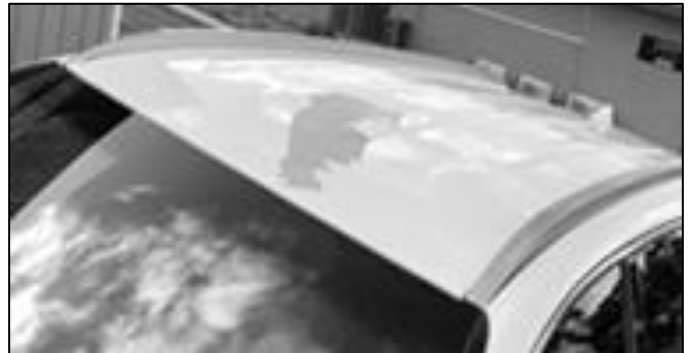
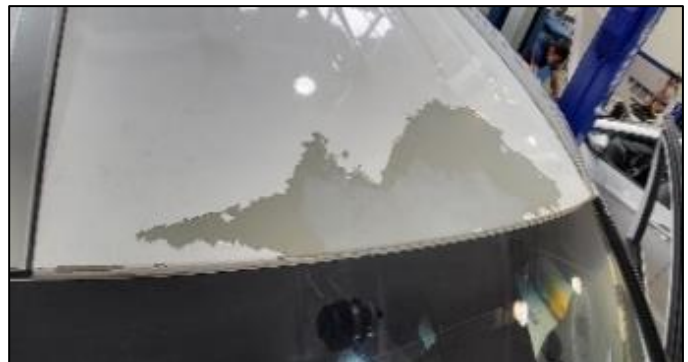
Peeling and/or bubbling of the white paint commonly occurs on the metal body panels: hood, fender(s), roof, door(s), quarter panel(s), and tailgate/trunk.

1. Inspect the entire vehicle for paint peeling/bubbling on the metal body panels: hood, fender(s), roof, door(s), quarter panel(s), and tailgate/trunk.

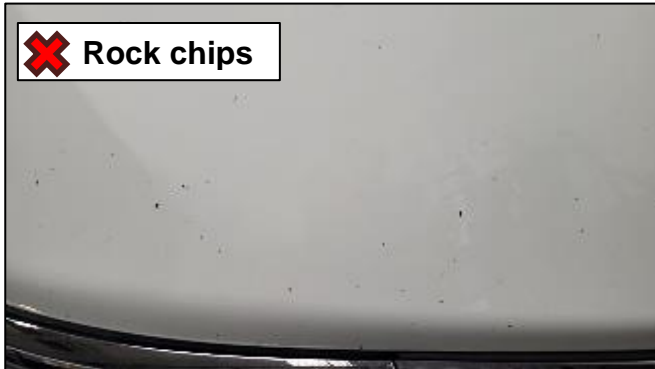
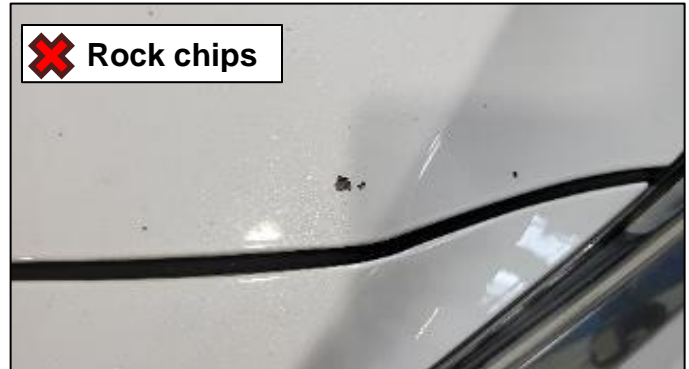
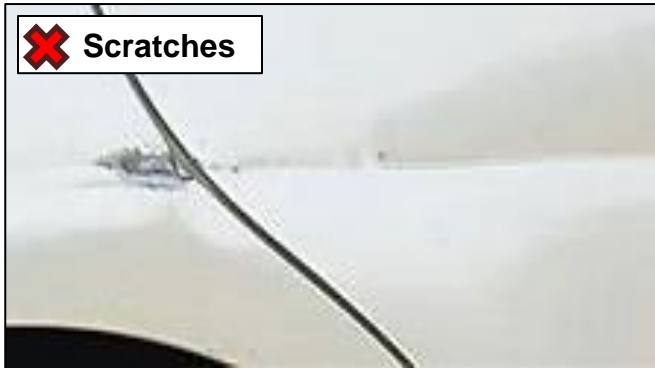
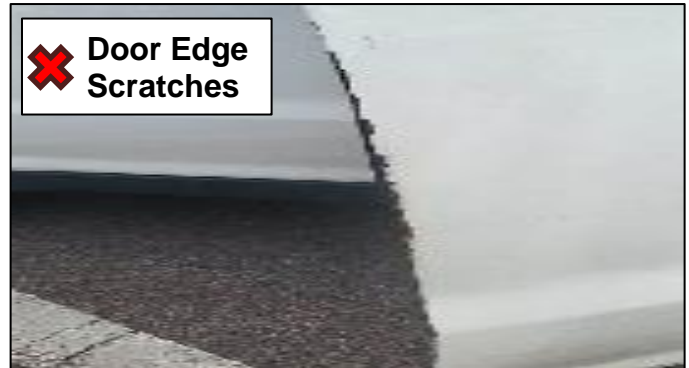
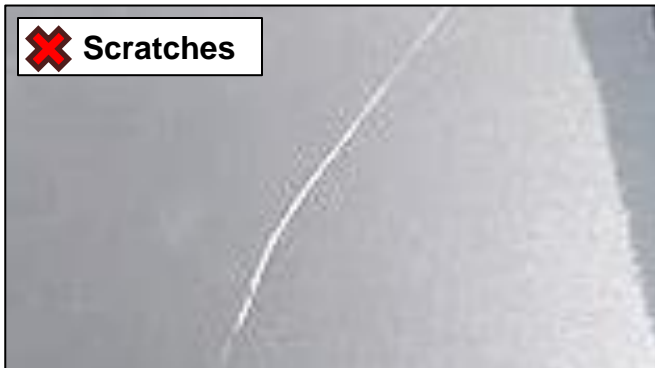
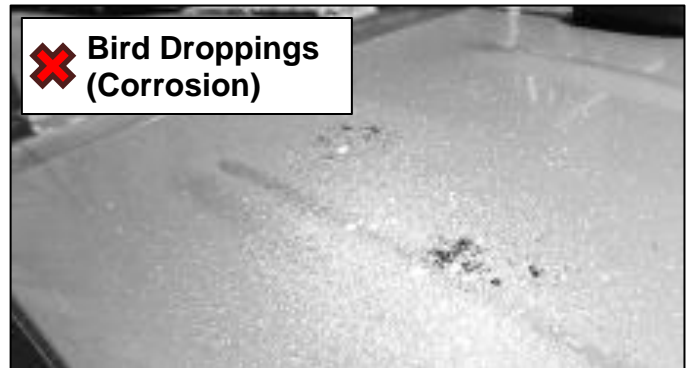
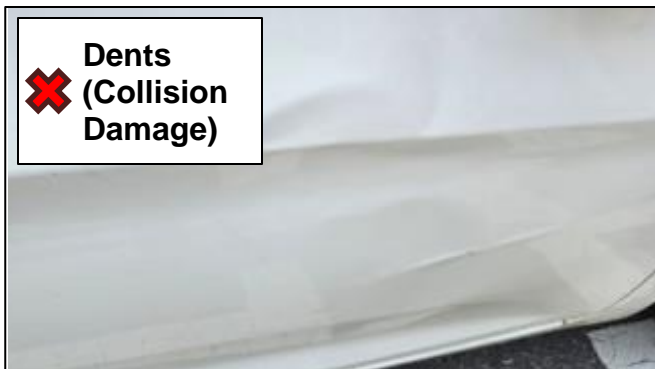
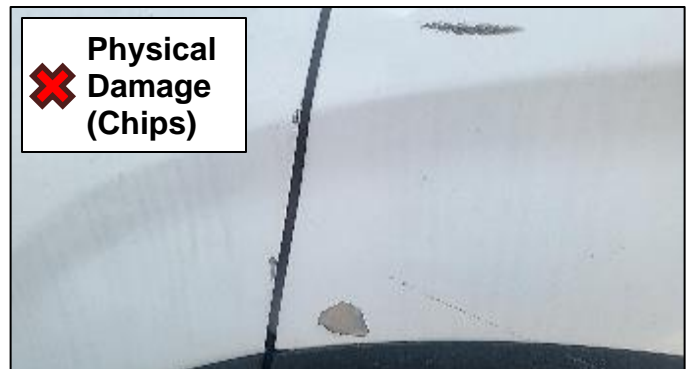
Paint issues such as rock chips, scratches, bird droppings, sap/wax, aftermarket wraps, collision damage, and/or customer-induced damage are excluded (❌ = **NOT** covered) by the warranty extension.
