<b>HYUNDAI</b> <b>Technical Service Bulletin</b>	<b>GROUP</b> <b>BODY ELECTRICAL</b>	<b>NUMBER</b> <b>25-BE-011H</b>
	<b>DATE</b> <b>MAY 2025</b>	<b>MODEL(S)</b> <b>IONIQ 5 (NEA EV)</b>
<b>SUBJECT:</b> INSIDE REAR COMBINATION LAMP INSPECTION AND REPLACEMENT

**Description:** Certain 2025MY IONIQ 5 (NEA EV) vehicles may exhibit some or all inoperative LEDs on the inner rear combination lamp. The concerning LEDs, housed within the inner rear combination lamp assembly, are components of the auxiliary lamp circuit and do not affect brake or turn signal operation. Follow the procedure outlined in this TSB to inspect and, if necessary, replace the inner rear combination lamp assembly.

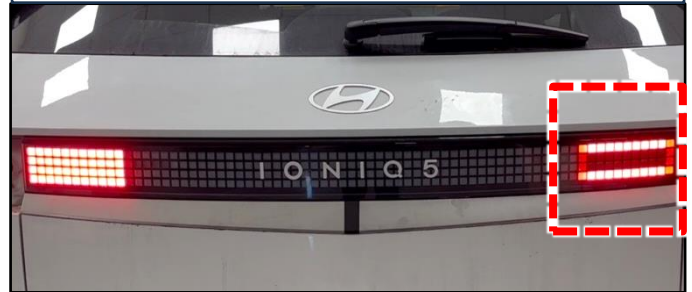
**Example of Inside Rear Combination Lamp NOT Working as Designed**

3. Each time the key fob lock button is pressed, the entire rear tail lamp will cycle **ON** and **OFF**. Pay close attention to the inside rear combination lamps ensuring all the LED lights are working as designed.

If the inside rear combination lamps are **NOT** working as designed, then proceed with the replacement procedure.

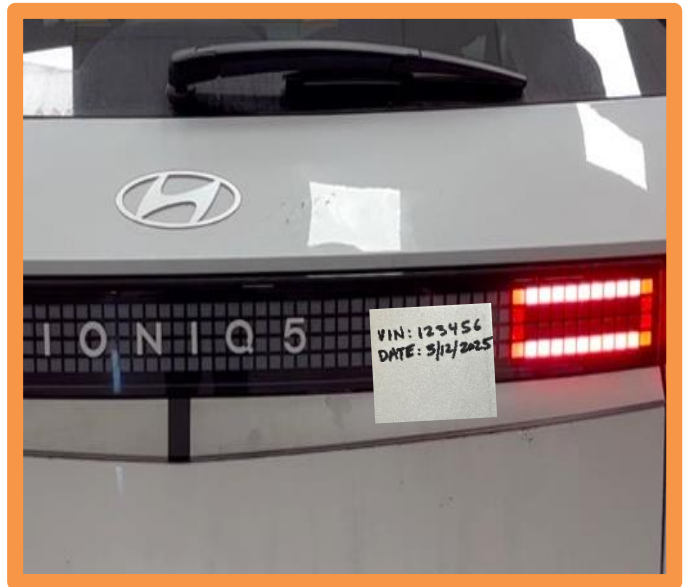
Using STUI, take a photo of the malfunctioning tail lamp(s) housed in the Inside Rear Combination Lamp Assembly with the last 6 digits of the VIN and the date of repair on a piece of paper.
