SERVICE BULLETIN

APPLICABILITY: 2019-23MY Forester w/ Gen 3.1
 2019-23MY Impreza & Crosstrek w/ Gen 3.1
 2019-21MY WRX/STI w/ Gen 3.1
 2022-23MY WRX/STI w/ CP1
 2019-22MY Ascent w/ Gen 3.1
 2019MY Outback & Legacy w/ Gen 3.1
 2020-22MY Outback & Legacy w/ CP1

NUMBER: 15-322-25R

SUBJECT: CP1 & Gen 3.1 Head Unit Warranty Extension

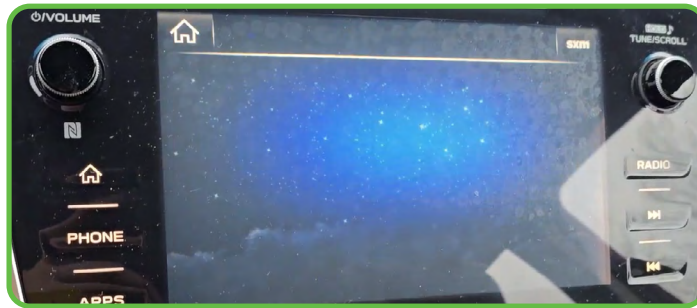
Display ON

BUBBLED SCREEN SCENARIO (COVERED)

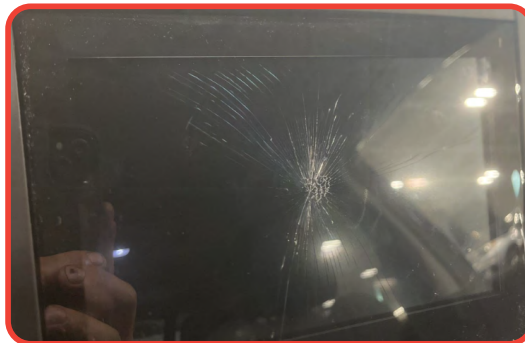
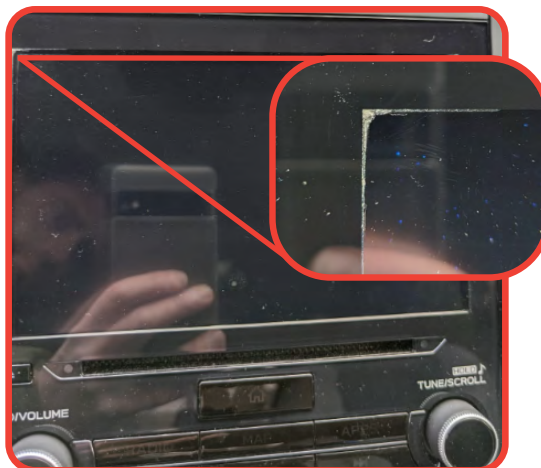
PHYSICAL DAMAGE (NOT COVERED)
