SERVICE BULLETIN

APPLICABILITY: 2020-24MY Legacy and Outback 2.5L NA and 2.4L DIT
 2018-24MY Crosstrek
 2017-24MY Impreza
 2019-24MY Forester 2.5 NA
 2014-18MY Forester 2.0L DIT
 2015-24MY WRX 2.0 DIT
 2019-24MY Ascent

NUMBER: 02-193-24R

SUBJECT: Walnut Blast Cleaning Procedure for Carbon Deposit Removal to Address Engine Misfire DTCs, Black Smoke from the Exhaust, Lack of Power, Knocking (Ping) and / or Rough Idle Concerns

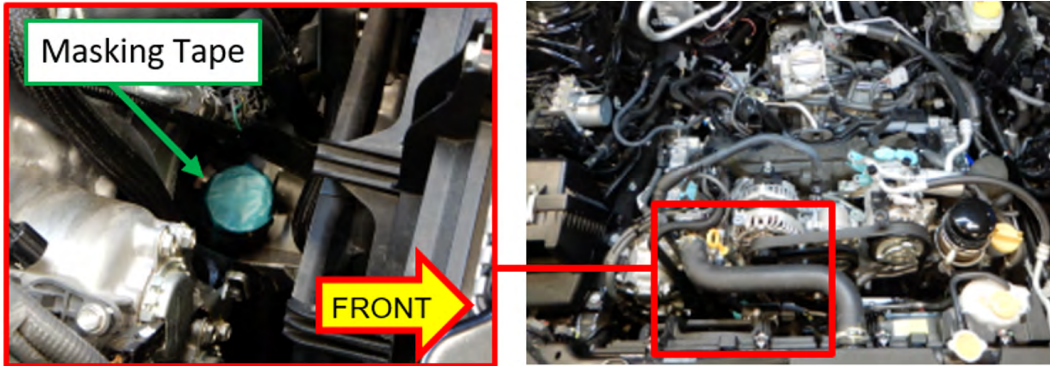
2.0L DIT & 2.4L DIT: Cover the turbo charger duct opening with making tape.

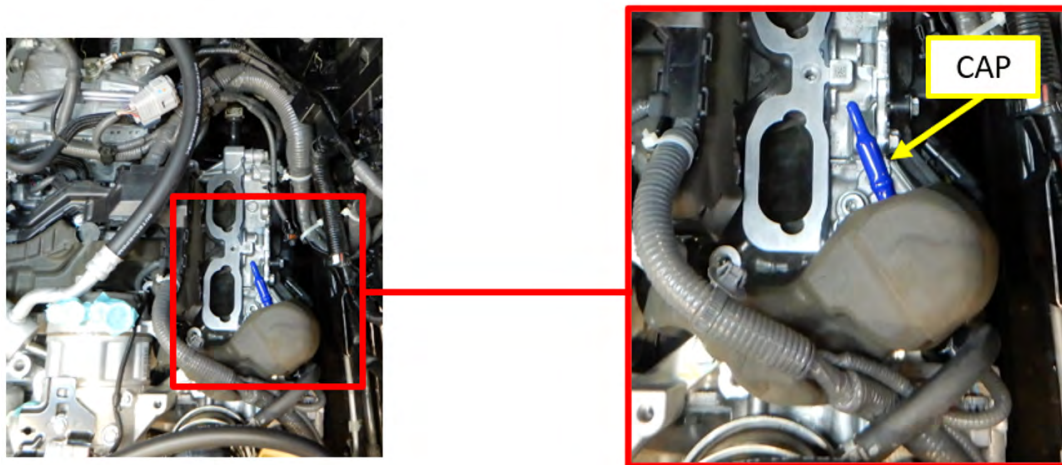
2.4L DIT: Install the cap (p.n. 16519AA100) on to the high pressure fuel pump connection.

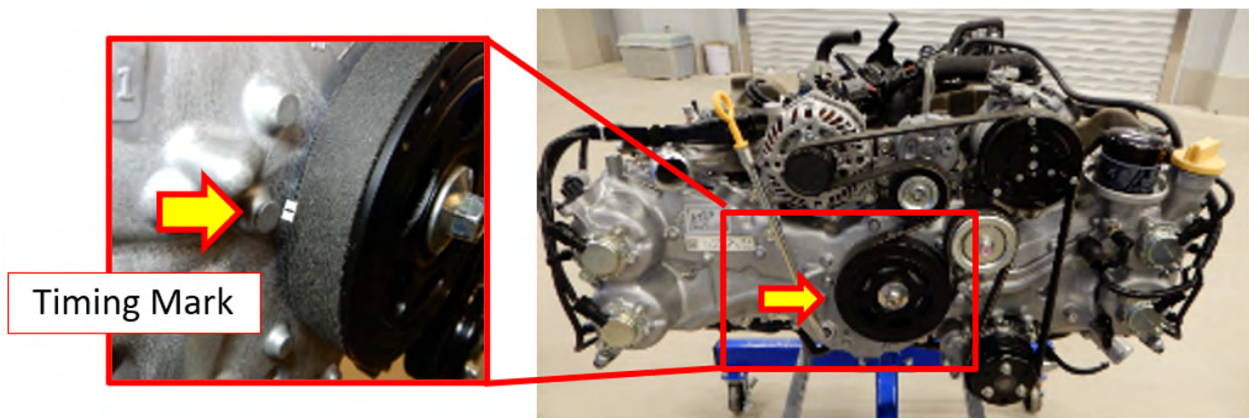
STEP 5: Rotate the crank pulley clockwise until the timing mark matches the position indicated below.

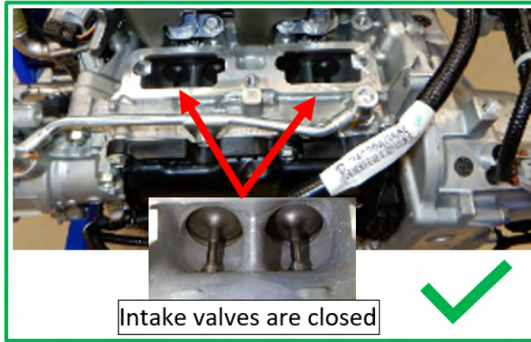
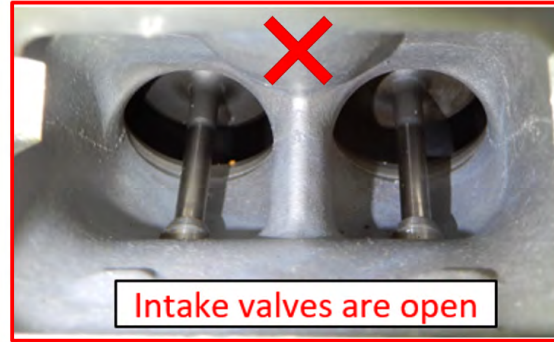
STEP 6: Visually inspect the intake valves of cylinders #1 and #3. Confirm the valves are in the closed position.

NOTE: If the valves are open, rotate the crank pulley 360 degrees in the clockwise direction and monitor the valve position. DO NOT continue until the valves are confirmed to be closed.

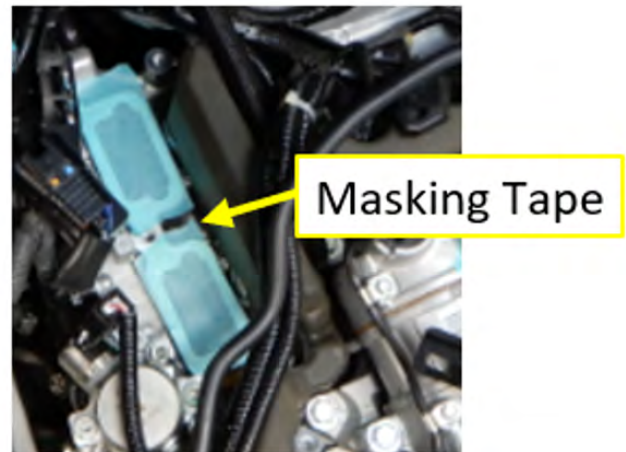
STEP 7: Seal the intake ports of cylinders #2 and #4 with masking tape. This will prevent any foreign material from entering.

CAUTION: Contamination or adhesion of foreign material such as walnut shell media inside the engine may cause starting failure and/or engine stalling.

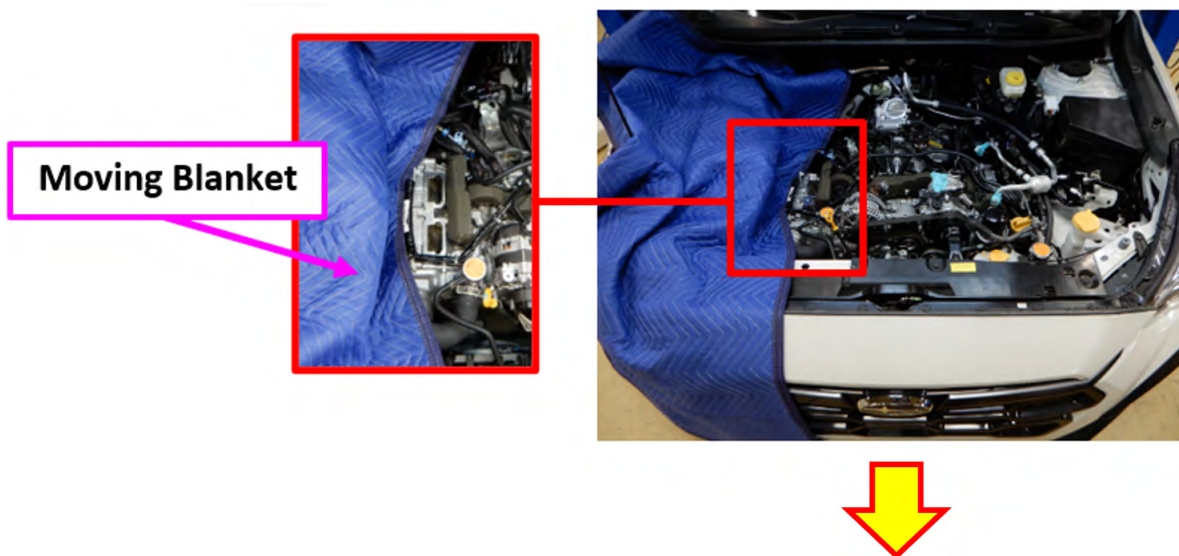
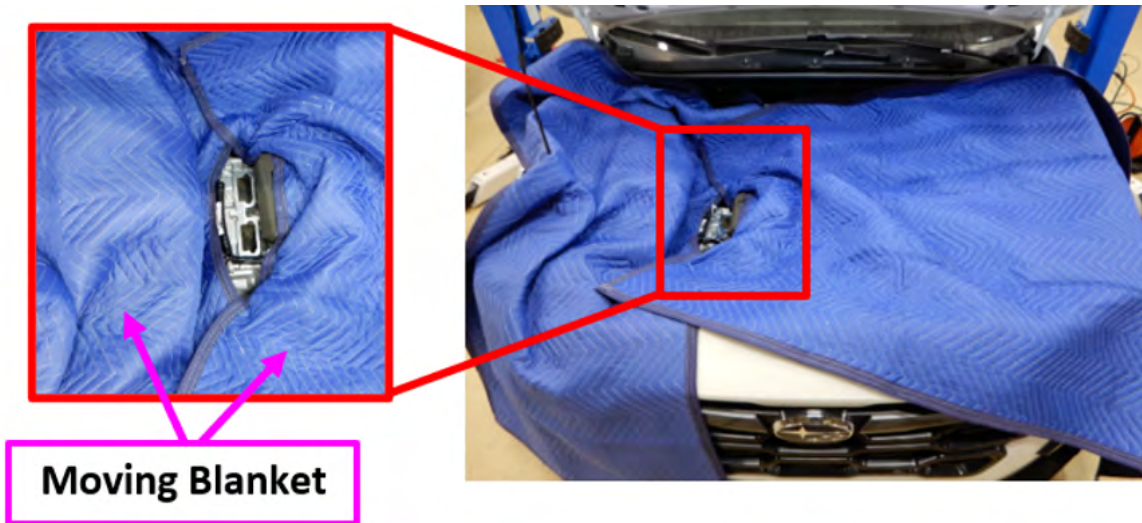
STEP 8: Cover the area around the intake port with two moving blankets. This will help prevent any walnut shell material from contamination.

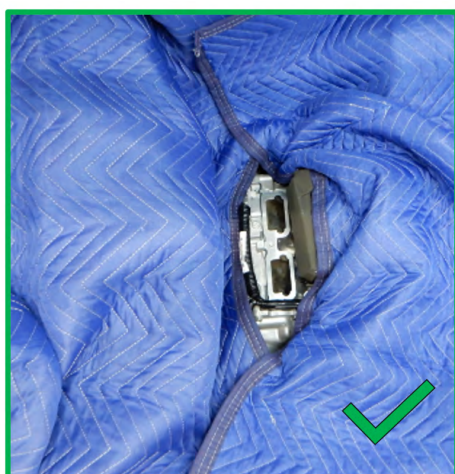
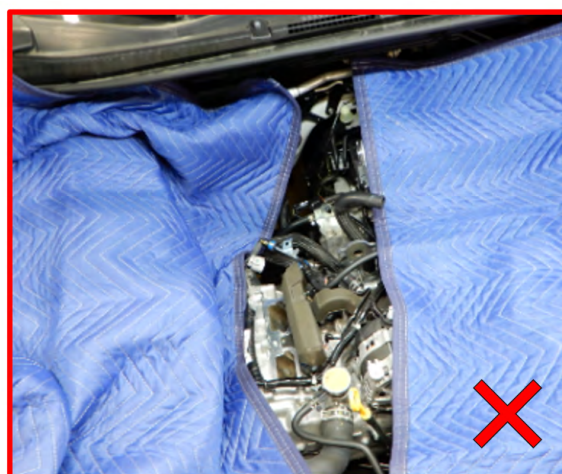
CAUTION: Confirm harness connections, fuels lines, and ALL other components are covered prior to cleaning.

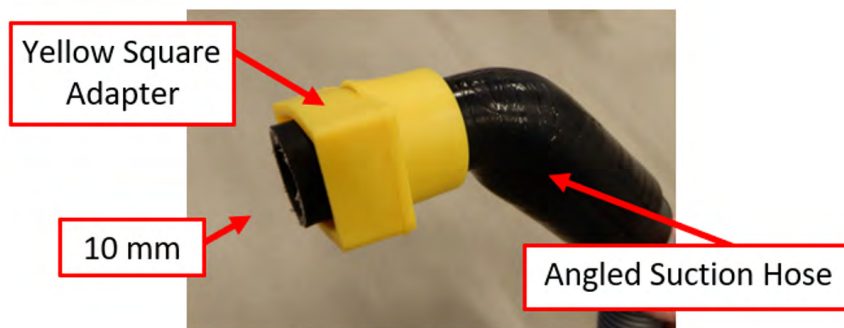
STEP 10: Prepare the angled suction hose by inserting the square yellow adapter onto the end of the hose. Allow approximately 10mm of the hose to protrude from the adapter. This will provide added stability when cleaning.

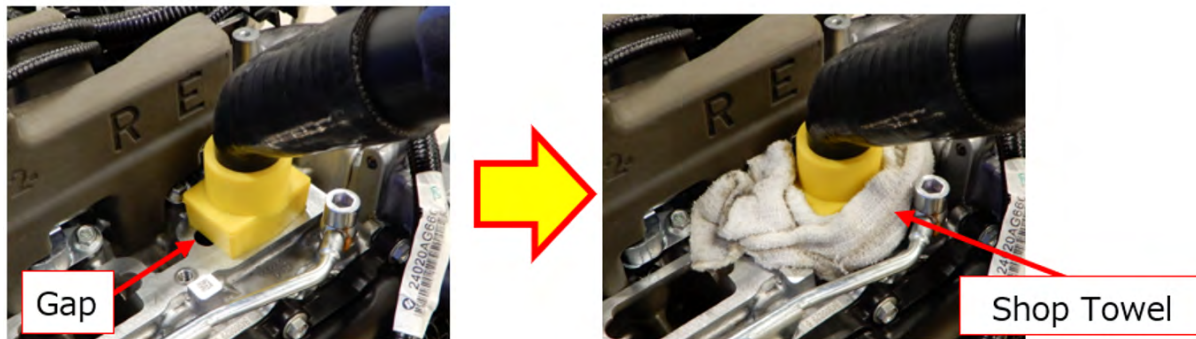
STEP 11: Set the hose into the cylinder #1 intake port. Cover any gaps with a shop towel.

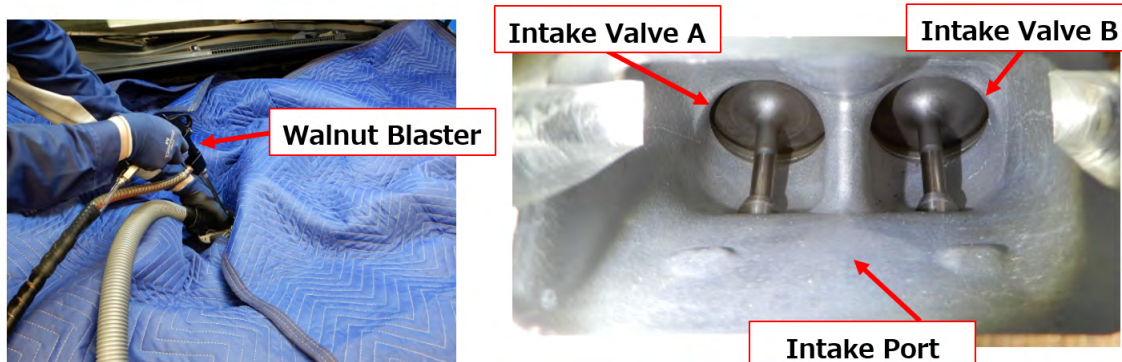
STEP 12: Clean the intake valve and intake port of cylinders #1.

- A. Confirm the walnut blaster is turned on.
- B. Insert the nozzle of the walnut blaster into the suction hose.
- C. Pull the trigger and allow the abrasive material to pass through the nozzle.
- D. Aim the nozzle in the direction of Valve A.
- E. Aim the nozzle in the direction of Valve B.
- F. Move the nozzle up, down, left, and right to ensure the entire area is cleaned.

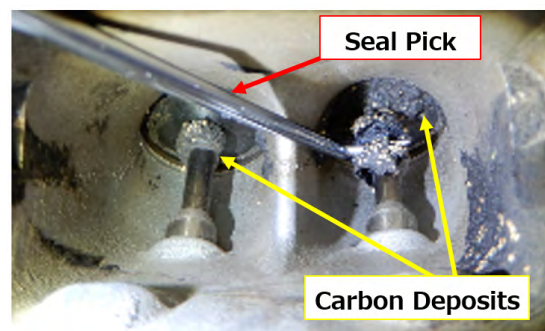
TIP: A seal pick can be used for the removal of some of the more difficult to remove carbon deposits. Be careful not to scratch the valves or cylinder head.

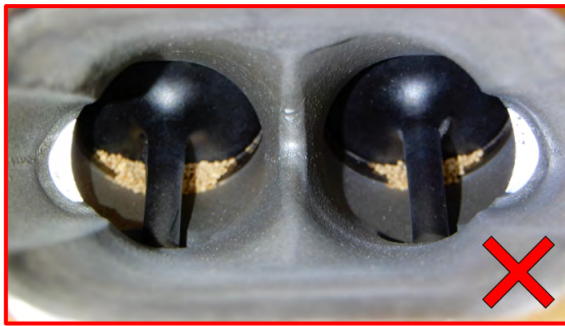
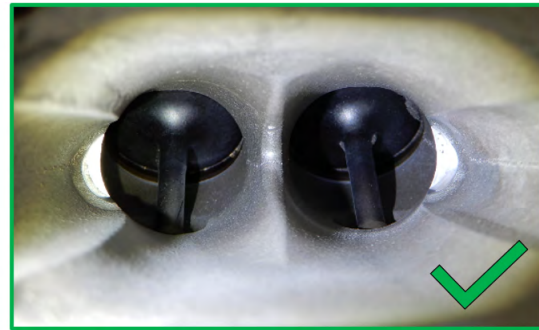
STEP 14: After cleaning is completed, remove any remaining abrasive material using the suction hose. Using a flashlight, inspect the ports and confirm there is no remaining material.

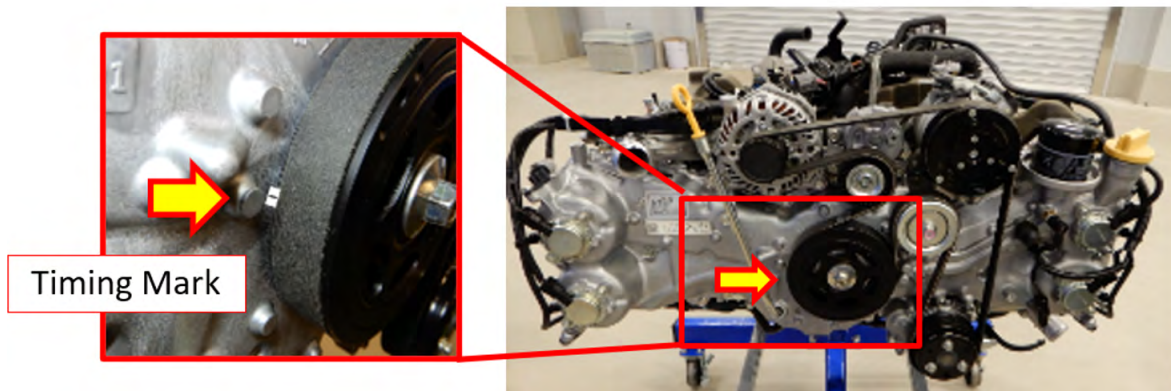
STEP 16: Rotate the crank pulley clockwise 360 degrees until the timing mark matches the position indicated below.

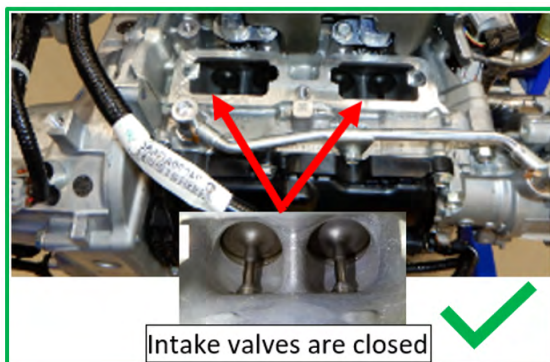
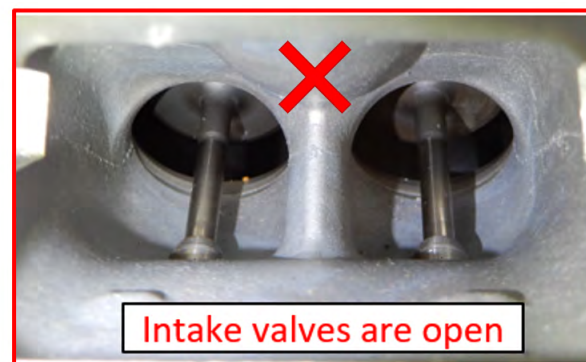
STEP 17: Visually inspect the intake valves of cylinders #2 and #4. Confirm the valves are in the closed position.

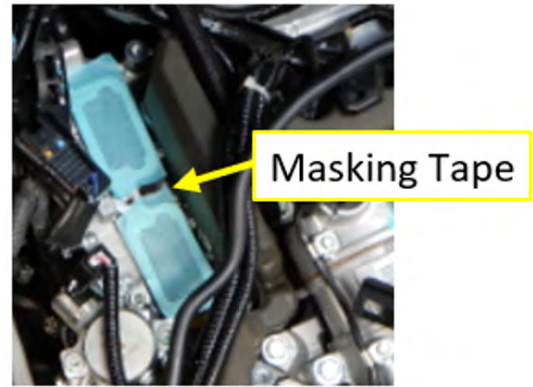
STEP 18: Seal the intake ports of cylinders #1 and #3 with masking tape. This will prevent any foreign material from entering.

CAUTION: Contamination or adhesion of foreign material such as walnut shell media inside the engine may cause starting failure and/or engine stalling.

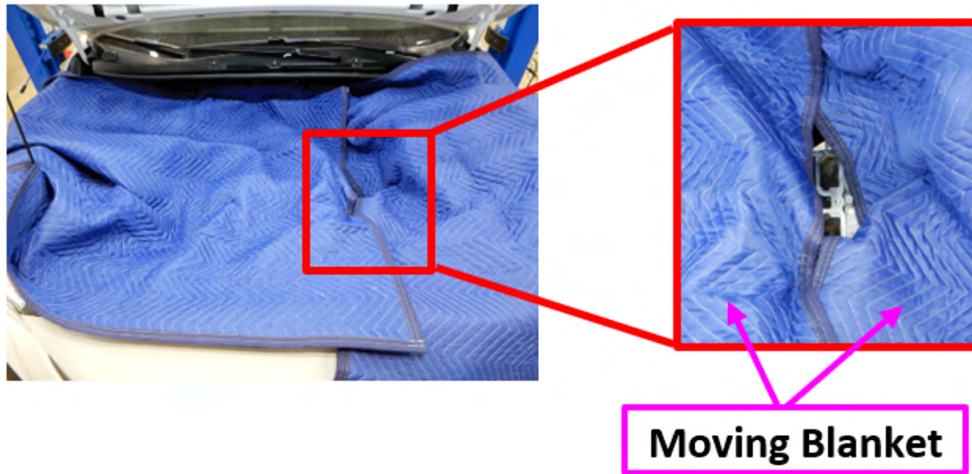
STEP 19: Cover the area around the intake port with two moving blankets. This will help prevent any walnut shell material from contamination.

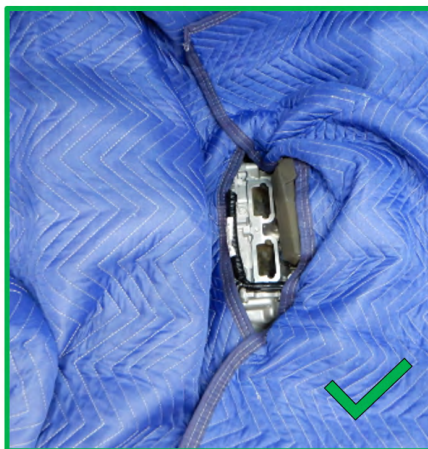
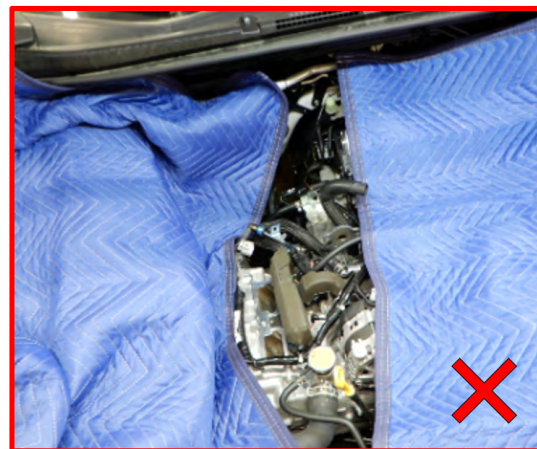
CAUTION: Confirm harness connections, fuels lines, and ALL other components are covered prior to cleaning.

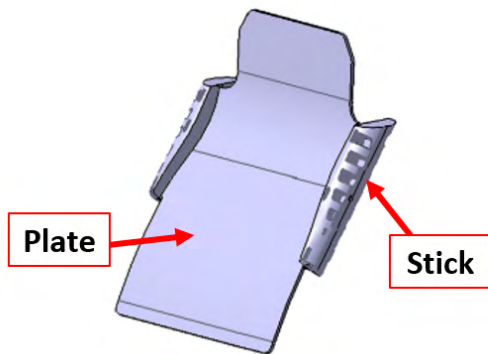
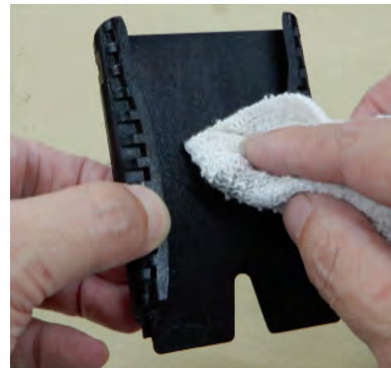
STEP 21: Clean the plate and stick portions of all the cylinder head plates using throttle plate cleaner. Dry the cylinder head plates with a clean shop towel. Confirm there is no cleaner remaining on the plates.

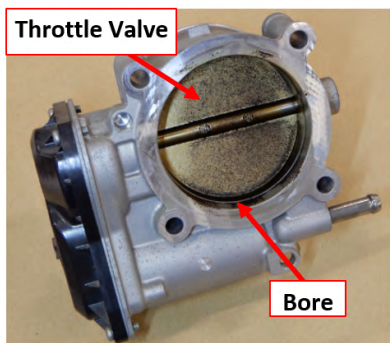
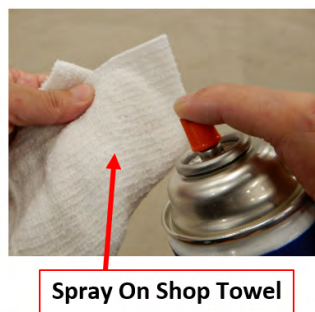
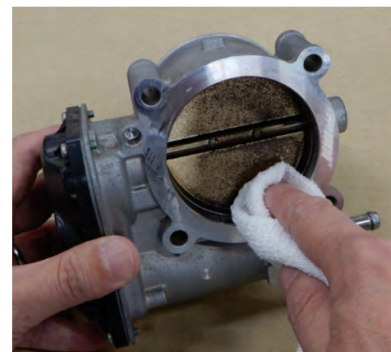
STEP 22: Clean the throttle body.

- A. Remove the throttle body from the intake manifold.
- B. Soak a shop towel in throttle plate cleaner.
- C. Wipe the throttle valve and bore inner surfaces from both the intake manifold and intake duct sides.
- D. Wipe the cleaned areas with a clean shop towel and confirm no throttle plate cleaner remains.

CAUTION: DO NOT open and close the throttle valve manually during cleaning. DO NOT deform or scratch the throttle valve/bore.
