EGR Valve Diagnosis and Cleaning Procedure using TU-NAP 926® on 906, 907 Sprinter with OM642 Diesel Engine

| Topic number | LI14.20-N-073867 |
| Function group | 14.20 - Exhaust gas recirculation |
| Validity | 906, 907 Sprinter with OM642 V6 Diesel Engine |

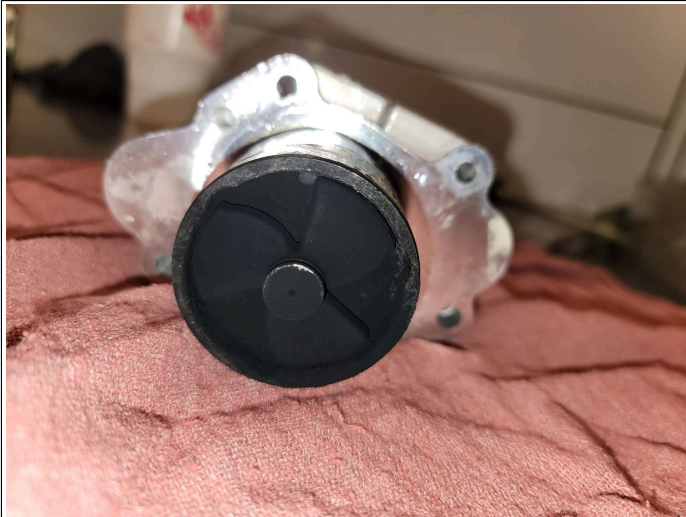
Cause of Complaint B:  
Soot deposits between the EGR Valve blade and seat leading to the EGR Valve no longer being able to meet the desired target of the EGR Valve position controller.

| Attachments | |
|---|---|
| <a href="#">OM642 EGR Valve before 1.jpeg</a> | Bottom of sooted EGR Valve. |

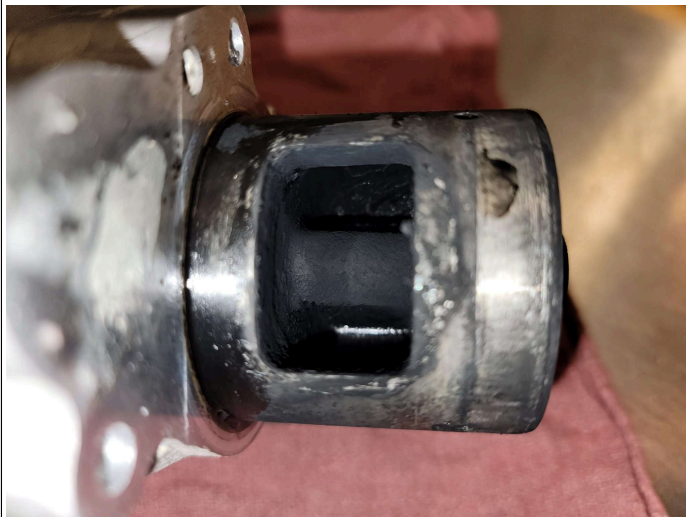
[OM642 EGR Valve before 2.jpeg](#)

Side view of sooted EGR Valve.

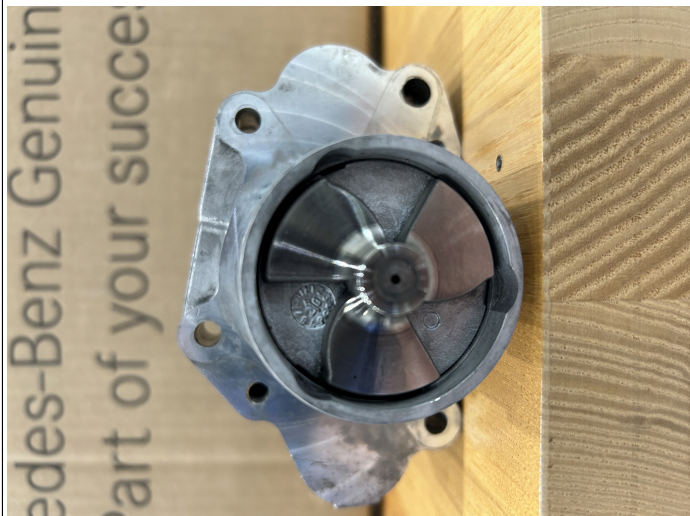
OM642 After Cleaning 1.JPG

Bottom view of cleaned EGR Valve looking at blades.

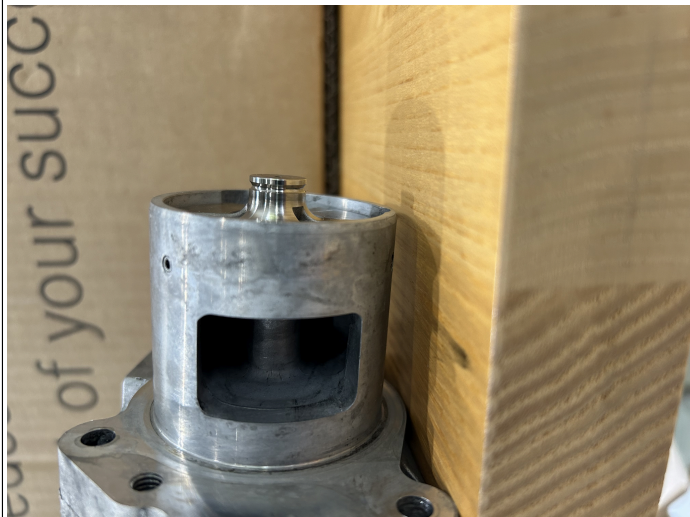
OM642 EGR After Cleaning 2.JPG

Side view of cleaned EGR Valve.

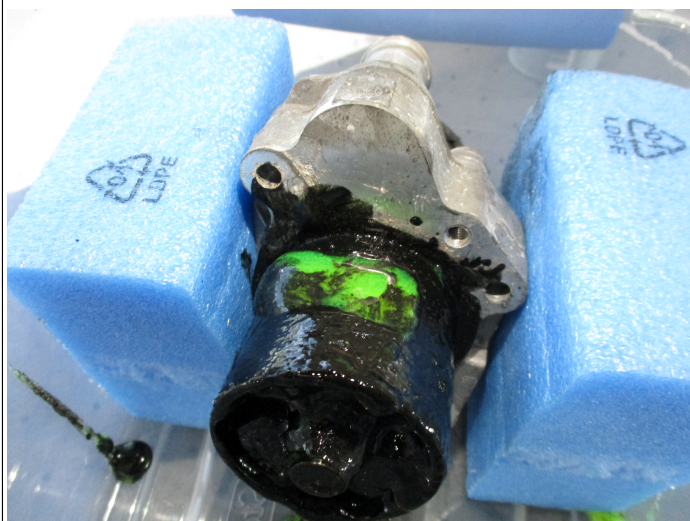
EGR Valve Cleaner Application.JPG

EGR Valve with cavity filled, and blades covered in cleaner.

2. Position EGR Valve so open cavity is facing upward. Fill the cavity with cleaner, and then proceed to apply cleaner to the blades from the outside. Additionally, apply cleaner to the outside where additional soot is found.

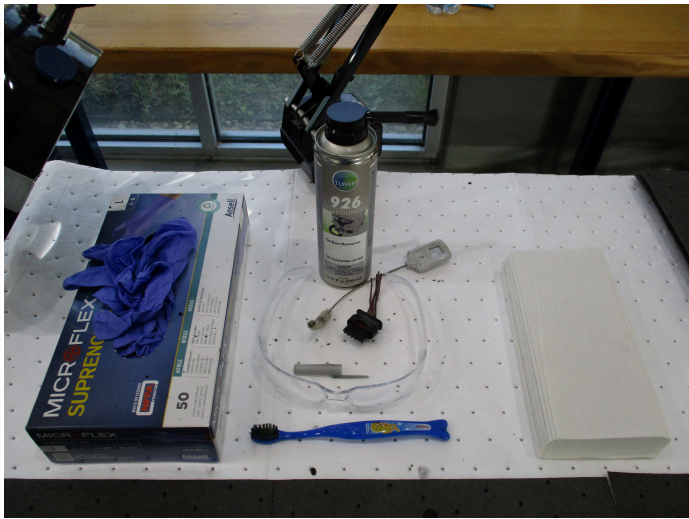
Brushes.JPG

Non-metallic soft brushes to assist in cleaning, and pen cap used to hold blades open for cleaning.

3. Allow 15 minutes for the cleaning gel to take effect.
4. Carefully brush the areas with the supplied cleaner brush or another suitable non-metallic brush with soft bristles; e.g. Kids' size toothbrush and straw cleaning brush (see picture in attachments).

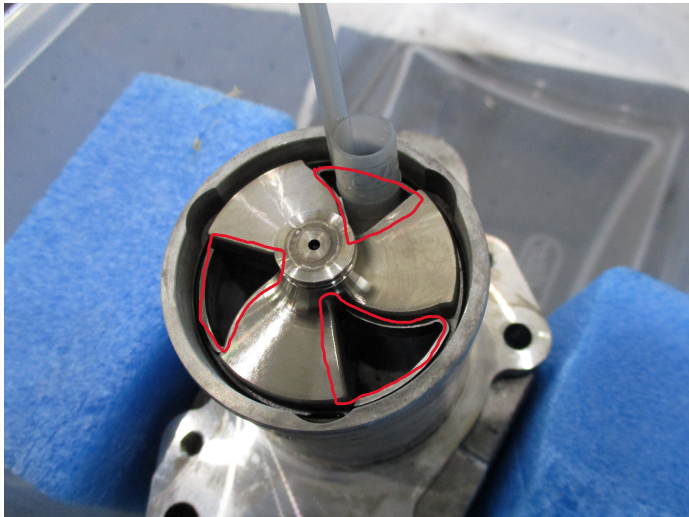
Blades Open.JPG

Hold blades open to clean using suitable non-metallic holder/wedge placed in the hole directly in front of the open cavity (i.e. pen cap) to clean blade seats.

5. Continue to clean the EGR Valve by turning the EGR Valve blades clockwise to the open position to enable cleaning the blade seat area. Hold blades in open position by placing a suitable non-metallic holder/wedge in the hole directly in front of the open cavity (see picture labeled "Blades Open" in attachments).
