Emissions Service Action

Code: 26OB

Subject	Exhaust Pressure Sensor				
Document History	Date		Summary		
	05/20/2025		Original publication		
Affected Vehicles	Country	Beginning Model Year	Ending Model Year	Vehicle	Vehicle Count
	USA	2025	2025	JETTA	19
	USA	2025	2025	TAOS	9
	CAN	2025	2025	JETTA	63
	CAN	2025	2025	TAOS	242
	<p><i>Check Campaigns/Actions screen in Elsa on the day of repair to verify that a VIN qualifies for repair under this action. Elsa is the <u>only</u> valid campaign inquiry & verification source.</i></p> <ul style="list-style-type: none"> ✓ <i>Campaign status must show "open."</i> ✓ <i>If Elsa shows other open action(s), inform your customer so that the work can also be completed at the same time the vehicle is in the workshop for this campaign.</i> 				
About this service action:	In affected vehicles it is possible that a faulty exhaust pressure sensor may impact tailpipe emissions. To address this issue, the exhaust pressure sensor will be replaced on affected vehicles.

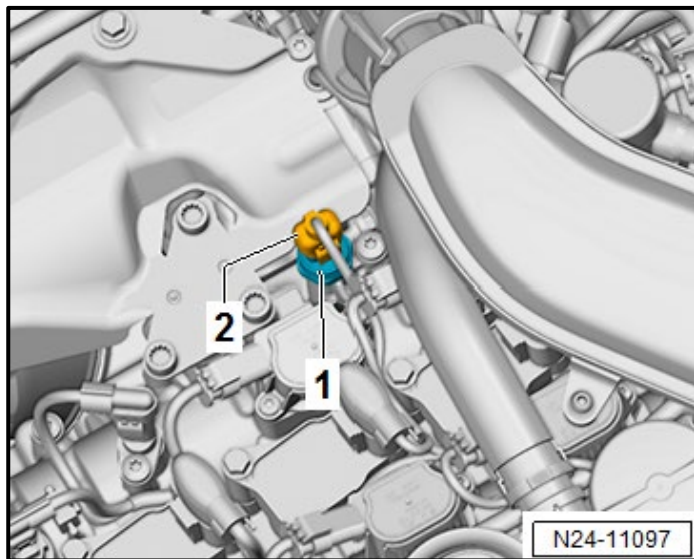
The condition addressed by this campaign may cause the MIL to illuminate and fault code P0471 – “exhaust pressure sensor implausible signal” to be stored.

Replace G450 exhaust pressure sensor:

- Replace the G450 exhaust pressure sensor <1> per the ELSA repair manual:
 - *Repair manual > Engine > 4-Cylinder Direct Injection 1.5L 4V, EA 211 evo2 Engine, Turbocharger > 24 Multiport Fuel Injection > Sensors > Exhaust Pressure Sensor 1 G450, Removing and Installing.*
