Condition

Applicable Vehicles					
Model(s)	Year	Eng. Code	Trans. Code	VIN Range From	VIN Range To
Jetta	2020 – 2021	1.4T (DGXA, DJXA)	All	All	All

DTC	Description
P242100	EVAP System Vent Valve Stuck Open

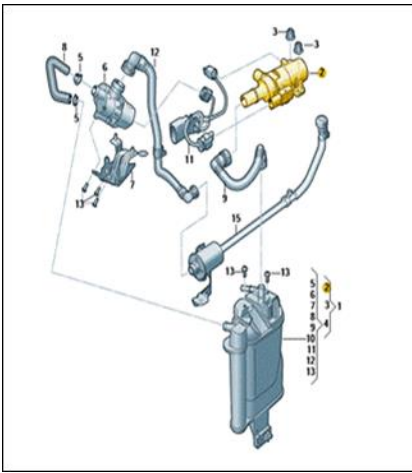
Figure 1.

In addition to the software update detailed below, there is an improvement to the FTIV (fuel tank isolation valve / tank switch-off valve -**N288-**) (Figure 1.), which is necessary in preventing erroneous occurrences of the P2421 fault code.

The FTIV / tank switch-off valve -**N288-** currently installed on the vehicle must be inspected, to verify whether an improved part has already been installed. The FTIV / tank switch-off valve -**N288-** is mounted to the EVAP canister assembly, as shown below.

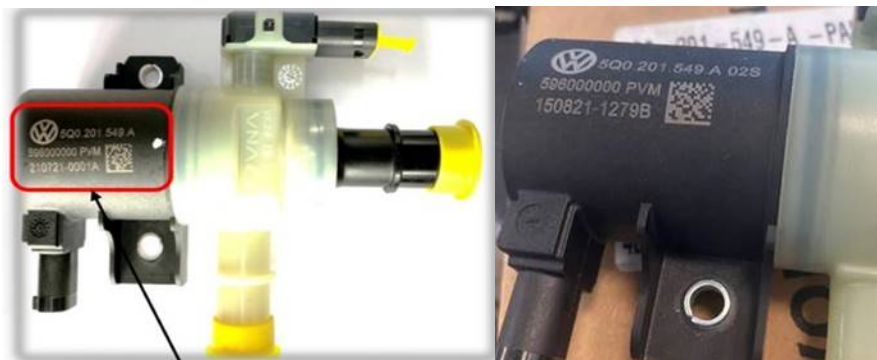
Remove the EVAP canister assembly and inspect the face of the FTIV / tank switch-off valve -N288-. If the part is already updated, it will be part number 5Q0.201.549.C. Alternatively, it may have a white paint marking or an "02S" printed after the part number, as shown in Figure 2.

- If the part number is 5Q0.201.549.C, the FTIV / tank switch-off valve -N288- is already the updated component. In this case, DO NOT replace it, and instead reinstall the EVAP canister assembly. Only the software update will be required.
- If the part has a white paint mark or "02S", the FTIV / tank switch-off valve -N288- is already the updated component. In this case, DO NOT replace it, and instead reinstall the EVAP canister assembly. Only the software update will be required.
- If the part number is not 5Q0.201.549.C, there is no white paint mark, and "02S" is not included on the FTIV / tank switch-off valve -N288-, the component must also be replaced in addition to the software update. Always refer to ETKA for the most up to date part number information.
