Condition

Applicable Vehicles					
Model(s)	Year	Eng. Code	Trans. Code	VIN Range From	VIN Range To
Atlas Atlas Cross Sport	2024	2.0T (DRKB)	All	All	All

Revision Table			
Instance Number	Published Date	Version Number	Reason For Update
2075320/3	5/8/2025	15-25-01	Updated labor operation.
2075320/1	9/19/24	15-24-01	Original publication.

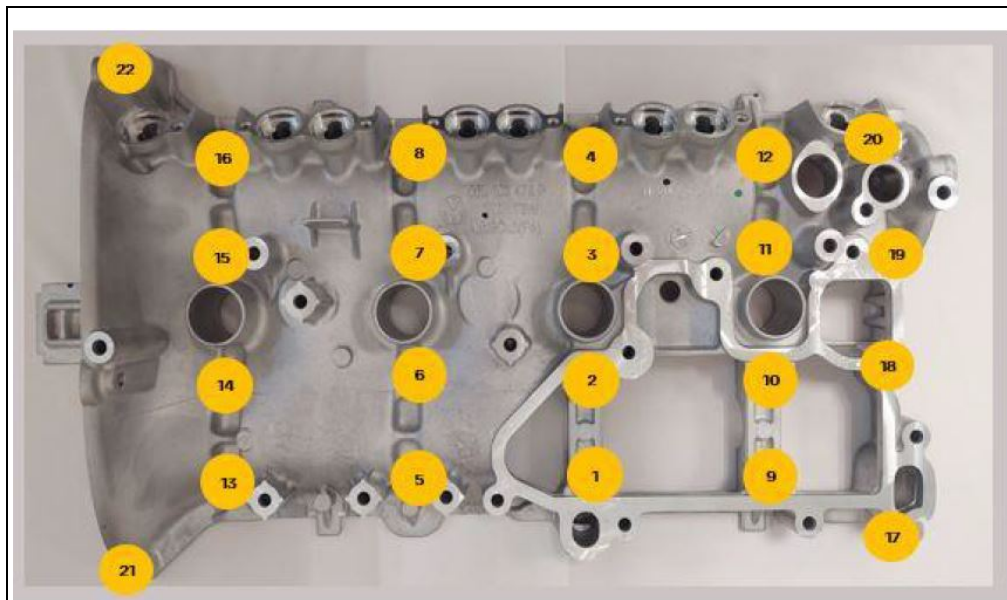
Order for checking torque

Check that the cylinder head cover bolts are tightened to a torque of 14 Nm in the order shown in the illustration below.

If, while checking the cylinder head cover bolts are tightened to 14 Nm, if the torque wrench does not click after a quarter turn (90°), the affected bolt must be replaced.

Replace any loose bolts.

Tighten the new bolt(s) to a torque of 8 Nm + 90°.

If several cylinder head cover bolts are affected, do not loose them at the same time (i.e. several at once). Remove, replace and tighten the bolts one by one in the order shown above.

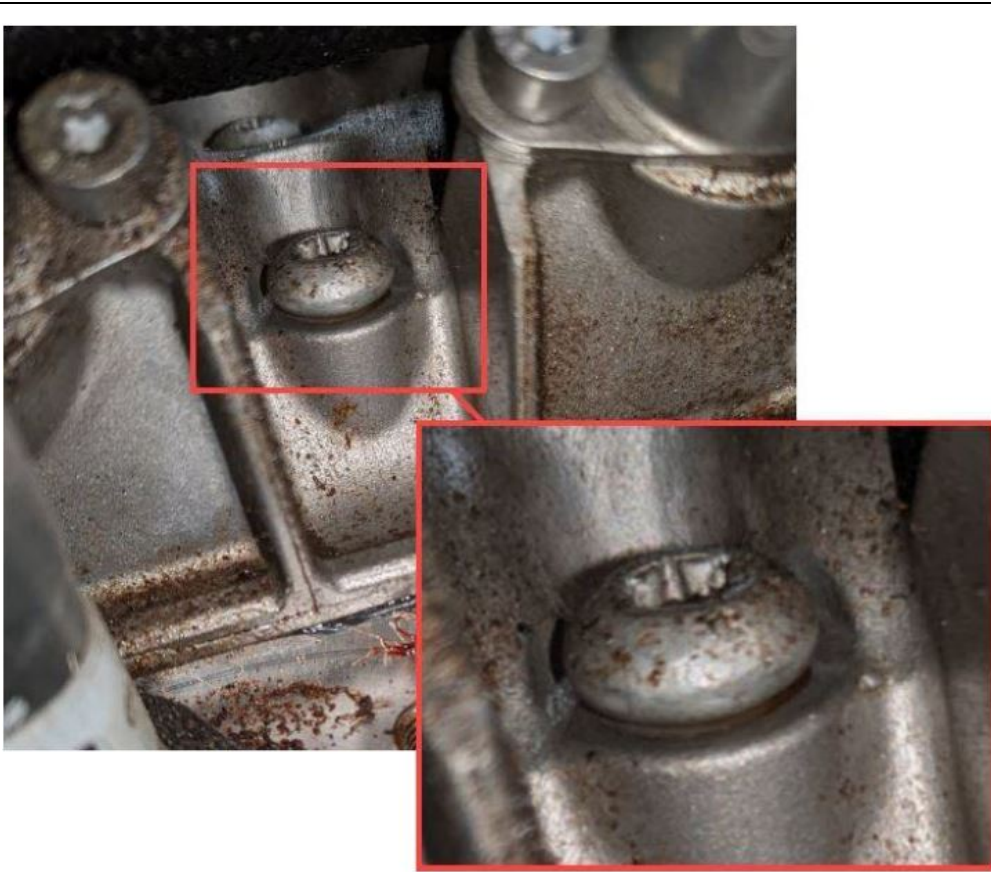
Example image

- Cylinder head cover leaking in the area around the threaded connection (on one or multiple bolts).

In rare cases, the cylinder head cover bolts may become loose, resulting in oil residue in the area of the threaded connection.

Please ensure that replacing the bolts remedies the leaking.
