Applicable Vehicles					
Model(s)	Year	Eng. Code	Trans. Code	VIN Range From	VIN Range To
Atlas, Atlas Cross Sport	2021	All	All	All	All
Arteon, Atlas, Atlas Cross Sport, Golf R, GTI, Jetta, Taos, Tiguan	2022 - 2025	All	All	All	All

Revision Table			
Instance Number	Published Date	Version Number	Reason for Update
2071790/2	5/13/2025	91-23-04	Update to model and model year applicability.
2071790/1	10-18-2023	91-23-04	Original publication.

The MIB infotainment system may be experiencing an unresponsive condition such as failure to power on, display stuck in “emergency mode”, and/or a freezing or rebooting condition. In this state, attempts to operate the unit and/or perform necessary updates may not be possible. Installation of a corrective file via USB may restore normal operation and permit further use and/or perform necessary updates.

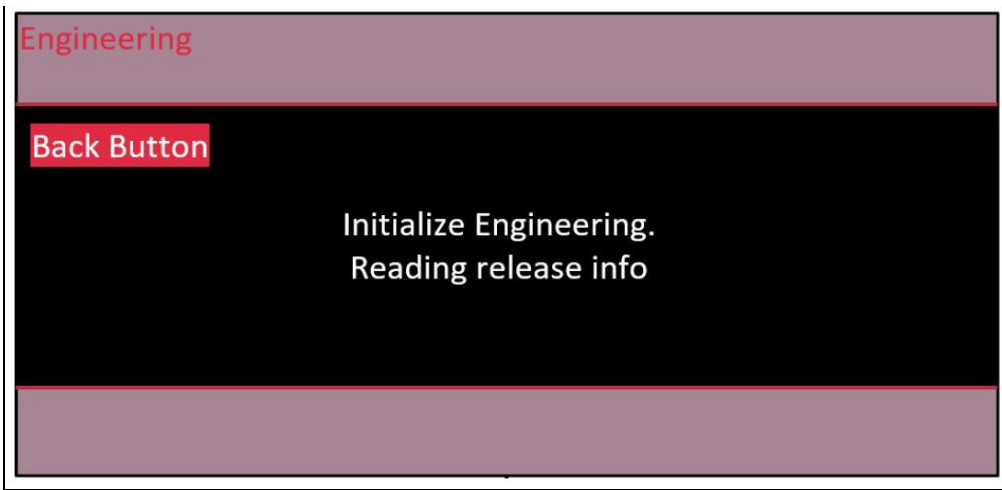
- Refer to Technical Bulletin 00-19-04 (2054866) Set up SD/USB Creator to Obtain Software Updates.
- Use USB part number **3G0.919.360.SE**.
- Switch the ignition to the OFF position.
- Connect the MTRMSP0702 battery maintainer/charger to the vehicle’s battery.
- Insert the USB **3G0.919.360.SE** into the front USB-C connection.
- Switch the ignition to the ON position.
- Hold the “On/Off” button on the MIB display for a minimum of 10 seconds, then release.
- At this point, it may take up to 5 minutes to the system to start and initialize.
- If after 5 minutes, there is no response from the system, the above process may be repeated.
- If the recovery attempt is successful, the following screen may appear on the MIB display and additional files may install at this time.

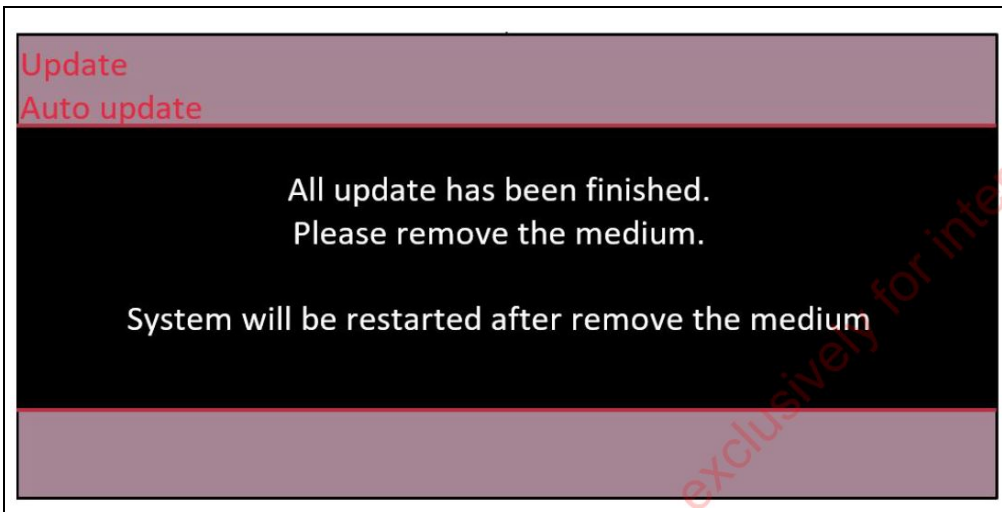
- Lastly, the following screen will appear on the MIB display indicating the process is complete.

- Remove the USB drive.
- The infotainment system should now boot up automatically.
- Once normal operation is restored, refer to any applicable technical bulletins regarding specific software level updates as applicable.
