## Technical Service Bulletin

<b>Topic</b>	15 Engine: Cylinder head cover - oil residue Q5 (inline 4-cyl., 2.0 ltr. TFSI)
<b>Market area</b>	United States 444 Volkswagen of America, Inc. (6444)
<b>Brand</b>	Audi
<b>Transaction No.</b>	2072716/7
<b>Level</b>	EH
<b>Status</b>	Released for publishing
<b>Release date</b>	May 21, 2025

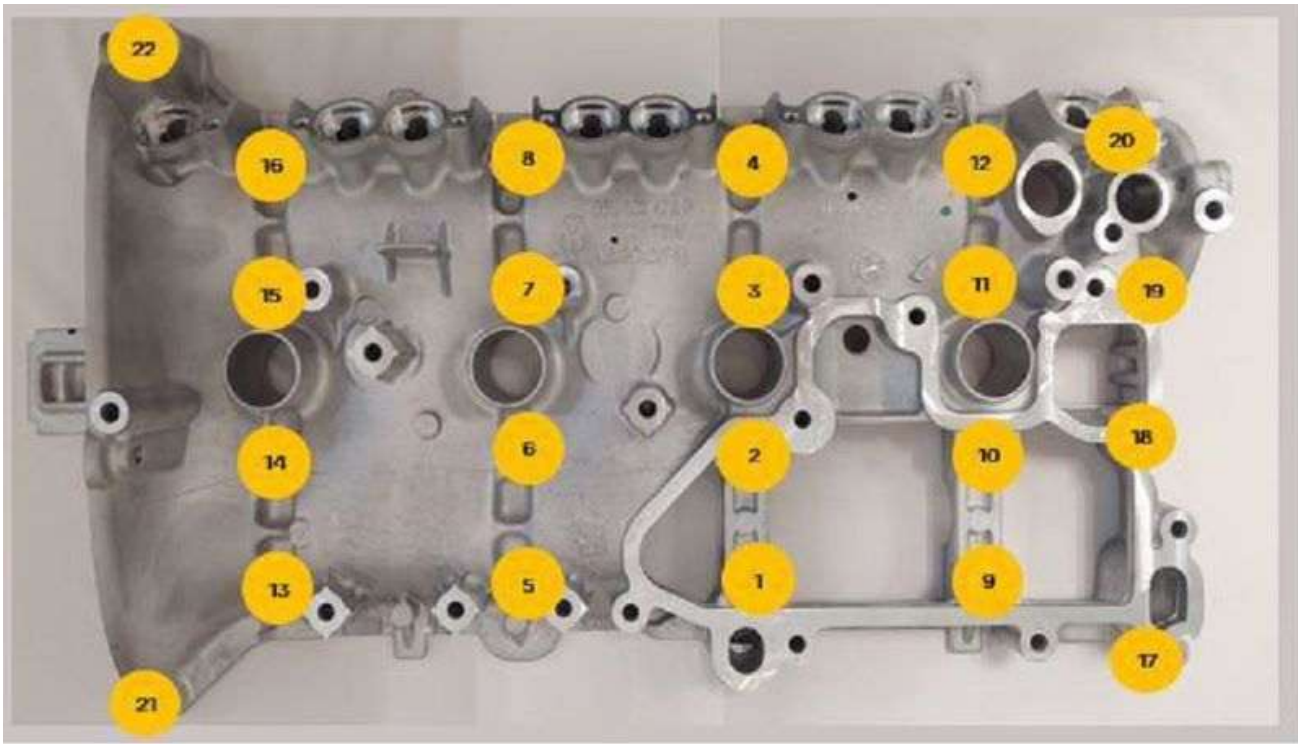
**Figure 1:** Sequence of checking bolts

- Please check all 22-cylinder head cover bolts
- The oil separator must be removed.
- Check that the bolts are tightened to a torque of 14 Nm in the order shown in Figure 1.

- Replace any loose bolts.
- Tighten the new bolt(s) to a torque of 8 Nm + 90°.
- If several bolts are affected, do not loosen them at the same time (i.e. several at once). Please remove, replace, and tighten the bolts one by one in order shown in Figure 1.

- **When replacing the new bolt, it must be tightened to a torque of 8 Nm + 90°. If several bolts are affected, do not loosen them at the same time (i.e. several at once). Please remove, replace, and tighten the bolts one by one in order shown in figure 1.**
- **When re-tightening the bolt(s), the maximum torque of 14 Nm must not be exceeded.**

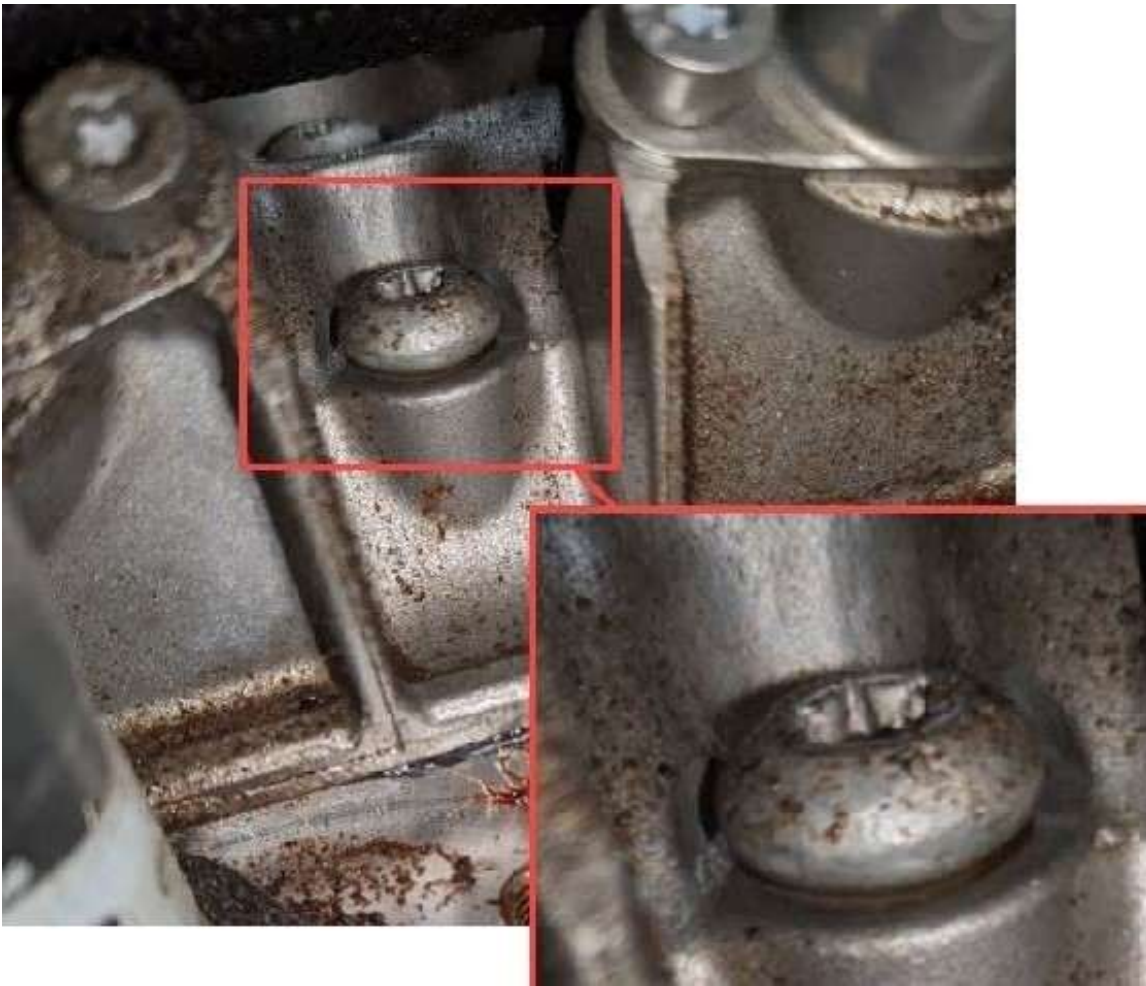
- Cylinder head cover leaking in the area around the threaded connection (on one or more bolts).

In rare cases, the cylinder head cover bolts may become loose, resulting in oil residue around the threaded connection.

**Figure 2:** Oil on the threaded connection.

- Please ensure that replacing the bolts remedies the leaking.
- In this case, contrary to the information in ELSA, the oil separator gasket should be reused after removing the oil separator if it is not damaged. Please only remove the gasket from the oil separator if it is damaged.
