Technical Service Bulletin

Topic	93 e-tron GE various warning messages in the cluster, electric motor leaking P0AA600
Market area	United States 444 Volkswagen of America, Inc. (6444)
Brand	Audi
Transaction No.	2073858/8
Level	EH
Status	Released for publishing
Release date	May 14, 2025

e-tron GE MJ19-25

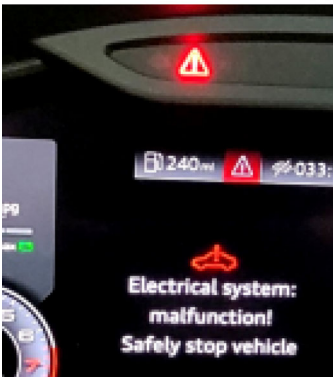
- A Drive System/Electrical System Malfunction message (Figure 1) appears in the in the instrument cluster; the warning may not be present at the time of inspection.

Figure 1. Warning lamp associated with message.

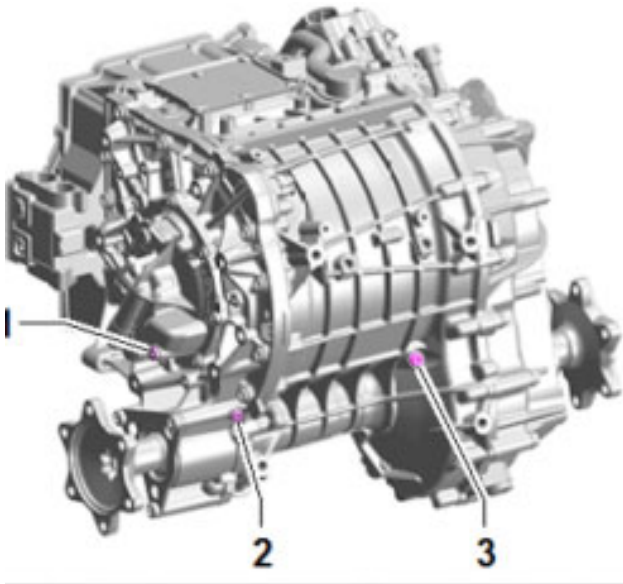
Front axle (Figure 3):

- Coolant leaking from active chamber.

Figure 3: 1) *Resolver cover:* A few milliliters of coolant leakage is not an issue from a technical perspective. 2) *Active chamber:* No coolant may escape from the bores.

The power electronics must not be replaced if the electric drive motor is leaking.
