## Technical Service Bulletin

| <b>Topic</b> | 55 Rear lid does not close and opens again |
| <b>Transaction No.</b> | 2077738/2 |

### Audi Q6 Etron

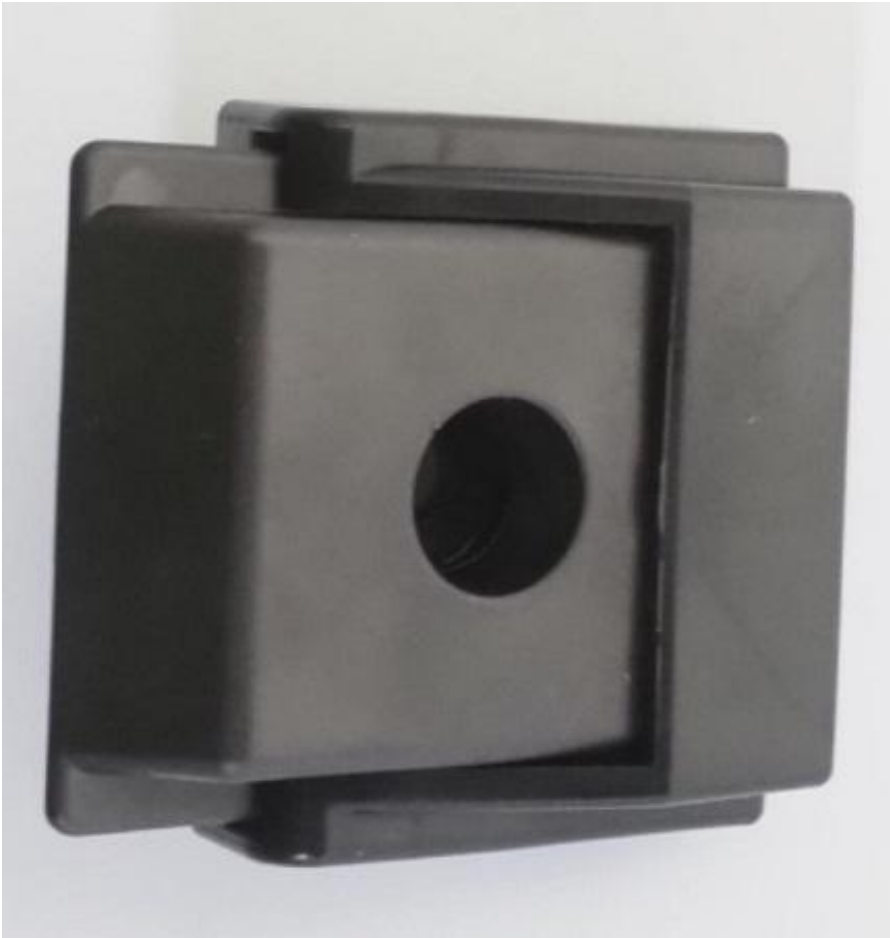
The control unit detects excessive force at the buffers.

**Figure 1.** *Pre-tensioned bump stop.*

1. Remove the side bump stops (pre-tensioned spring buffers (Figure 1). Using the Workshop Manual, spring force gauge VAS 895 035 and measurement film VAS 859 037, adjust the rear lid buffer force to between 40 N and 60 N and then fit the pre-tensioned spring buffers again. Alternatively, you can leave the side bump stop installed and set the buffer forces to the lower limit of 40 N. Please also observe the Special Technical Service Training video on the spring force gauge VAS 895 035 in the Audi Knowledge Tank (AKT). **NOTE:** If your vehicle is not equipped with side bump stops (Figure 1), please start from the point: "**Adjusting buffer forces using spring force gauge VAS 895 035**".
2. Then reset initialization of the rear lid and then adapt the flap opening angle again. Proceed as follows:

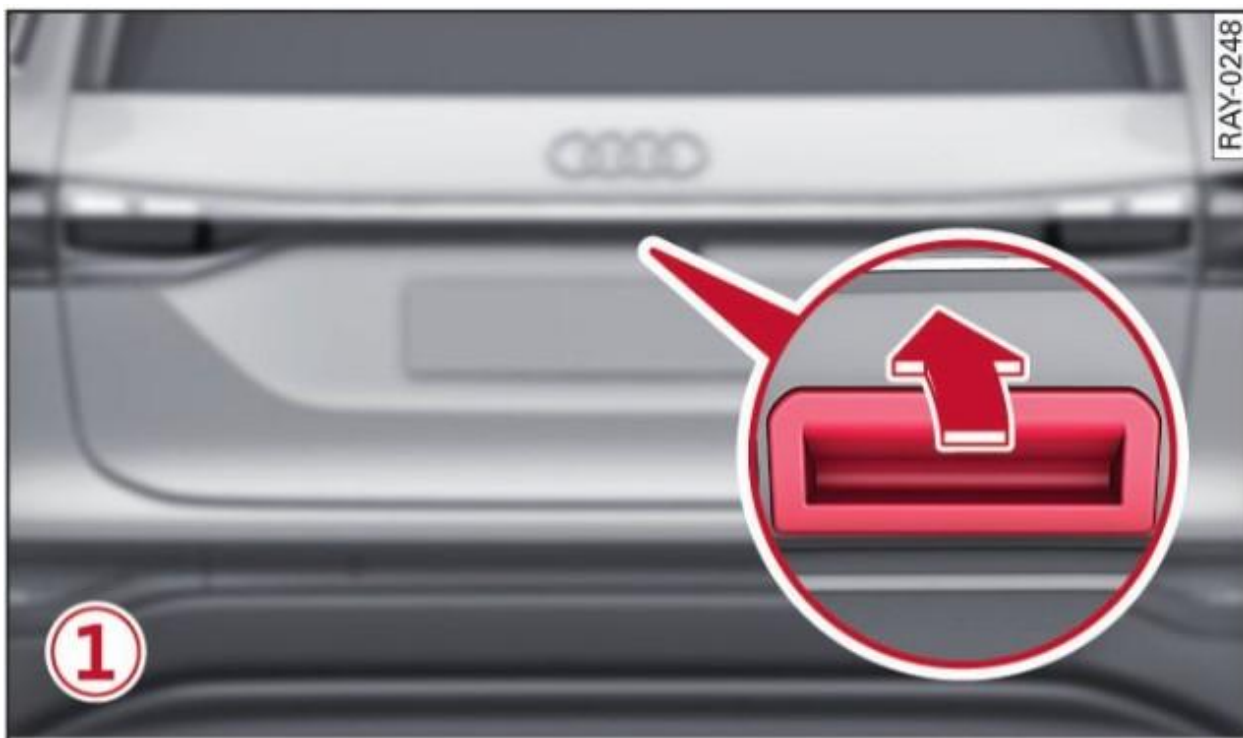
**Figure 2.** Electric rear lid lock actuation button.

Press and hold the electric rear lid lock actuation button on the outside (Figure 2) and the electric rear lid lock actuation button on the inside (Figure 3, item 3) simultaneously for at least 5 seconds. An audible signal will be given.

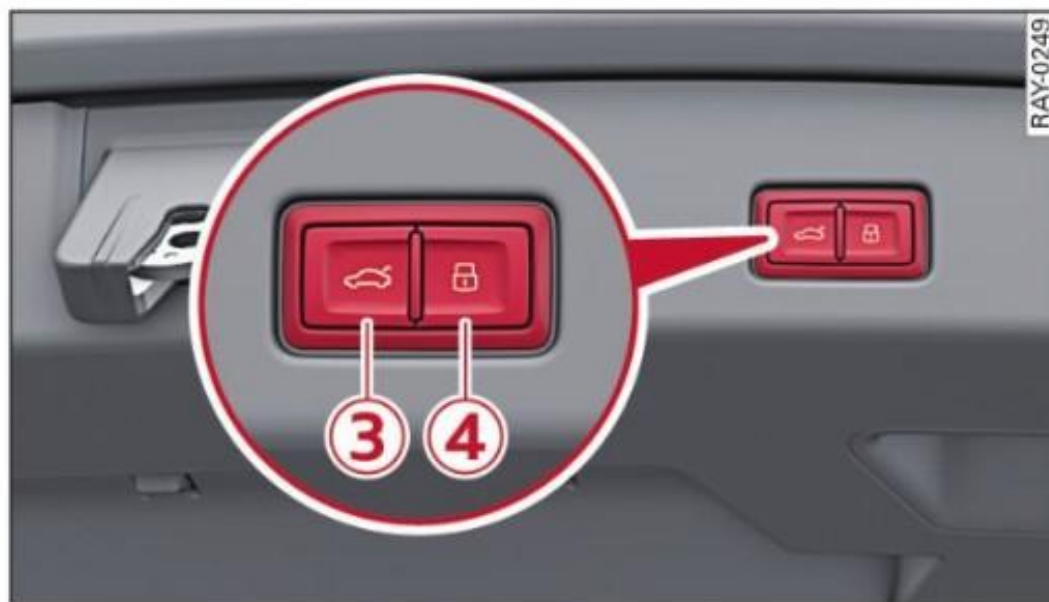
**Figure 3.** Electric rear lid lock actuation button (3).
