Technical Service Bulletin

Transaction No.: **2078134/1**

93 Q4 e-tron - electric drive system warning lamp lights up / event memory entry:
P0BBD00 in 008C

Release date: May 29, 2025

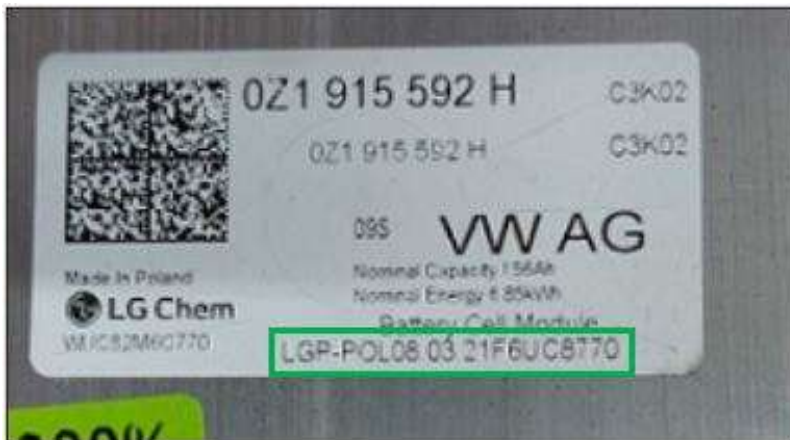
- **It is essential that you observe and adhere to the safety information/safety measures in the Workshop Manual during all work on the high-voltage system.**
- Remove and open the high-voltage battery as per the Workshop Manual.
 - Check the manufacturing date on type plate of the battery module to be renewed (see Figure 1):
 - The consecutive production number (see Figure 1, highlighted in green) also includes the manufacturing date of the battery module. The manufacturing date of the battery module from the example (see image 1, highlighted green): LGP-POL **08.03.21** F6CUC8770 would therefore be **08.03.2021**.

Figure 1. Example image of a battery module type plate with production date: 08 03 21 (= 08.03.2021)

- If a battery module with a manufacturing date **prior to 04.12.2023** is installed **and** has one of the following part numbers: 0Z1.915.592.G, 0Z1.915.592.H, 0Z1.915.592.J, 0Z1.915.599.G, 0Z1.915.599.H, 0Z1.915.599.J, 0Z1.915.599.P, the battery module must be replaced according to the Workshop Manual/parts catalogue.
- If a battery module with a manufacturing date **from 04.12.2023 onwards** is installed, a *technical repair query* must be created.
