# Service Bulletin

Bulletin No.: 24-NA-193

**Subject: Radio Software Update W52E-176.1.2-M170-SQBR5-250.2**

**This Service Bulletin replaces PIC6527, PIC6579 and covers vehicles formerly in PIC6498. Please discard PIC6527 and PIC6579.**

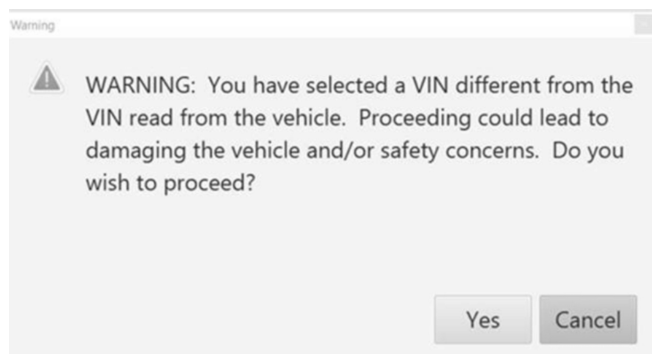
5877000

**Important:** If the vehicle VIN DOES NOT match, the message below will be shown.

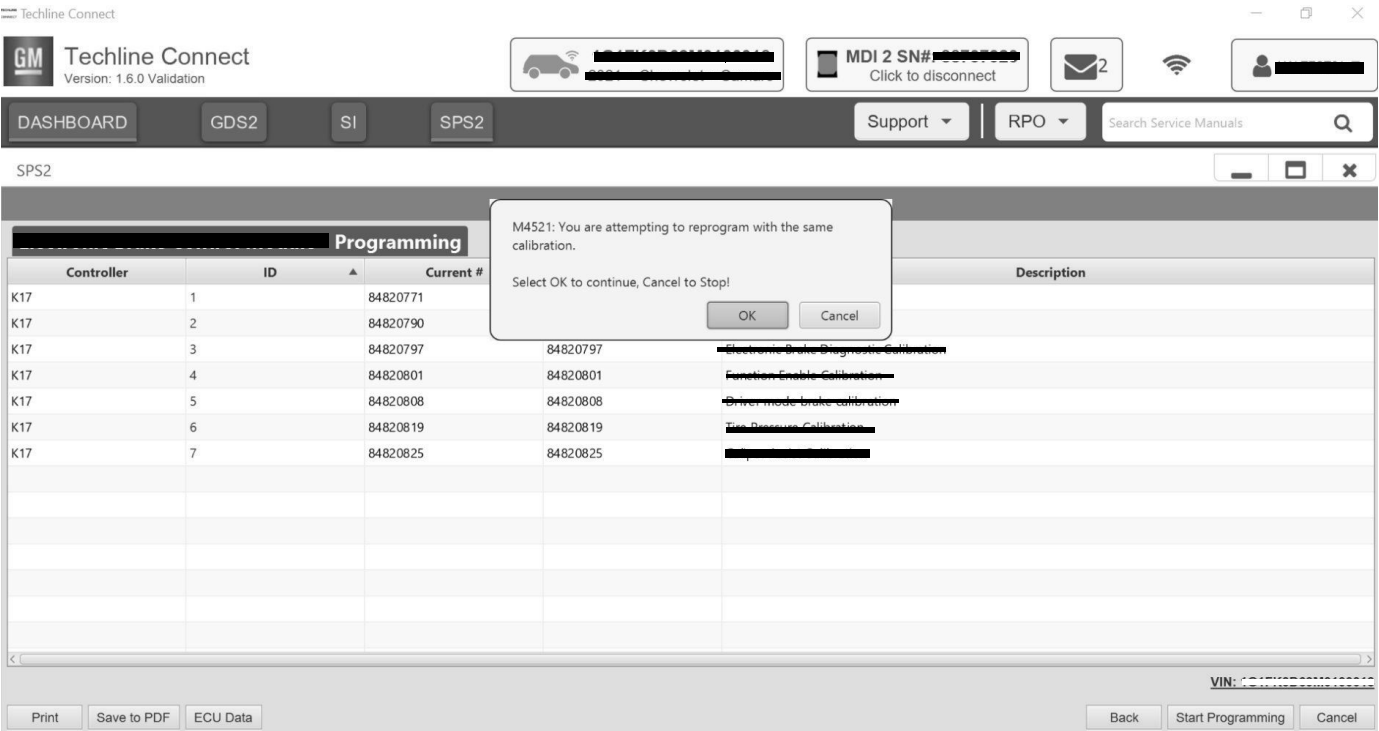
5644477

**Important:** Techline Connect screen shown above.

**Important:** If the same calibration/software warning is noted on the TLC Summary screen, select OK and follow screen instructions. After a successful programming event, the WCC is located in the Service Programming System dialogue box of the SPS Summary screen. Record the WCC on the job card. No further action is required. Refer to the Warranty Information section of this bulletin.

1. Reprogram the radio. Refer to *A11 Radio: Programming and Setup* in SI.

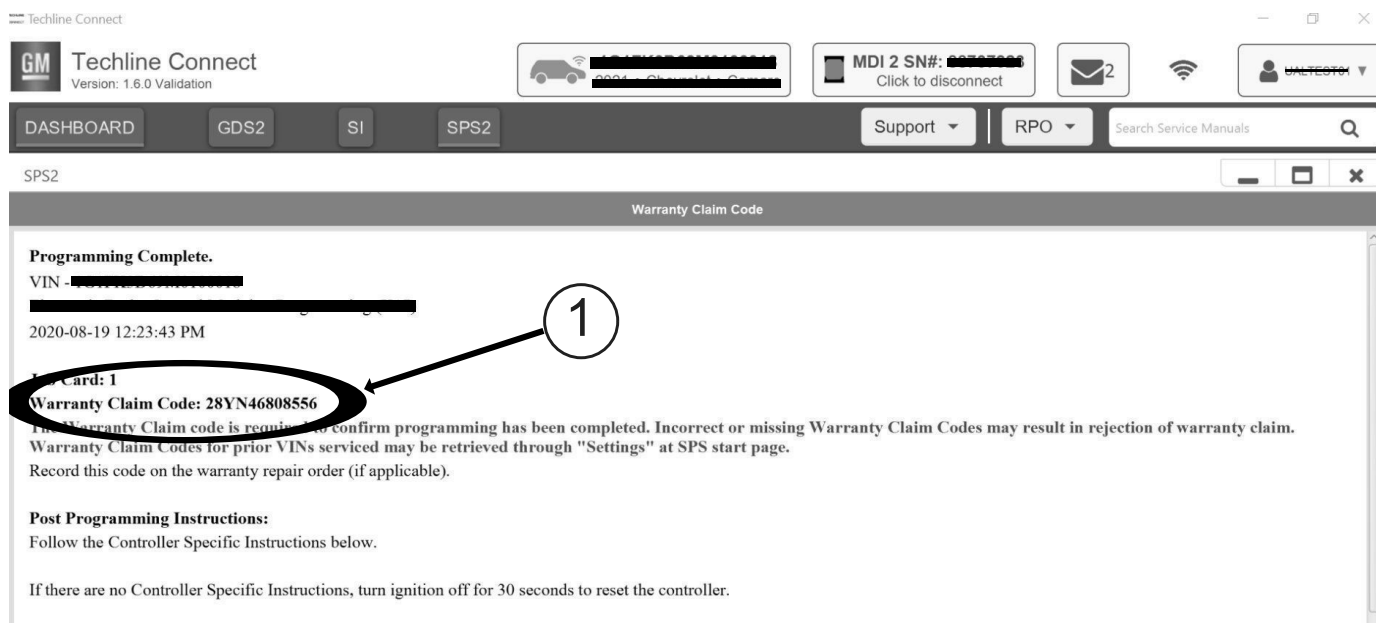
5644478

**Note:** The screenshot above is an example of module programming and may not be indicative of the specific module that is being programmed. Module selection and VIN information have been blacked out.

**Important:** To avoid warranty transaction rejections, you **MUST** record the warranty claim code provided on the Warranty Claim Code (WCC) screen shown above on the job card. Refer to callout 1 above for the location of the WCC on the screen.

- Record the SPS Warranty Claim Code on the job card for warranty transaction submission.
