Throttle lift-off clunking noises at drive shafts of front axle

Topic number	LI33.30-P-056665
Version	10
Function group	33.30 - Final drive, differential, drive shaft
Date	5/21/25
Validity	Models: All Mercedes-Benz cars with front-wheel drive and 4x4 vehicles
Reason for change	Validity adjusted

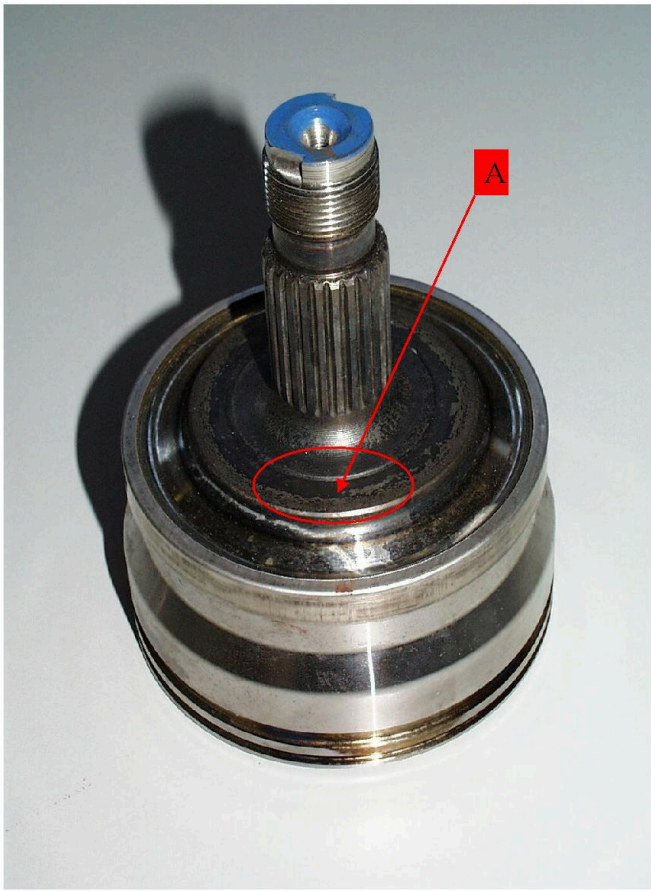
Attachments	
File	Description
Gelenkgehäuse aussen vor.jpg	Before coating with Molykote paint

If the complaint is eliminated by experimentally loosening the outboard collar nut (by 1 turn), the problem is due to micromovement in the connection between the wheel bearing inner race and the joint housing of the side shaft.

1. Remove outboard side shafts (extract outer joint gearing from wheel hub)
2. Clean contact surface A (see image file in attachment "Outer joint housing before") before coating with Molykote, using "spirit" (free of dust and grease)
3. Coat contact surface A (see image file in attachment "Outer joint housing after") using Molykote and leave to dry for one hour in removed condition
4. Reinstall side shafts

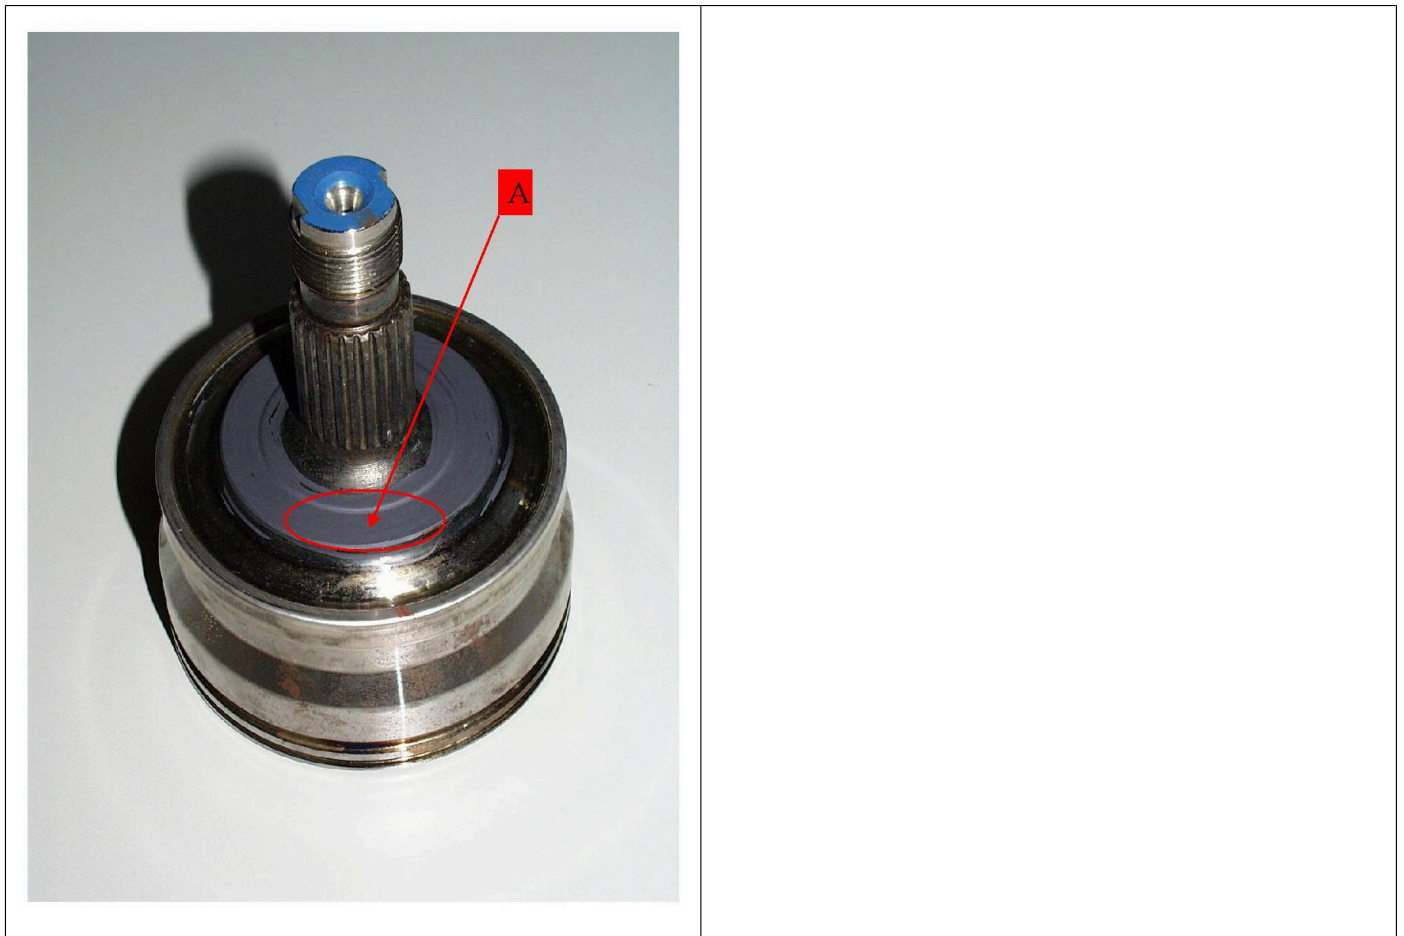
Gelenkgehäuse aussen nach.jpg

After coating with Molykote paint
