# Service Bulletin

Bulletin No.: 25-NA-061

**Subject: Driver or Passenger Rear Door Handle Will Not Fold In**

| Brand: | Model: | Model Year: | | Vehicle Build Date: | | Engine: | Transmission: |
|---|---|---|---|---|---|---|---|
| Chevrolet | Equinox EV | 2024 | 2024 | SOP | February 21, 2024 | All | All |

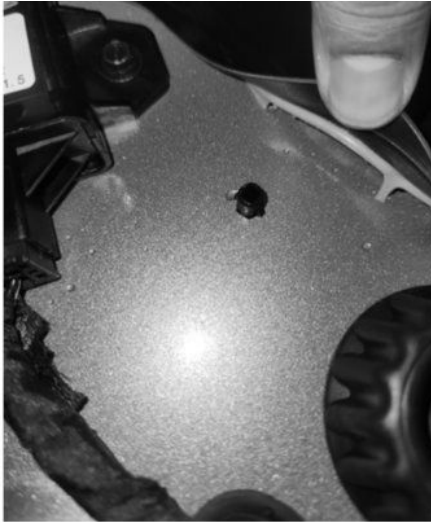
6862948

| Cause | Water may be entering through the door insulator seal and causing the door harness to corrode over time. |

- Depending on which side has the concern, remove the rear driver or passenger side interior door trim panel, refer to SI Doc ID 6367600. Upon inspection, the door water deflector adhesive may not be applied properly, see photos below. A gap may exist between the seal and the door metal where the water intrusion can occur. Please locate where leak is occurring first and re-seal using an appropriate body sealer or adhesive. The water deflector may then be pressed on by hand or rolled on using a hand roller.

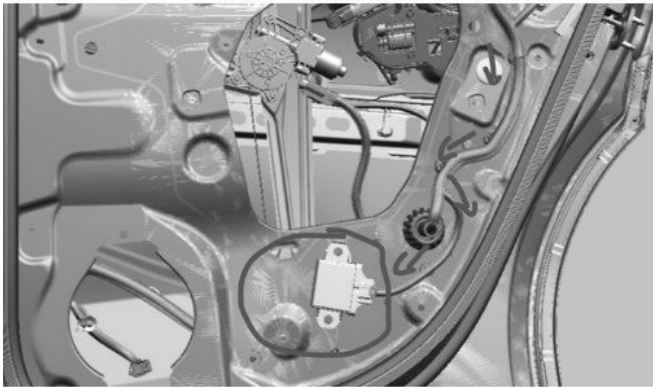
6862951

2. Please also check the door harness wiring and connectors for corrosion, the area of concern would be the J801 Rear Side Door Wiring Harness at or near the Rear Side Door Handle Control Module. The photo below shows where the module is located, and the arrows point toward where the water may be traveling toward the Rear Side Door Handle Control Module.

3. Depending on the amount of corrosion and where located, replace the wiring harness and/or door handle module as needed.
