Service Bulletin

Bulletin No.: 25-NA-011

Subject: Rattle Noise, Malfunction Indicator Lamp (MIL) Illuminated - DTC P0011, P0016, and/or P05CC Set

Brand:	Model:	Model Year:		Build Date:		Engine:	Transmission:
		from	to	from	to		
Buick	Enclave	2025	2025			LK0	
Chevrolet	Traverse	2024					
GMC	Acadia

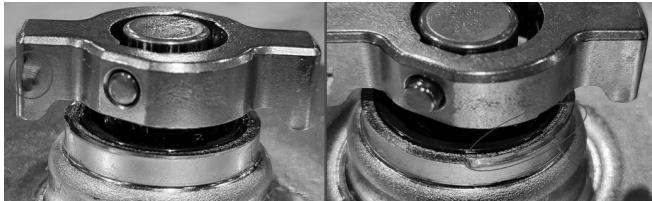
6815220

<p>This condition may be caused by damaged E-Phaser Motor.</p>
