Service Bulletin

Bulletin No.: 25-NA-089

Subject: Information on Front Compartment Hood May Not Fully Unlatch When Release Button is Pressed and Gets Stuck in Secondary Latch Position and/or When Pulling Manual Release Cable Near Steering Column Does Not Release Hood Once it is in this Stuck Position

Brand:	Model:	Model Year:		VIN Breakpoint:		Engine:	Transmission:
		from	to	from	to		
Chevrolet	Corvette	2024	2025	—	—	—	—

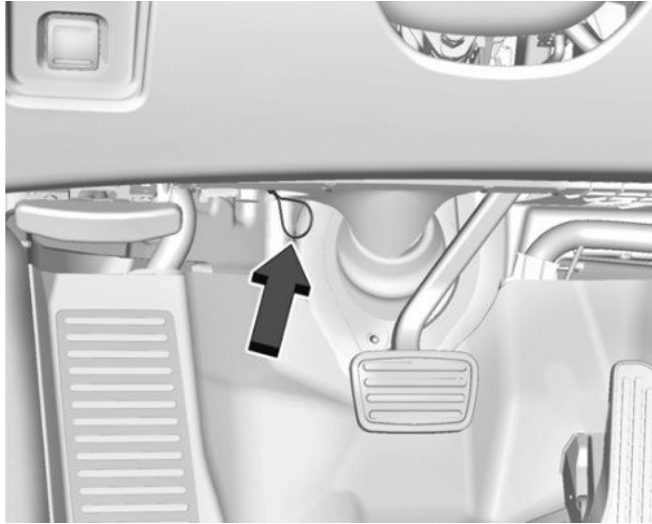
6880615

Involved Region or Country	North America, Europe, Middle East, Israel, Palestine, Japan, Philippines, Australia/New Zealand
Condition	<p>Some customers may comment on having one or more of the following conditions.</p> <ul style="list-style-type: none"> • The front compartment hood may not fully unlatch when the release button is pressed and gets stuck in the secondary latch position. • Pulling the manual release cable near the steering column does not release the hood once it is in this stuck position.
Cause	<p>The condition may be caused by the 12V battery being too weak to start the engine, yet it may still be strong enough to electrically release the front compartment lid when commanded. The front compartment lid may release from the primary release latch, but it is possible that it may become stuck on the secondary latch. The secondary latch release requires more power than what is available from the vehicle's 12V battery in that moment.</p> <p>Note: This is a common condition when trying to access the compartment to charge a weak 12V battery.</p>

<p>If the situation described above is encountered, dealership technicians are to first press down and manually close the front compartment lid all the way. Next, firmly pull the</p>

manual release cable twice to open the front compartment lid that is located at the base of the steering column, as shown in the picture above.

Note: The cable does require a fair amount of effort to pull. If a hook tool is available, it may work much easier than using just a finger.

Important: For the manual release cable to work properly, the front compartment lid must be fully closed on the primary latch.
