LTB01306NAS2

# TECHNICAL BULLETIN

Roof Opening Panel Seal Adrift

<b>MODEL:</b>	<b>MODEL YEAR:</b>	<b>VIN:</b>	<b>ASSEMBLY PLANT:</b>
Discovery (LR)	2017 Onwards	000225 Onwards	Solihull

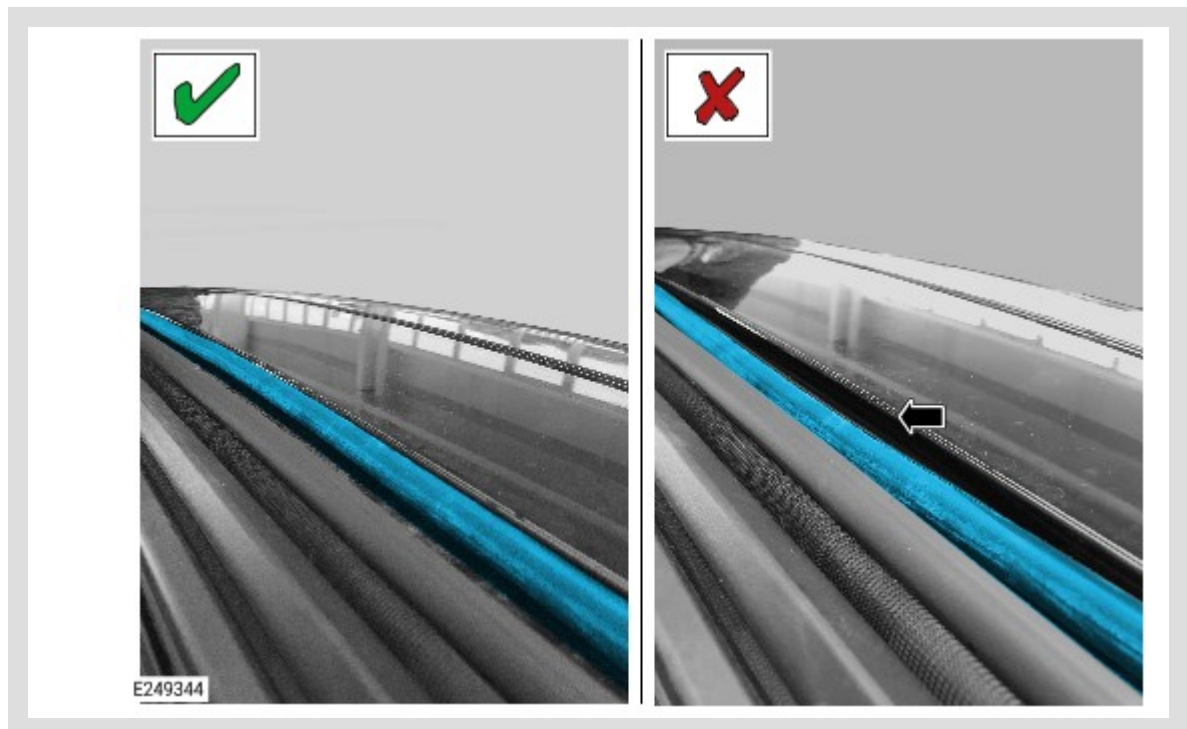
2.

Visually inspect the roof opening panel main seal.

- If any part of the roof opening panel main seal **is not** installed correctly, **continue to step 3.**
- If the roof opening panel main seal **is** installed correctly, **this is not the cause of the customer's concern. Continue diagnosis using the TOPIx Workshop Manual section 501-17: Roof Opening Panel - Diagnosis and Testing - Symptom Chart - Wind noise.**
