Service Bulletin

Bulletin No.: PIC6609

Subject: Service High Voltage Message - DTC P1C01 and-or U016B

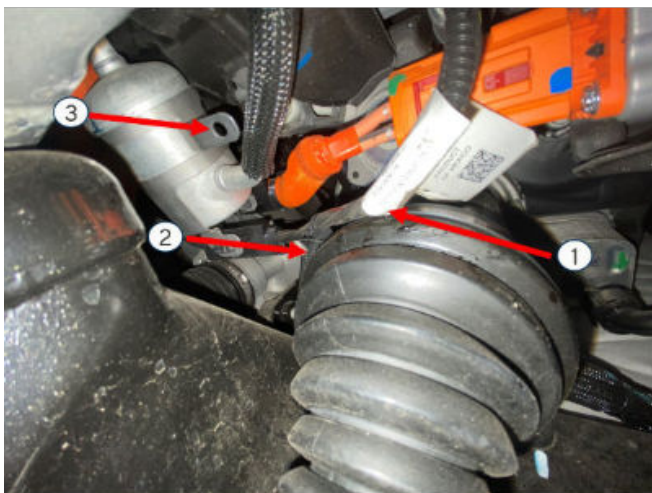
6946483

Involved Region or Country	North America
Condition	Customers may comment on a Service High Voltage system with charge limited to 26% message with the MIL illuminated. Technicians may find stored at current or history P1C01 and U016B.
Cause	Engine bay low voltage harness to air conditioner compressor rubbing on the right front axle shaft.

- 1) Harness chaff location, on the clamp of the CV boot of the RF CV axle.
- 2) Harness retainer “Christmas Tree”.
- 3) Location harness retainer “Christmas Tree” should be inserted.

If the above condition is found, the technician will need to perform a wire-to-wire repair, following the instructions called out in Service Information.

Once the wire-to-wire repairs are completed, the technician will need to properly route and secure harness.
