L636-A.12.25

To: After Sales Official Network
Object: CAL ID - CVN Misalignment
Date: 06/05/2025
Pages: 11

Campaign name:
CAL ID - CVN Misalignment

Model:
URUS SE

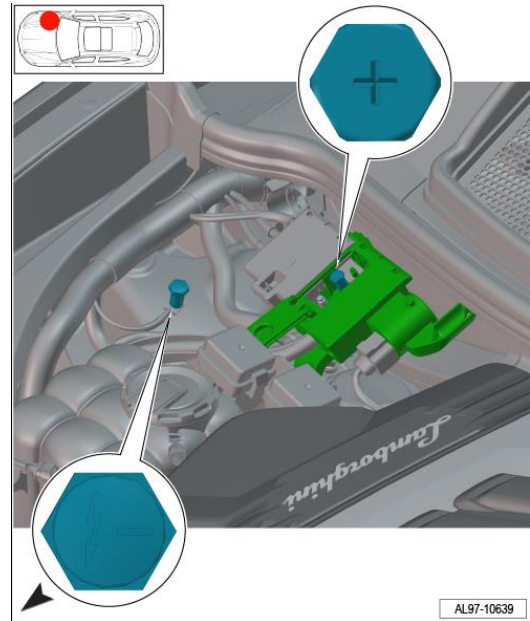
It is essential that you connect an appropriate battery charger to the charge points available in the luggage hood (front center of the vehicle). Please refer to the following figure.

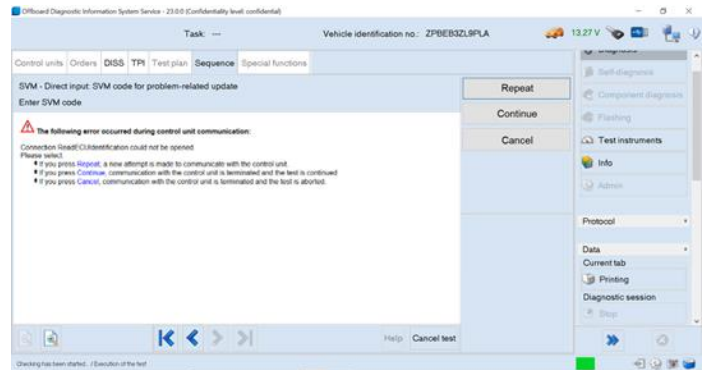
A. If the following error screen is displayed, abort the guided function by clicking on “Cancel Test” and contact Technical Support.

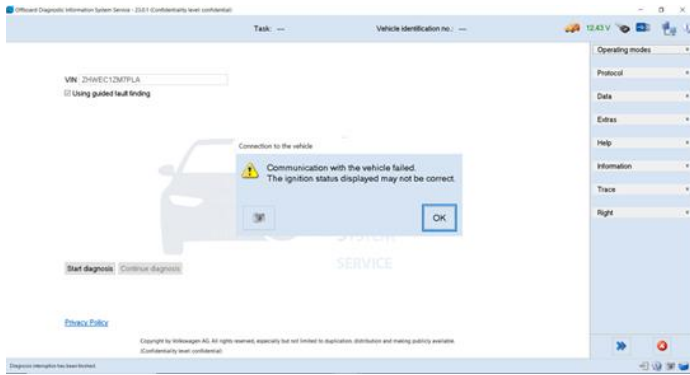
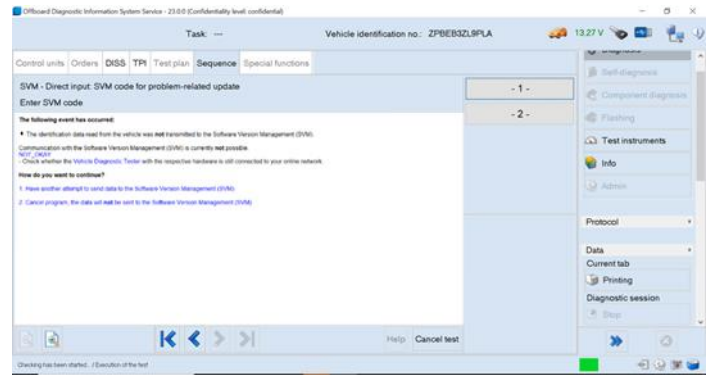
B. If an error is displayed that regards the hardware interface, and the "connection to vehicle" and "key state" icons appear as shown in the figure below:

- Click “Cancel”;
- Repeat installation of the interface 6154/6154A/6154B for the instructions in procedure (*) “Checking the VAS 6154”, selecting the right-hand “Extras” menu in O.D.I.S. and clicking on the “Diagnostic interface” button.

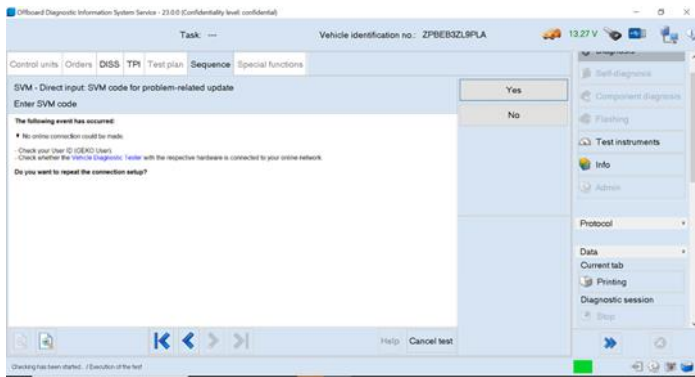
C. If the following connection error is displayed like in the following example screenshots:

- It is not possible to connect to the central server; check that your laptop is correctly connected to the Internet and retry by clicking on “Yes” or “Done/continue”, as appropriate.
