FIELD SERVICE CAMPAIGN – 25102

27 May 2025

A/C Relay Board

IC Bus™ Electric CE Series buses

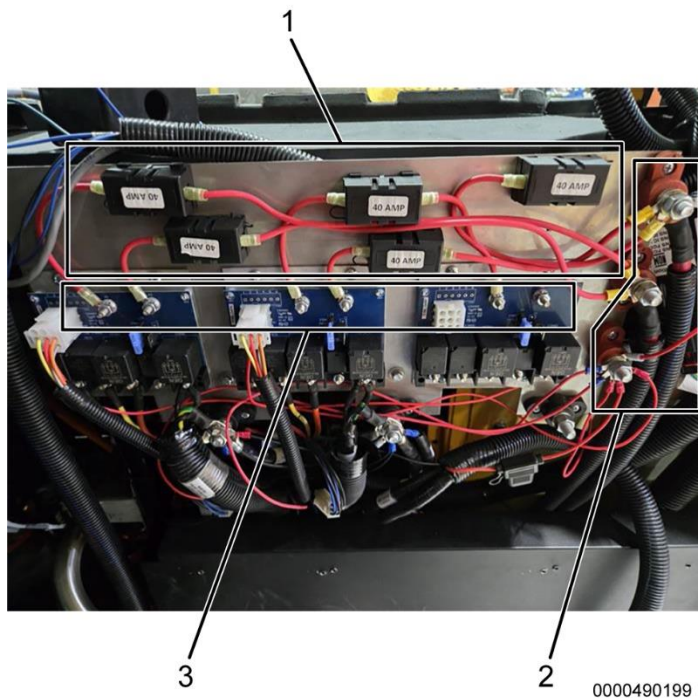
Figure 1. A/C Relay Board

Certain IC Bus™ Electric CE Series buses may have an A/C Relay Board that was incorrectly assembled.

1. 40-amp fuse terminal nut (10) (located under the covers)
 2. Power stud terminal nut (6)
 3. Relay board terminal stud (3)
6. Gain access to the A/C Relay Board (Figure 1) by removing the right-side dashboard panel. Refer to the appropriate service manual for detailed procedure.
 7. Perform a pull test in the wiring to each of the ring terminals.
