Title: Supplemental A26 MAF Fault Diagnostics

Applies To: All A26 Engines

This document will guide users through supplemental diagnostics for SPN 132, Mass Air Flow, fault codes.

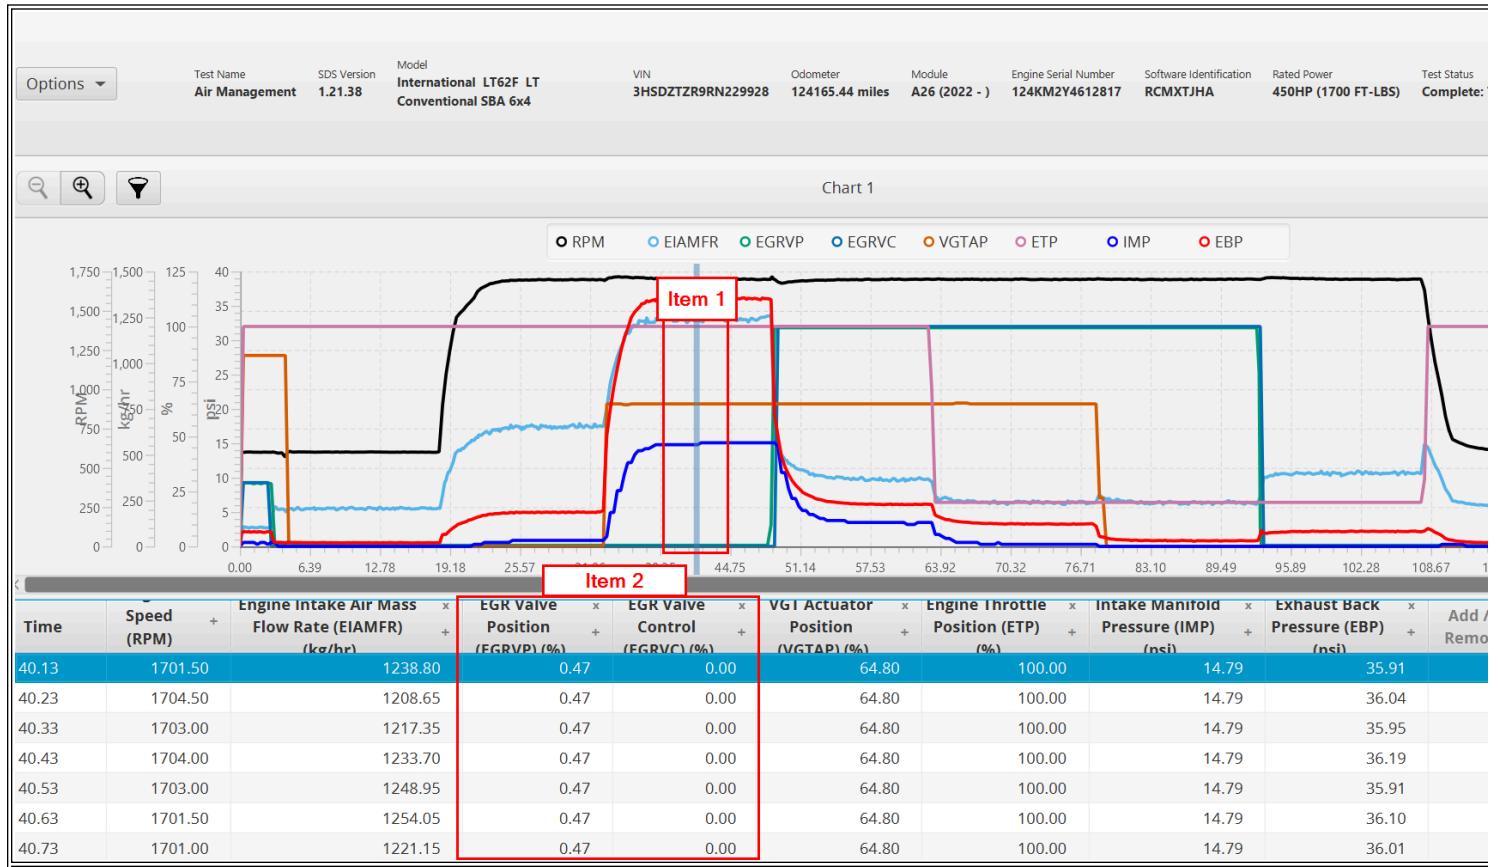
STEP 5

Step	Confirm EGRV operation	Decision
#5	<p>Perform an Air Management Test and inspect for EGRV operation per Image #1:</p> <p>Was a failed EGRV identified?</p> <p>NOTE: At the selection point in Image 1, the EGRV should be 0.00% when commanded is 0.00%. If it is not, this should be considered a failed EGRV.</p>	<p>Yes.</p> <p>Replace the EGRV, perform a MAF calibration, and re-test for the issue. If the issue persists, proceed to step 6.</p> <p>NOTE: If the EGRV was replaced, another AMT should be completed before proceeding to step 6.</p>
		<p>No.</p> <p>Proceed to step 6.</p>

Item 1: Selection point of the AMT

Item 2: Example of EGRV position blowing open from commanded position
