WST 49X Hood Headlight Wiring Too Short

TSB 54-099

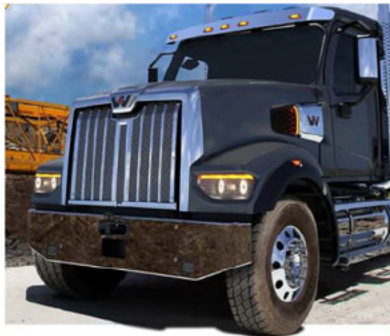
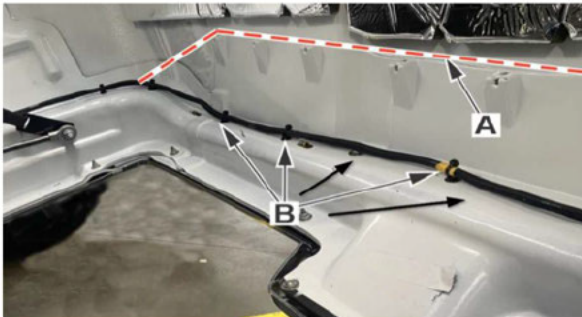
- TSB solution for an uncontrolled routing of the headlight wiring harness
- Headlight harness wiring was too short for 49X trucks equipped with the optional power hood built before 4/17/24
- In the picture below A was the intended routing path, and B is the containment solution

- Affected vehicles 49X with X-series power hood (non-sloped hood)
- Population 653 Units

- We only had one wiring harness length available that was too short for the power hood option

- 4/17/24 Cleveland started drilling lower mounting holes and started using pushpin fasteners to retain the harness

- P66126 released longer hood harness for power hood
