SF714

Subject: eCascadia eAxle Spring Seat

On behalf of the entity listed below, Daimler Truck North America LLC (DTNA), is initiating Field Service Campaign SF714 to modify the affected vehicles.

PROBLEM: On the affected vehicles, the rear eAxle spring seats may be installed backwards. This can alter the routing of the High-Voltage (HV) cable (from the inverter to the eMotor), potentially causing the cable to chafe against chassis components and damage the eAxle wiring.

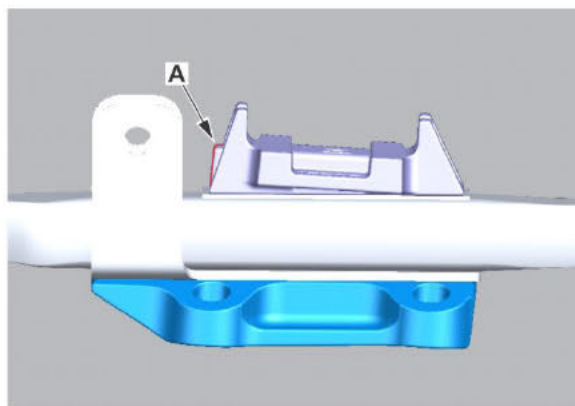
Fig. 1, Axle Seat Inspection

A. The boss protruding from the axle spring seat.

9. Remove one pair of U-bolts on the first axle.
10. Remove the axle seat and install it with the feature facing the shock mount.

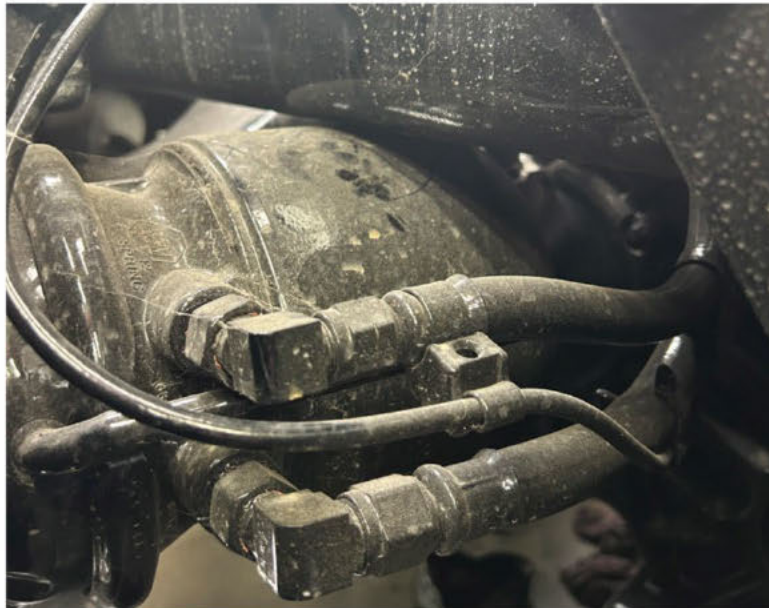
Fig. 2, Frame Contact with the Brake Chamber

NOTE: In some cases, installing the axle seat backwards causes the brake chambers to contact the frame when the suspension is fully deflated.

Contact with the frame can dent the air chamber, bend the mounting bolts on the brake caliper, or bend/break the chamber mounting feature. If there is additional damage to brake parts, other than the brake cans, submit a Warranty Support Center (WSC) ticket to get instructions on adjusting the claim to include these parts.

13. Check for evidence of contact between the brake chambers and the frame, as shown in [Fig. 2](#).

YES → Replace the brake chambers and any other damaged parts. For instructions, see **Group 42** of the *eCascadia Workshop Manual*. Then go to step 14.

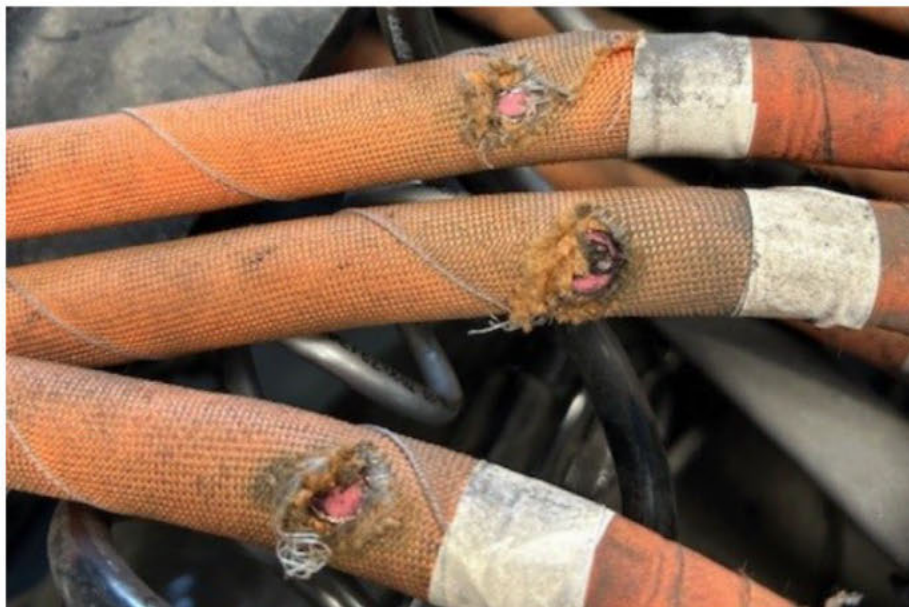
Fig. 3, Abrasion on the High-Voltage Cable Outer Cover

14. Slide the fifth wheel to the forward-most position to expose the high-voltage cable routing from the chassis to the rear drive axle.
15. For all axles with spring seats installed backwards, inspect the high-voltage cables for evidence of rubbing abrasion between the axle and frame-side support bracket, as shown in [Fig. 3](#).

YES → Replace the damaged high-voltage cables. For instructions, see **Group 8** of the *eCascadia Workshop Manual*. Then go to step 16.
