SS 581167 FCCC eB2 (Jouley) 47% SoC Battery CAN Integrity Improvement (294)

FCCC eB2 (Jouley)

EB2 Gateway Controller Update

47% SoC Resolution

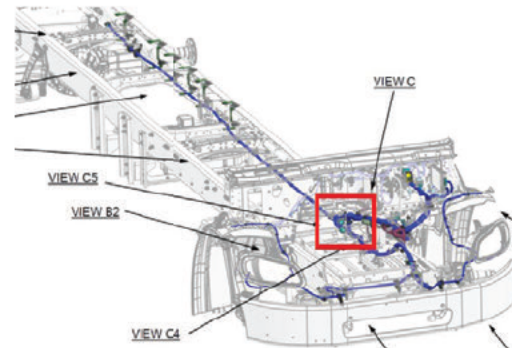
ID:	FRONT_BOX_H_POWERTRAIN_CAN_TERMINATING_RESISTOR
PN:	23-12144-004
	SEALED CONNECTOR
Add on:	23-13302-114
	23-13302-402
	23-12202-002
CAV:	CIR#
A:	1920+ # 1603 (Y)
B:	1920+ # 1603 (DKG)

Some units have an additional terminating resistor turned on in the CAN gateway (bridge) module. In addition to this software controlled terminating resistor, the circuit has an additional hardware terminating resistor inline that will need to be removed.

- Remove the terminating resistor from the BCAN circuit (FRONT_BOX_H_POWERTRAIN_CAN_TERMINATING_RESISTOR) located at the front box near the 47 cavity Chassis Interface Connector (FRONT_BOX_H_CHAS_H_INTERFACE_C1)
