Technical Service Bulletin

Topic	BRD Fault Diagnosis - Mechanical Malfunction DTC B140107 Continental GT/GTC/Flying Spur
Market area	Australia E04 Bentley rest Asia and Australia (6E04),China 723 Volkswagen (Anhui) Automotive CO (6723),China 796 VW Import Comp. Ltd (Vico), Beijing (6796),Germany E02 Bentley rest Europe (6E02),Japan E03 Bentley Japan (6E03),Korea, (South) E08 Bentley South Korea (6E08),United Arab Emirates E06 Bentley Middle East and Africa (6E06),United Kingdom E01 Bentley UK (6E01),United States E05 Bentley USA and rest America (6E05)
Brand	Bentley
Transaction No.	2067955/5
Level	EH
Status	Released for publishing
Release date	May 13, 2025

- Bentley Rotational Display (BRD) operational issues
- Mechanical malfunction DTC B140107 evident within 005F

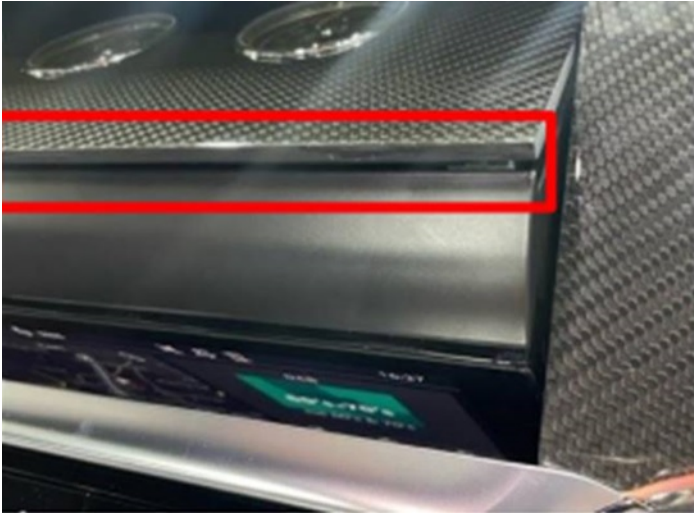
Figure 1

4) Figures 1 and 2 show an example of the display clocks and/or dials fascia unclipped)

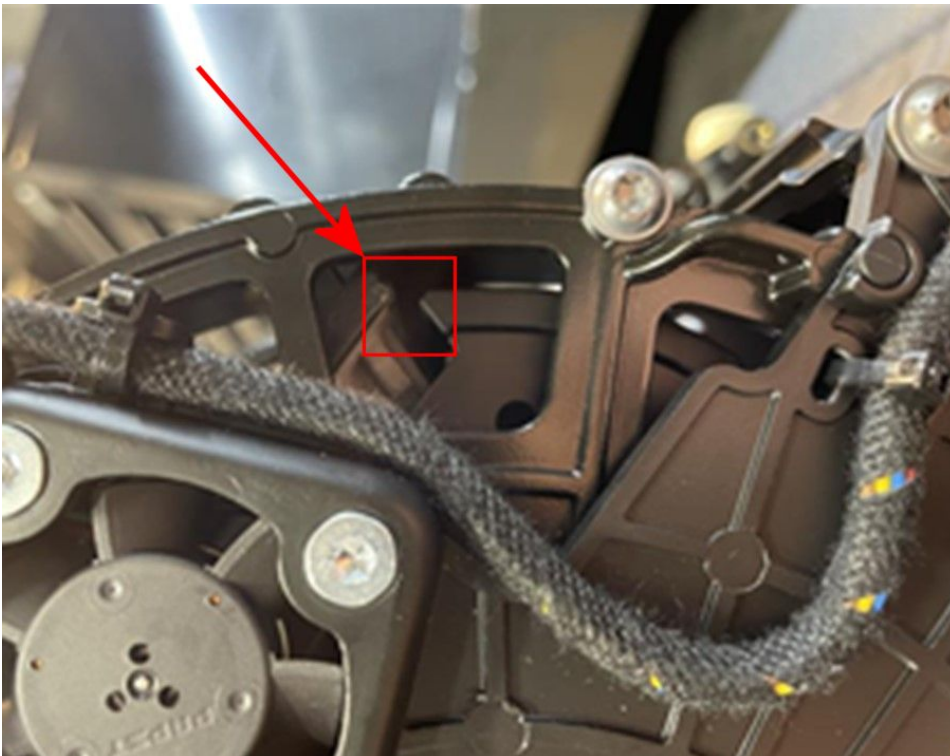
Figure 2

Please note: The BRD must be removed (Rep.Gr 91) to allow visual inspection of the panel at the back of the BRD for signs of unclipping (Figure 2)

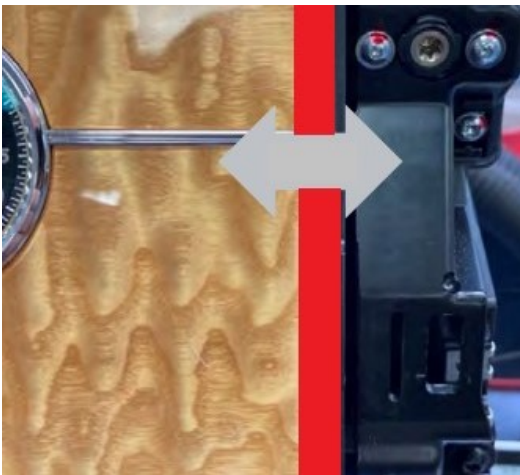
Figure 4

- **HINT: Referring to Figures 4 and 5, if there is a large gap on one side of the fascia panel and a small gap on the opposing side or a report of clashing with driver fascia or clunking the operative should check to confirm the bearings of the unit have not displaced as shown in Figure 6**

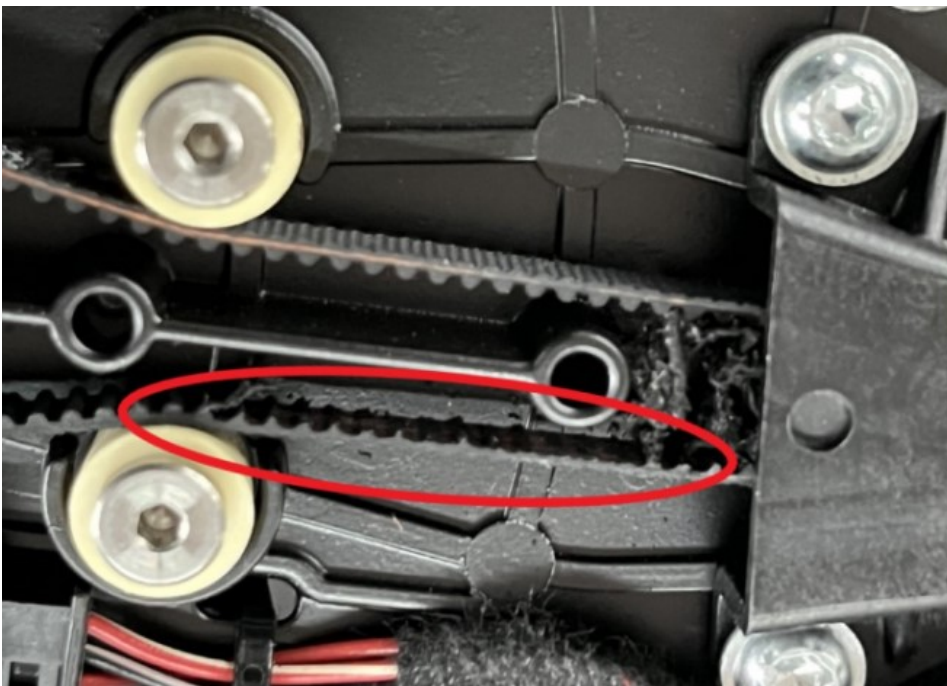
Figure 7

8) Belt drive check (Figure 7)
