# Technical Service Bulletin

<b>Topic</b>	Low fuel pressure regulation DTC 310B00   Bentayga W12   17MY - 23MY
<b>Market area</b>	Australia E04 Bentley rest Asia and Australia (6E04),China 723 Volkswagen (Anhui) Automotive CO (6723),China 796 VW Import Comp. Ltd (Vico), Beijing (6796),Germany E02 Bentley rest Europe (6E02),Japan E03 Bentley Japan (6E03),Korea, (South) E08 Bentley South Korea (6E08),United Arab Emirates E06 Bentley Middle East and Africa (6E06),United Kingdom E01 Bentley UK (6E01),United States E05 Bentley USA and rest America (6E05)
<b>Brand</b>	Bentley
<b>Transaction No.</b>	2055321/5
<b>Level</b>	EH
<b>Status</b>	Released for publishing
<b>Release date</b>	May 13, 2025

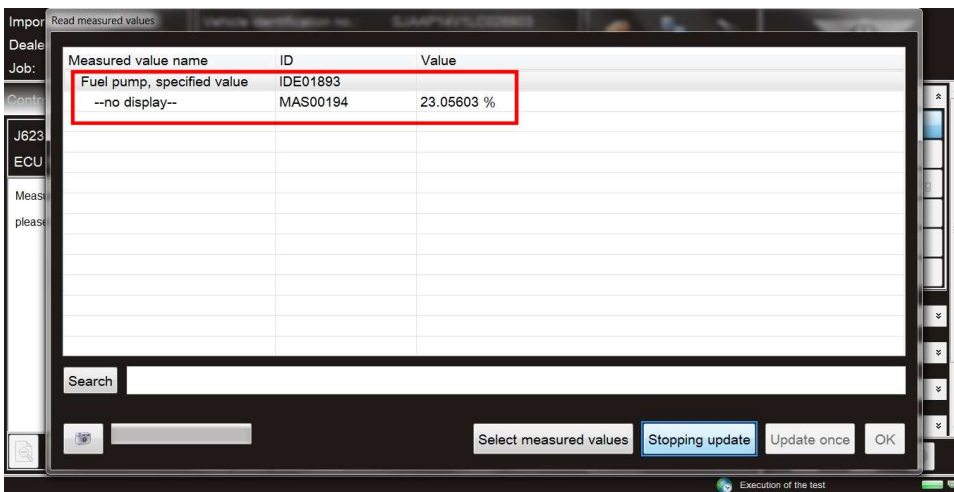
- Ensure the engine is idling at operating temperature - Ensure a suitable battery charger is also connected as per Rep.Gr 27
- Select Engine control module 1
- Select Guided functions – Read measured values
- Referring to Figure 1 - Navigate to Measured value IDE01893
- Select Starting update and monitor the Value – The value should be below 25%

**NOTE:** If the fuel pumps run faster at idle (above 25%) this is a sign of either a significant leakage or that the wrong fuel pump control modules are fitted - Carry out an inspection of the vehicles repair history, should the fuel pump control modules have been previously replaced you must ensure the correct specification were fitted, however if there is no replacement history of the control modules continue to step 2 – Fuel low pressure check

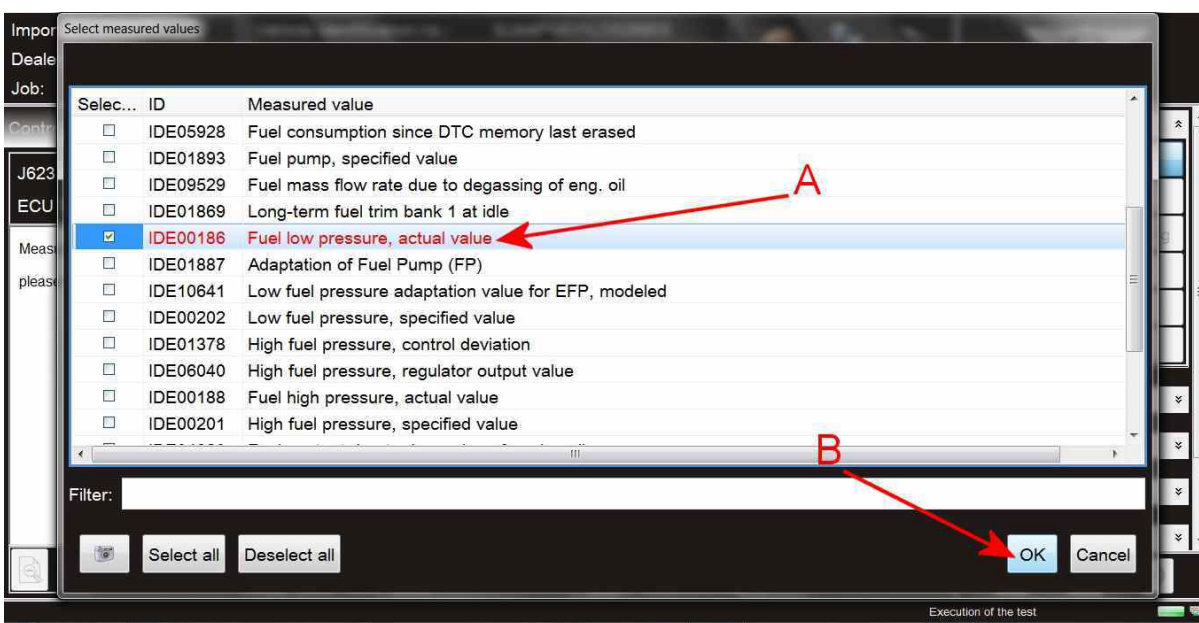
2) Fuel low pressure check - Referring to Figure 2 (Point A) navigate to Measured value IDE00186 Fuel low pressure, actual value

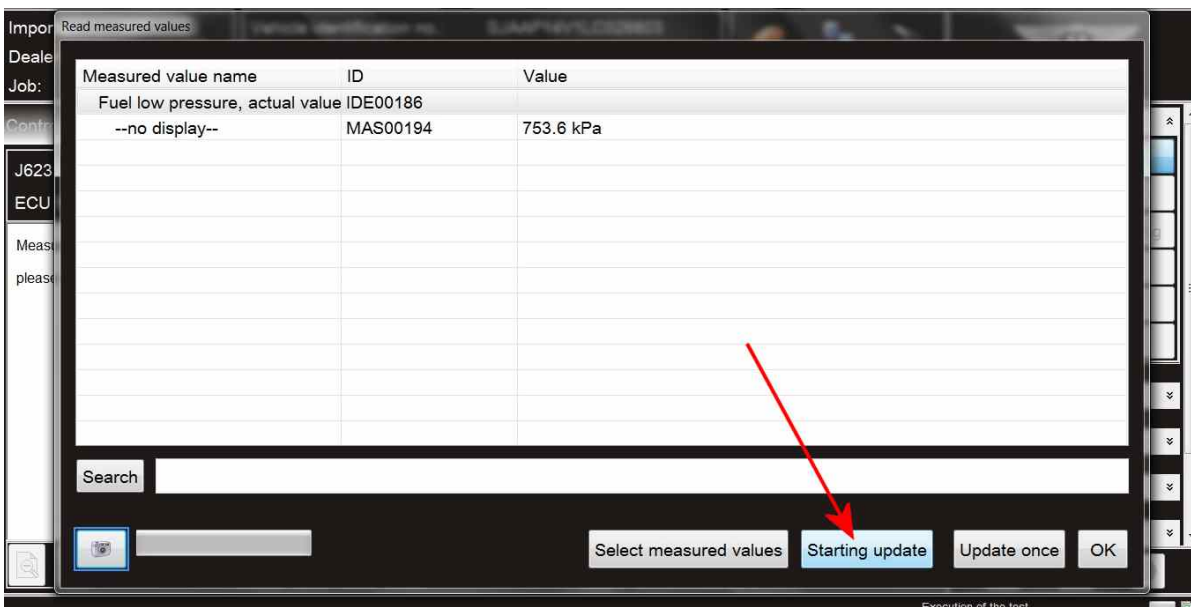
- Referring to Figure 3 – Select Starting update
- Switch off the engine and leave the ignition on
- Monitor the pressure decay of the low pressure fuel system for 10 minutes

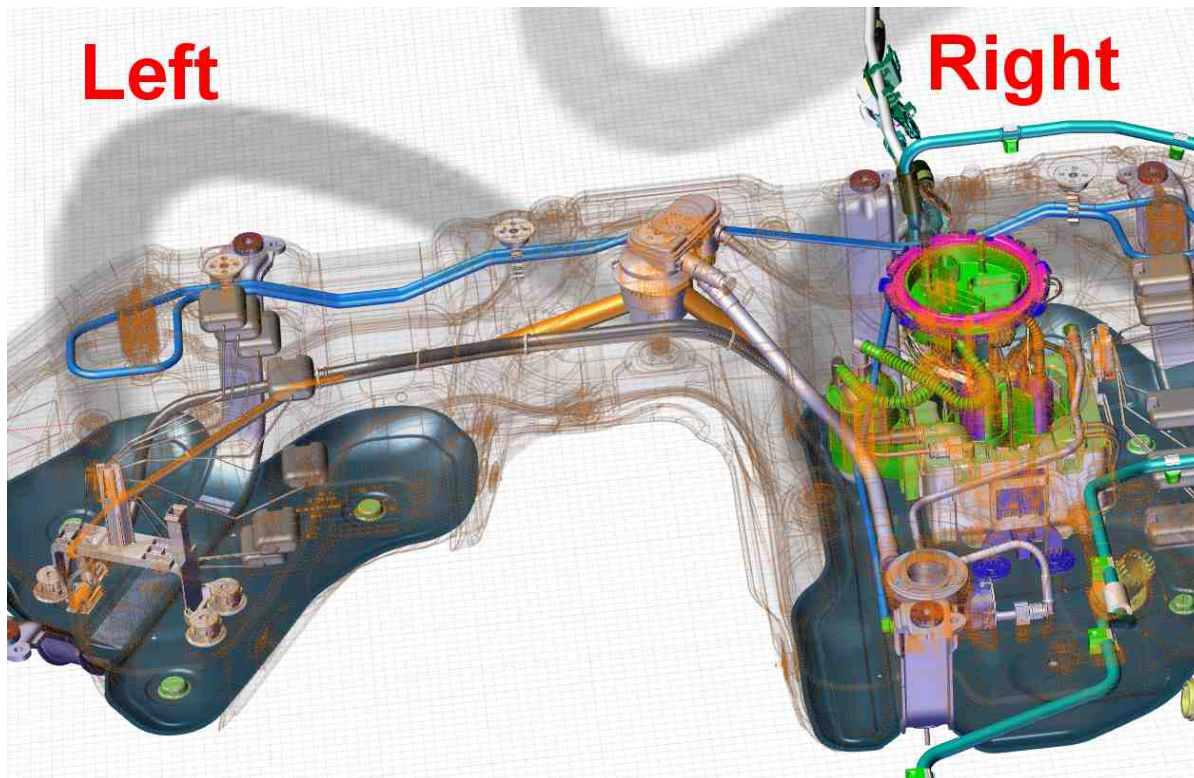
3) Should the pressure drop below 300 kPa after 10 minutes - Referring to Figure 4 - Gain access to the fuel pump assembly and fuel filter within the right hand side of the fuel tank - Rep.Gr 20

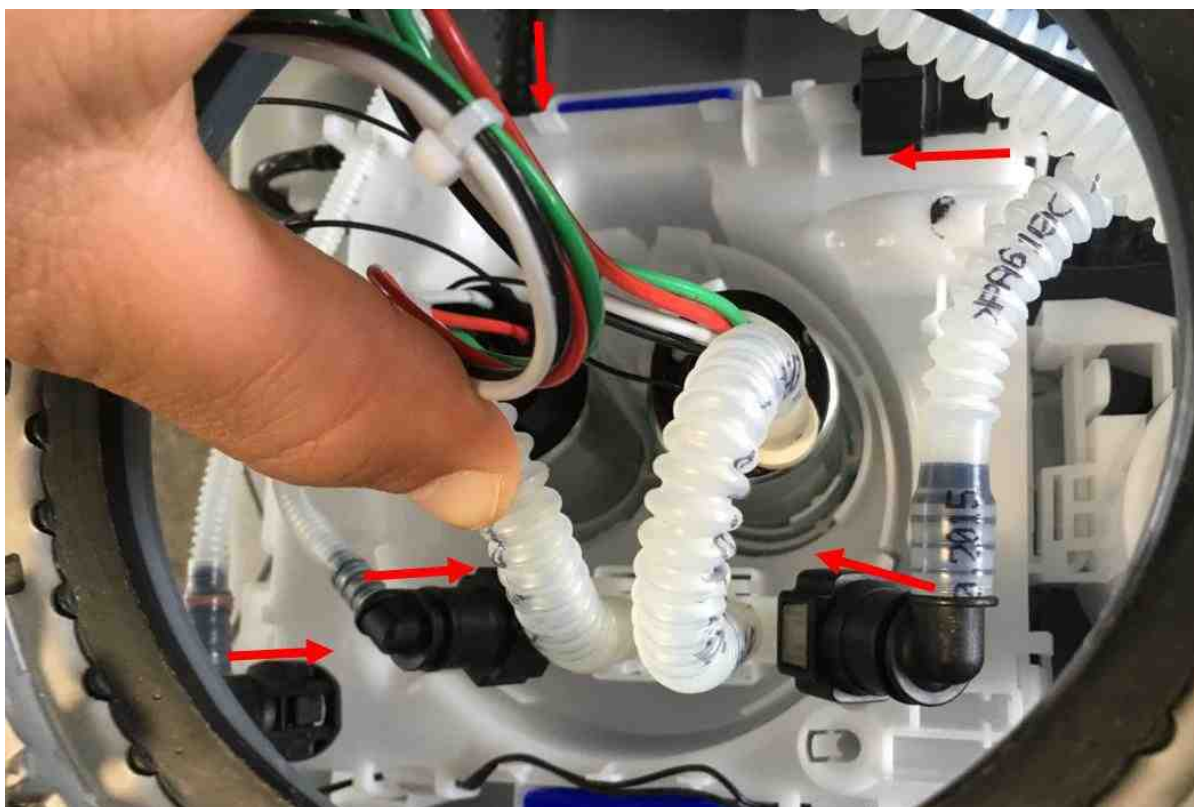
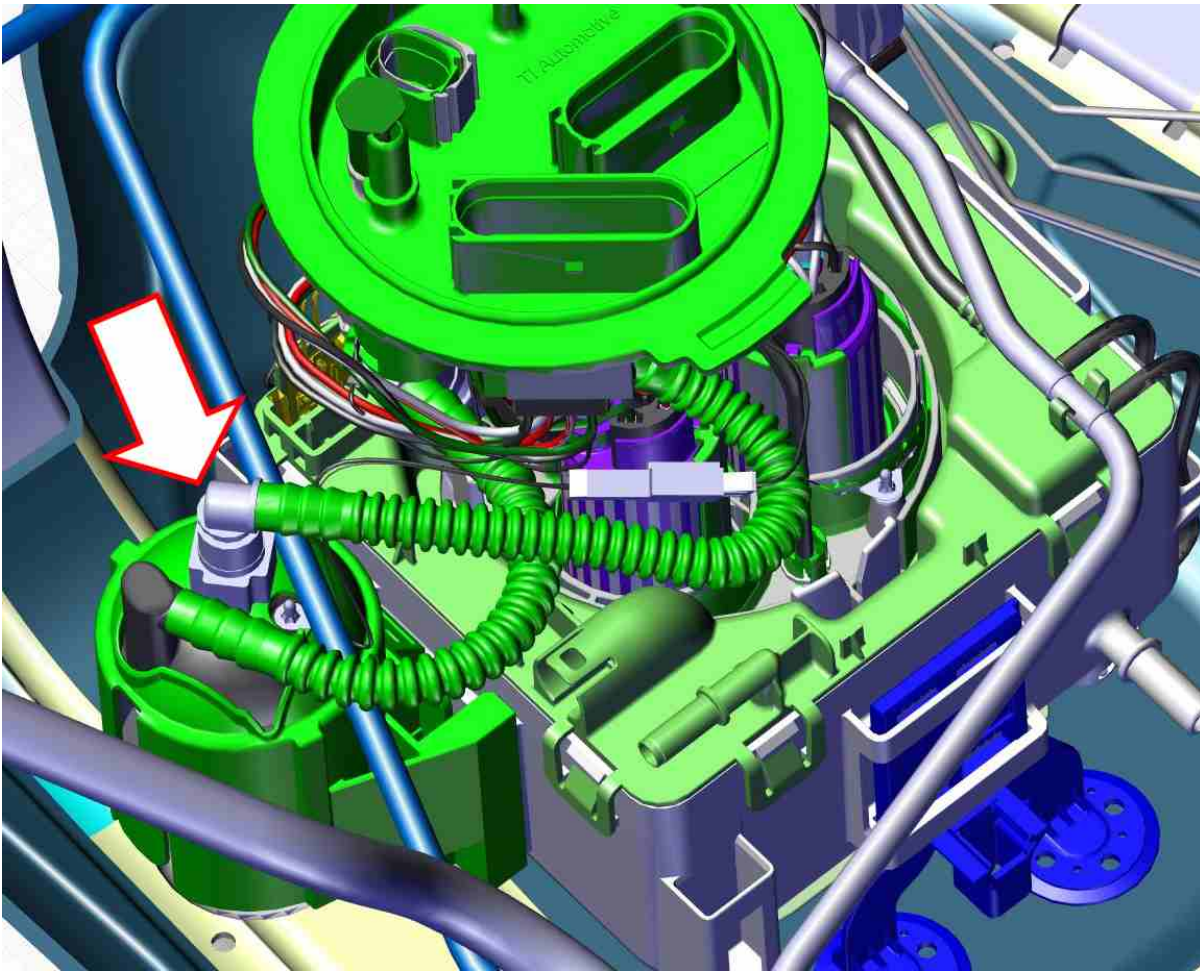
- Carry out an inspection of ALL accessible hoses and connections which connect to the fuel pump assembly/fuel filter assembly as shown in Figures 5 and 6
- Check for punctured/split hoses
- Check for broken and loose connections

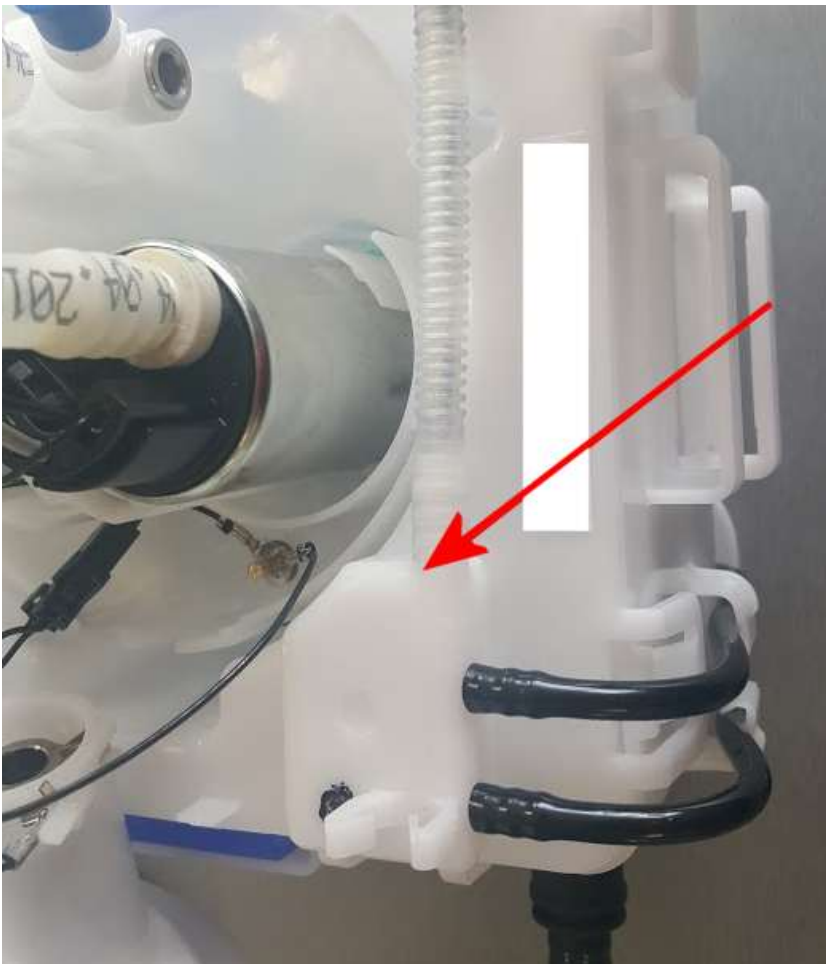
4) Referring to Figure 7 (For photographic purposes Figure 7, was taken with the fuel pump assembly removed from the fuel tank) Check the connection shown is not broken **NOTE:** Care should be taken when checking this part as damage can be caused when manipulating the fuel pump assembly

- Should any issues be found with the fuel pump assembly or fuel filter replace the fuel pump assembly and fuel filter as per the applicable Rep.Gr

- Should any issues be found with the fuel pump assembly or fuel filter after the checks from Steps 1 through to 4 have been conducted - The operative **MUST** raise a DISS query and await feedback before conducting any further work
