# Technical Service Bulletin

<b>Topic</b>	New Continental GT/GTC & Flying Spur Front and Rear Exterior Lighting Steamed Up/Leaks
<b>Market area</b>	Bentley: worldwide (2WBE),China 796 VW Import Comp. Ltd (Vico), Beijing (6796)
<b>Brand</b>	Bentley
<b>Transaction No.</b>	2076754/1
<b>Level</b>	EH
<b>Status</b>	Released for publishing
<b>Release date</b>	May 12, 2025

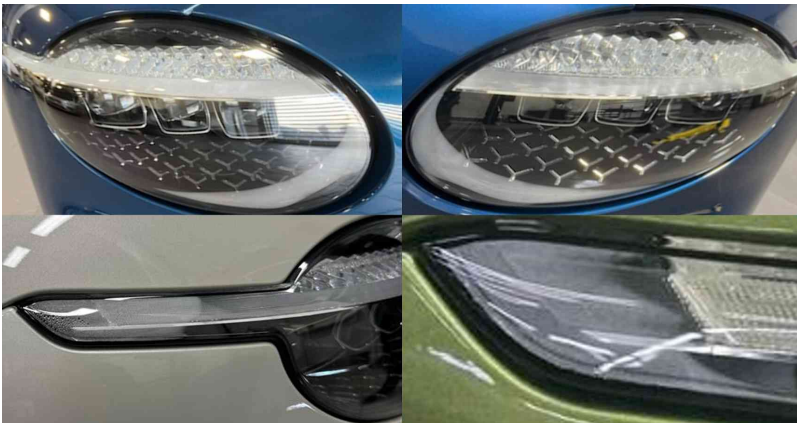
1. The lens of the headlight, front fog lamp or tail light is steamed up/damp from the inside with minor drips.

Figure 1a – Front headlights steamed up/damp from the inside with minor drips

**Customer statement for 1 (Figure 1):** The lens of the headlight, front fog lamp or tail light are steamed up/damp from the inside with minor drips.

1. Damp air settles on the inner lens of the headlights, tail lights or fog lamps, with recognisable misting in certain weather conditions
2. There is a leak on the headlights, tail lights or fog lamps. For example through open covers, a damaged seal of the cap or similar.

1. In case of a complaint, the light emission surface on the lens must be clear after a journey of 5-10 minutes with sufficient ventilation (for example country road/motorway) and switched-on dipped beam.

**The remaining inside surfaces may still have some condensation on them after the drive; this is not a problem.**

**NOTE: This is normal, in this case, replacement of the headlights/tail lights will NOT fix the problem and lead to a repeat repair.**

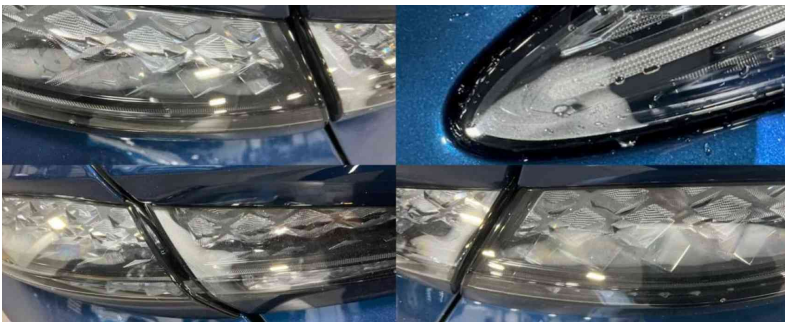
Figure 1b – Rear tail lights steamed up/damp from the inside with minor drips

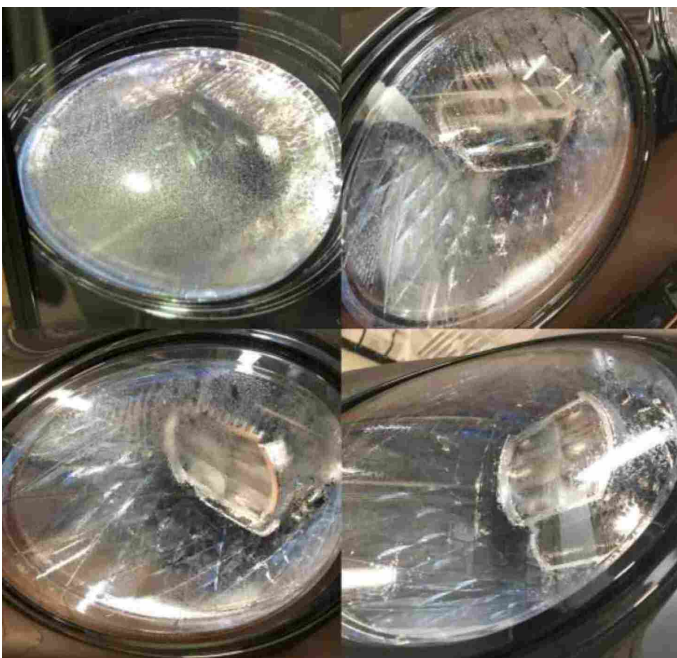
Figure 2 – Water is in the headlights as water marks/large droplets.

**NOTE:** Figure 2 shows an earlier model year and is for reference purposes only.

**Customer statement for 2 (Figure 2):** Water is in the headlight, front fog lamp or tail light as big droplets on the complete lens. There is a

leak on the headlight, front fog lamp or tail light.

2. In case of an obvious water ingress/leak (a lot of drips on the inside of the lens, Figure 2) use the test plan attached to establish the cause. Dry the effected light afterwards with filtered, oil-free compressed air.

In case of water ingress (damaged seal, lens and so on) perform the appropriate repairs according to the repair manual/parts catalogue and check whether the connectors or connections of any control units fitted, are damaged by corrosion.

Ask the customer to keep an eye on the situation. If despite the above repair the customer complains again about leaking headlights, front fog lamps or tail lights and water ingress or lots of drips can still be recognised after the checks (see attached test plan), replace the headlights, front fog lamps or tail lights according to the repair manual/parts catalogue.
