Subject: POOR WINDSHIELD WIPING, WIPER CHATTERING NOISE AND WIPER BLADE CONTACTING A-PILLAR	Service Alert No.: SA-025/25
	Last Issued : 05/15/2025

2020-2025 CX-30
2023-2025 CX-50
2025 CX-70
2024-2025 CX-90
2019-2025 Mazda3
2022-2023 MX-30

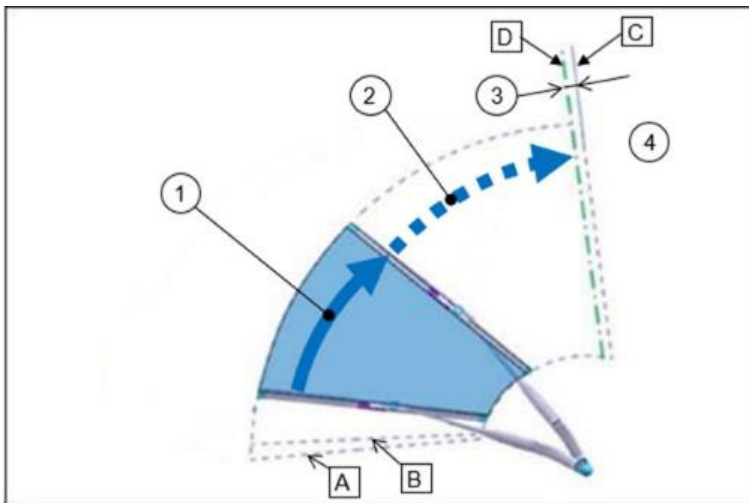
View from Front of Vehicle

The control unit installed in the wiper motor monitors variation of the resistance fluctuations when the wipers are operating, predicts the wiper's overrun, and controls the position at which the motor output is reversed. This control keeps the blade's operating range in the correct position.

B	Lower reverse position
C	Original upper reverse position
D	Corrected upper reverse position
1	Load accumulation range
2	Shifting to speed map for correction
3	Retreated 15 mm from the original position
4	A-pillar

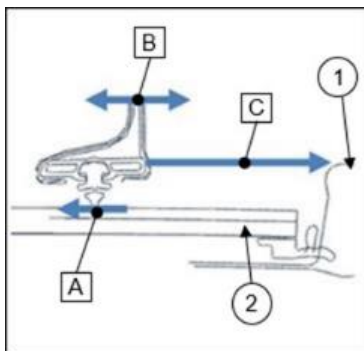
Under the following conditions, an unstable frictional resistance (A) on the windshield surface occurs, causing the wiper blade to experience more "chattering" (B) than expected.

- Oil film adheres to the windshield surface.
- Water-repellent treatment is uneven.
- The edge of the wiper blade rubber is worn or the coating peels off.

This condition may induce mis-detection of the friction resistance variations during wiper operation, causing the stick-slip control to fail. This leads to overrun (C) of the wiper, and the plastic part at the tip of the wiper blade lightly contacts the A-pillar.

B	Chattering wiper blades
C	Wiper over-run
1	A-pillar
2	Windshield

Clean the front windshield and replace the front windshield wiper blades with new ones.

YES	Follow the steps below: a. Verify that the wiper arm is not bent or otherwise damaged. If damaged, replace it and the wiper blade (as customer pay) according to the instructions on MGSS "WINDSHIELD WIPER ARM AND BLADE REMOVAL/INSTALLATION" for the appropriate model. b. If the wiper arm is ok, clean the wiper blade and retest; if it still chatters, replace it. c. Continue to Step 3.
-----	---
