Topic: McLaren Artura Ground Fault Detection Diagnosis Guide

Condition: Permanent **Diagnostic Trouble Codes:** P21F14D P21F14C P186909

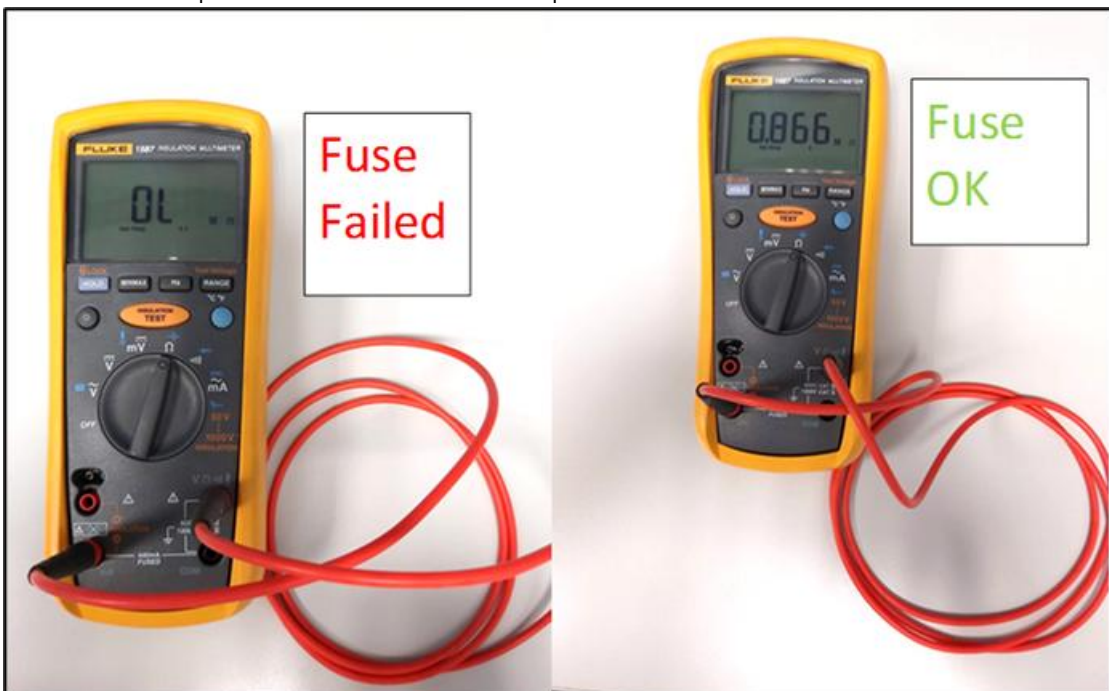
1. Set meter to resistance setting.
2. Short the terminals shown below with a test lead (V Ω to mA).
3. "OL" indicates that the fuse has failed and must be replaced before proceeding with the insulation test. Any other resistance reading indicates that the fuse is OK and the insulation test can proceed.

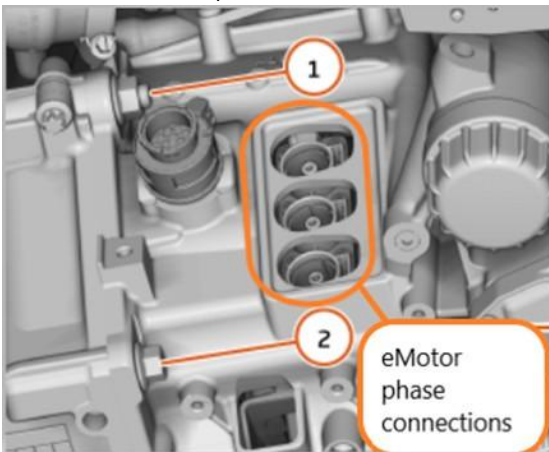
Test Point 1

Phase cables test point - Disconnect phase cable connector and check at each phase on eMotor to ground. Then measure at the phase cable connector (harness side), each phase to ground.

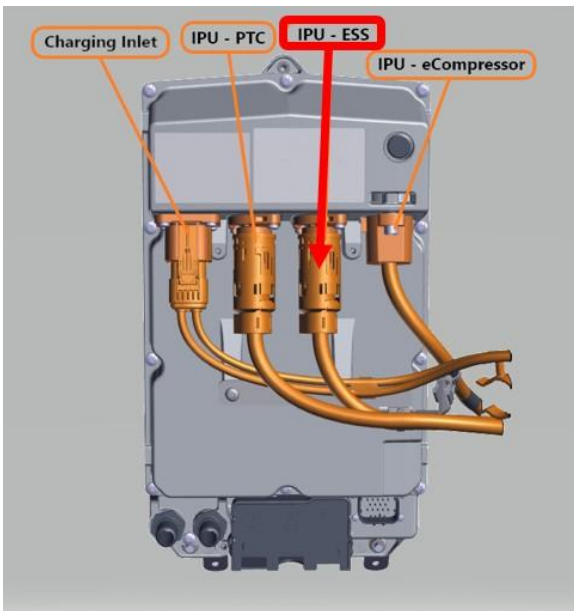
Test Point 2

IPU - ESS Auxiliary DC link test point - Disconnect HV connector highlighted in red and measure at HV connector (harness side) HV+ to ground then HV- to ground.

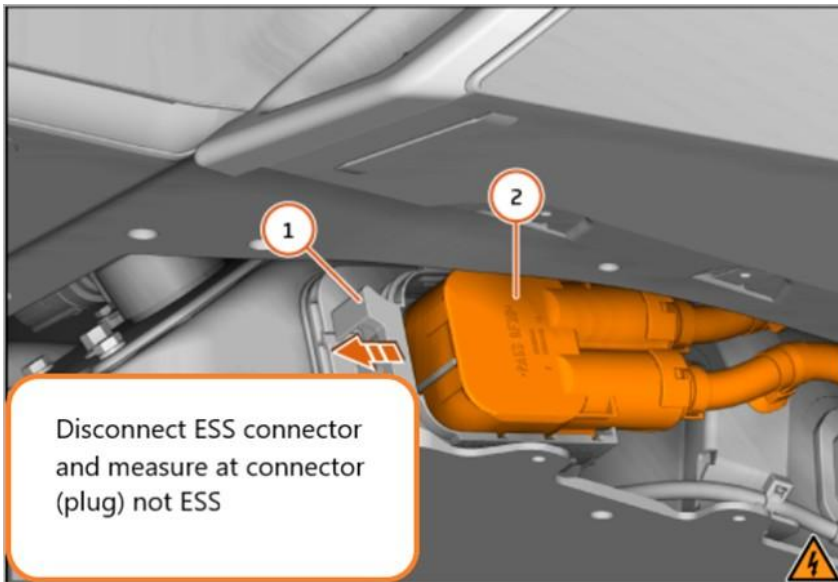
Test Point 3

ESS - MCU DC link test point - Disconnect square HV connector on side of ESS and measure at HV connector (harness side) HV+ to ground then HV- to ground.

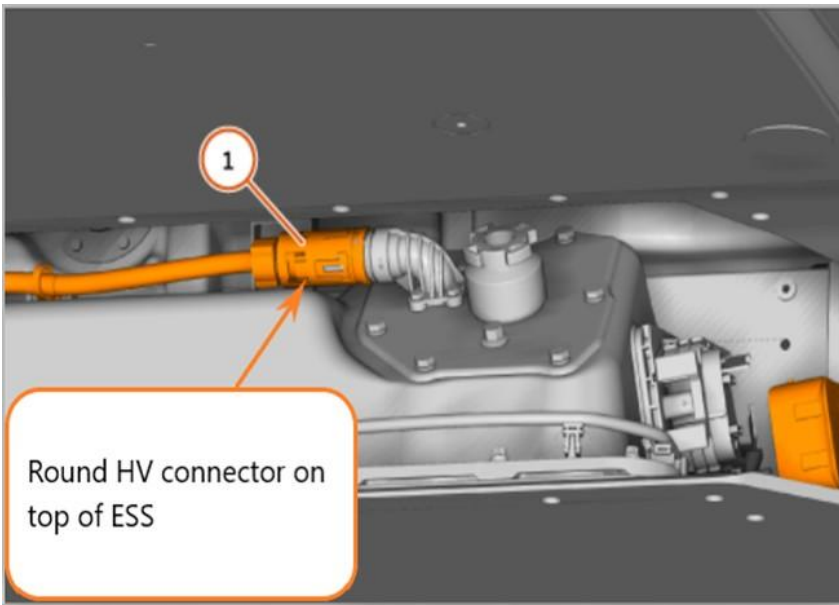
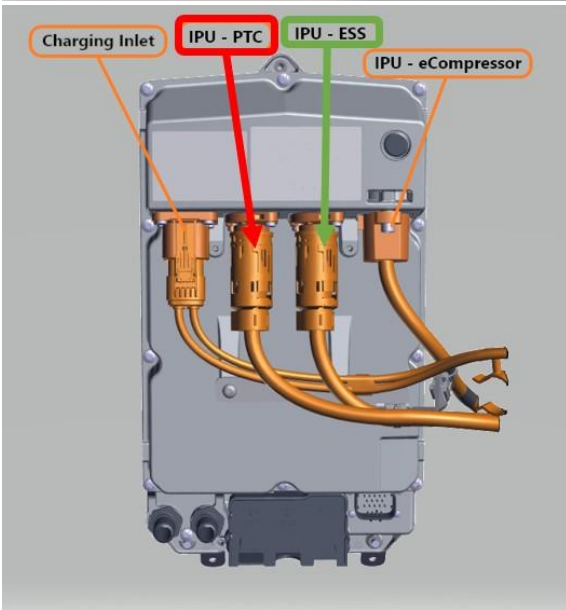
Test Point 4 eCompressor test point - Disconnect round HV connector on top of ESS and disconnect PTC HV connector on IPU highlighted in red. Make sure HV connector on IPU for the ESS is re-connected (test point 2) highlighted in green. Then measure at round HV connector (harness side) HV+ to ground then HV- to ground.

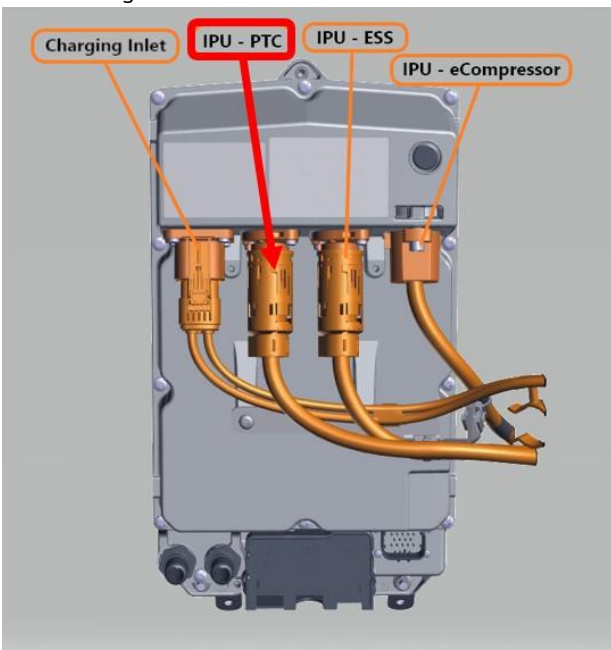
Test Point 5

PTC heater test point – Disconnect PTC heater HV connector at IPU highlighted in red and test at HV connector (harness side) HV+ to ground then HV- to ground.
