Subject: REVISION: N242451030-03 – Customer Satisfaction Program
Multiple Module Reprogramming
Revised Procedure and Warranty sections

Models: 2023 Chevrolet Colorado
2023 GMC Canyon

Customer Satisfaction Program

N242451030 Multiple Module Reprogramming

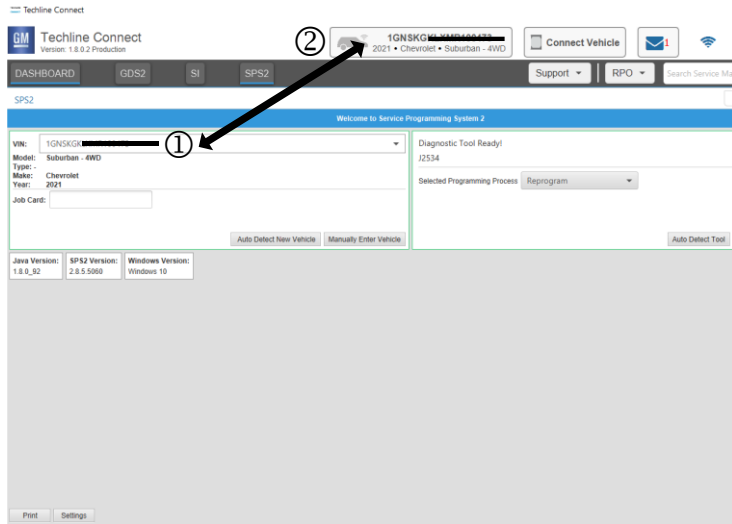
5743643

Caution: Be sure the VIN selected in the drop-down menu (1) is the same as the vehicle connected (2) before beginning programming.

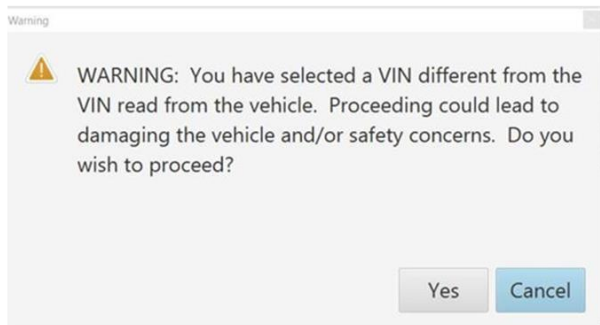
5877000

Important: If the vehicle VIN DOES NOT match, the message below will be shown.

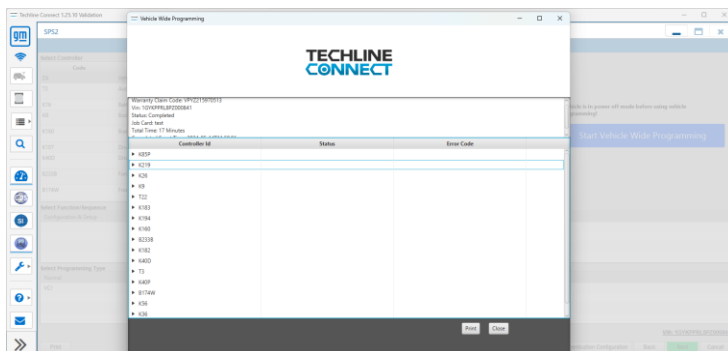
6693875

Important: To avoid warranty transaction rejections, you MUST record the Total Time provided on the Warranty Claim Code (WCC) screen shown above on the job card.

4. Print a copy of the Warranty Claim Code screen and attach to the repair order. “Status Completed” or “Status Blocked” must be achieved to close out the field action. It is also critical to record the total time in order to close out the Field Action.
