Technical Service Bulletin

Topic	Steering Knuckle Replacements Continental GT/GTC 12MY - 18MY
Market area	Bentley: worldwide (2WBE),China 796 VW Import Comp. Ltd (Vico), Beijing (6796)
Brand	Bentley
Transaction No.	2077205/1
Level	EH
Status	Released for publishing
Release date	May 12, 2025

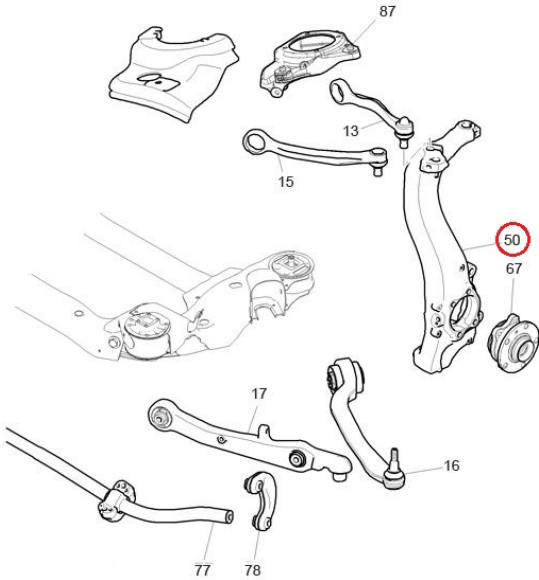
In the event of a steering knuckle change requirement. Parts initially need to be changed as a pair for both sides of the vehicle in place of the no longer available parts.

Once recorded in vehicle repair history that both sides have been replaced with new level parts. Only then can individual sides can be changed in the future if required.

Carry out an inspection of the vehicles repair history. If a steering knuckle has been previously replaced, you must ensure that the correct specification was fitted to both sides of the vehicle. Only then can individual sides can be replaced.

If old level parts are currently fitted. Replace **both** steering knuckles with the new level part numbers.
